MAY 2015

Kidder Township  
Stormwater Concept Plan  
Project No. 10635.13

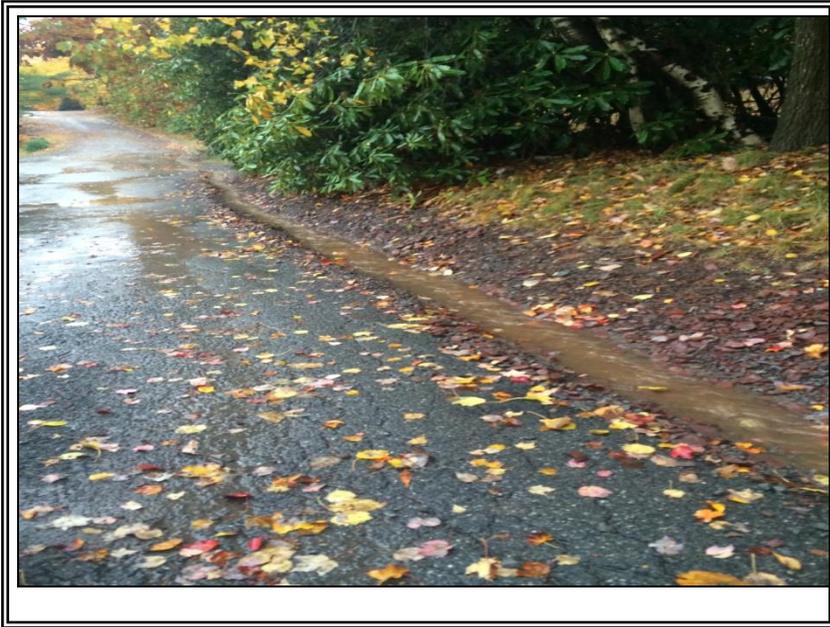
Existing Deficiency: Labarre Drive is a private gravel road with a paved portion at the low point of the road. Located at the low point are two inlets that collect runoff from the road and the upstream areas between Lebarre Drive and North Lake Drive. The inlets discharge directly to the lake. A concrete-lined overflow swale routes the remaining runoff, which bypasses the inlets, to the lake. Currently the inlets and overflow swale have no filters. Erosion was noted along the north shoulder of the road.

**T1-Labarre Drive**  
Roadway run-off upstream of inlets

Recommendation: The stone portions of the roadway should be paved with a rolled curb gutter on the north shoulder to alleviate erosion or vegetated swales with check dams should be installed along the road to direct water to the inlets and overflow swale. Inlets should be replaced at a lower elevation to capture the runoff and a sump should be provided in the inlets for the installation of snouts. The installation of the snouts and vegetated swale would provide filtering for the runoff, alleviating organic and soil pollution to the lake.

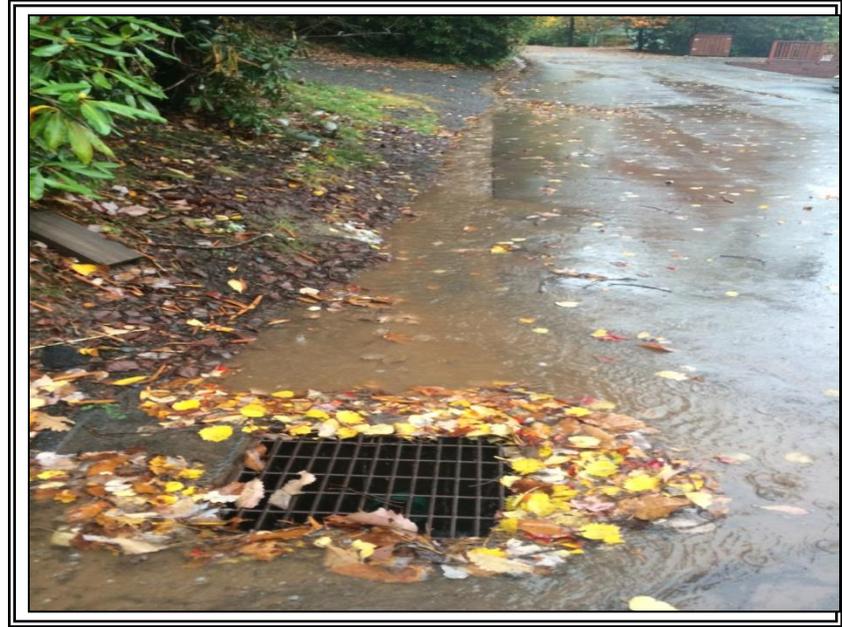
**T1-Labarre Drive**  
Inlet on north side of road

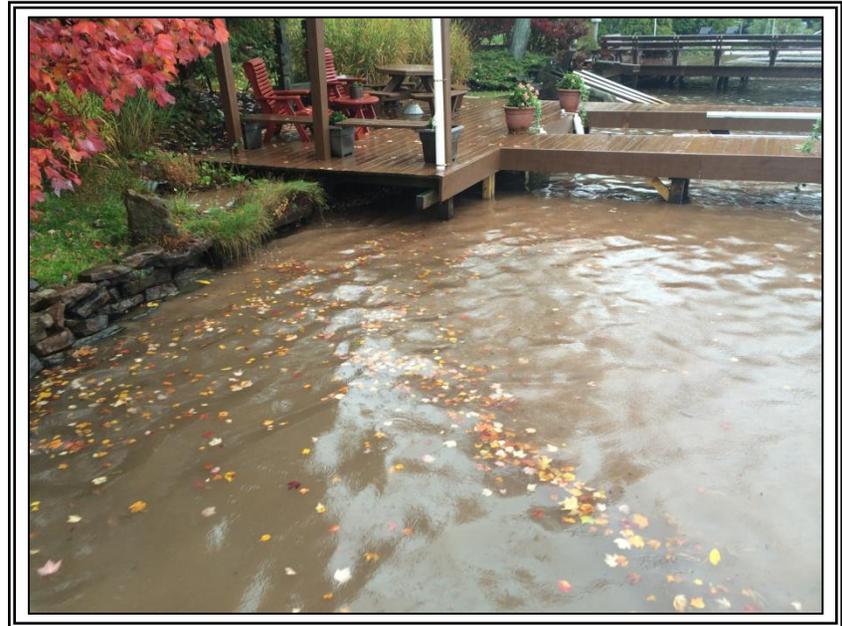
**T1-Labarre Drive**  
Lake downstream of overflow channel

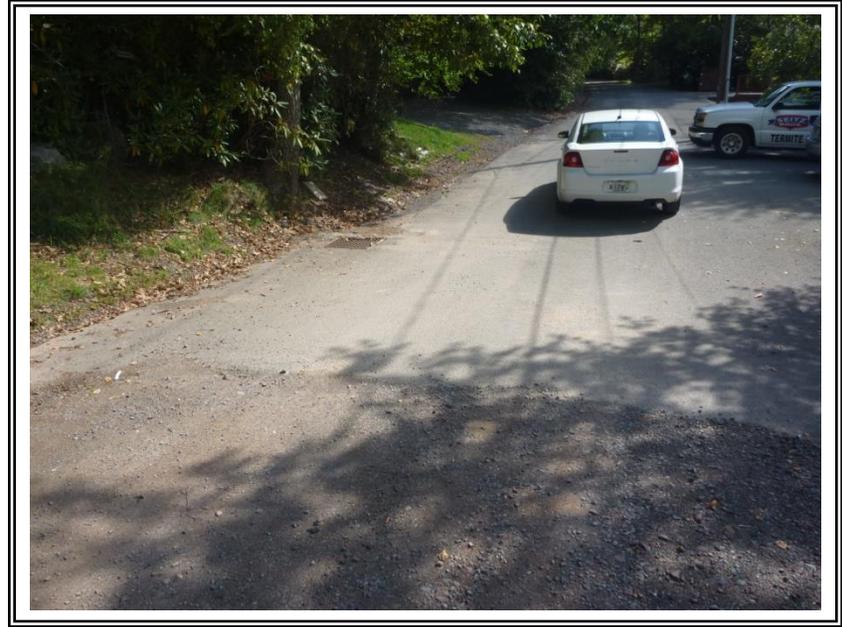
**T1-Labarre Drive**  
Unpaved road condition

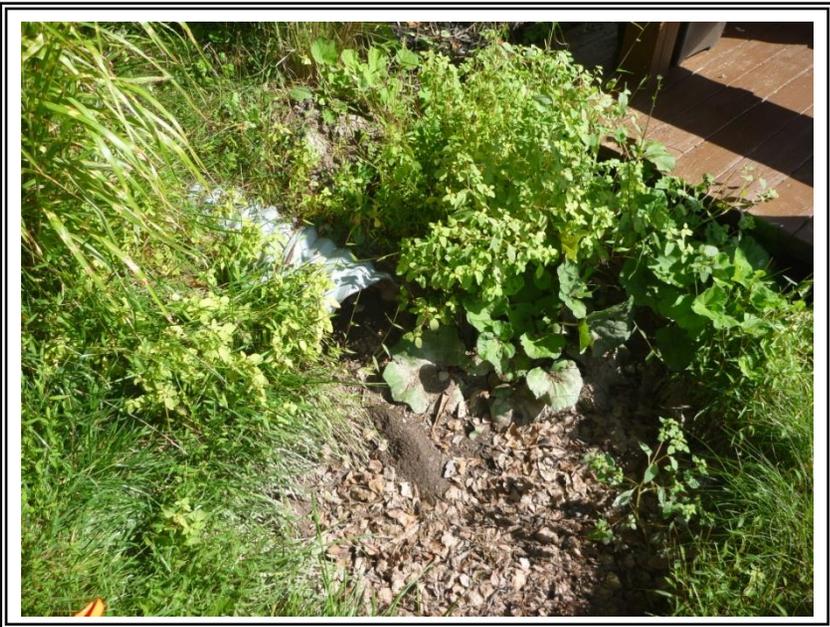
**T1-Labarre Drive**  
Discharge from inlets

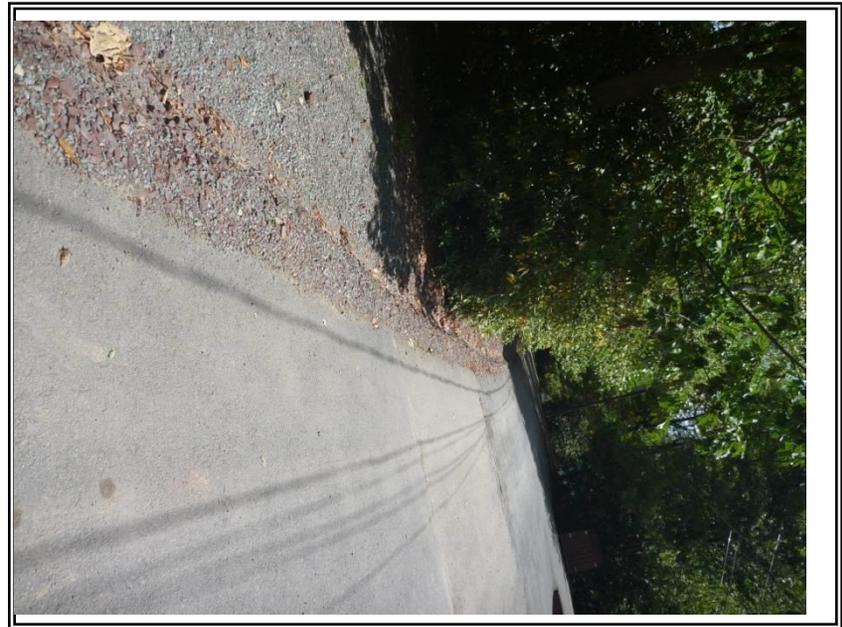
**T1-Labarre Drive**  
Roadside erosion

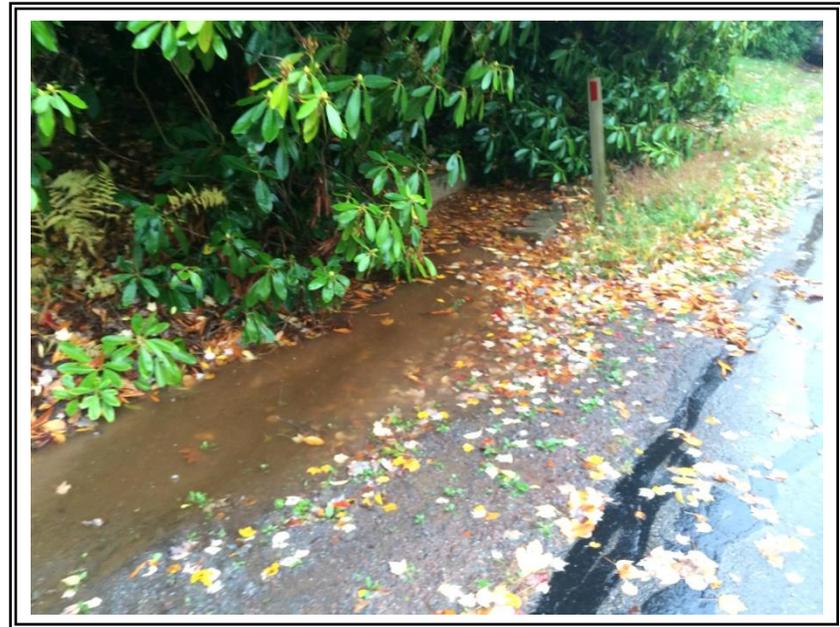
Existing Deficiency: Kidder Avenue is a private, steep, red stone road on Lake Harmony Estates property. An existing headwall and cross pipe are installed in North Lake Drive and it would assume used to discharge across the road down Kidder Avenue. In the location where the outlet of this pipe should be is a built-up residential parking area. It is assumed water that flows across the road is entering the stone subbase of the road. A new retaining wall at the end of the parking area with a trench grate system was recently installed at the bottom of the roadway and discharges to a rock rain garden. The rock rain garden is drained by a discharge pipe from the bottom directly to the lake. The rock rain garden is not adequately filtering the stormwater runoff as evident by the photos taken during heavy rain events.

**T3 – Kidder Avenue**  
Headwall at Kidder Avenue

Recommendation: The existing rock rain garden should be considered to be retrofitting with a vegetated rain garden with adequate freeboard and discharge pipe elevation designed to allow adequate filtering of pollutants. A more detailed analysis of the rain garden size should be performed to ensure that it is adequately sized to handle the amount runoff and that the PADEP recommended loading ratio is not significantly exceeded or if the size complies with the rain garden sizing chart in the small application for stormwater management adopted by the Township.

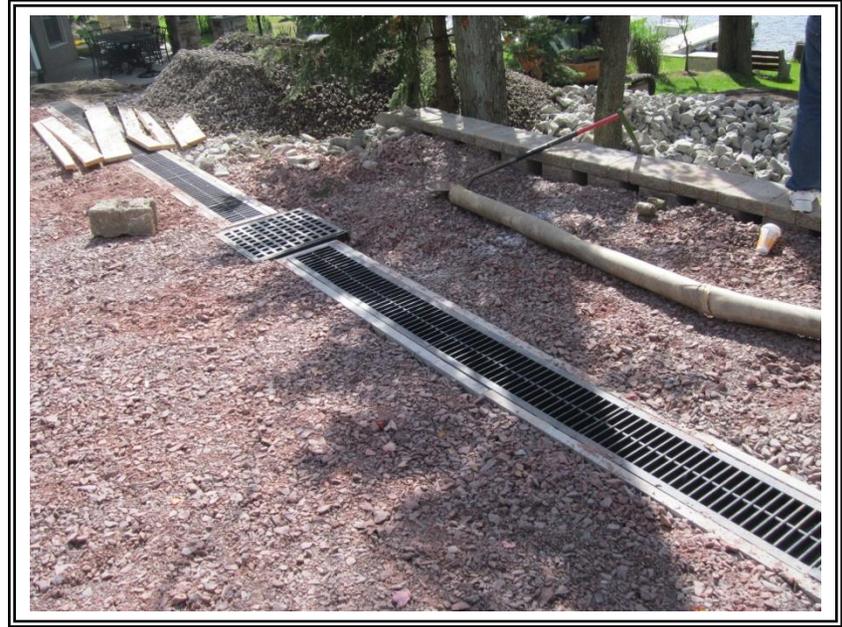
**T3-Kidder Avenue**  
Trench drain to rain garden

The driveway/road should be considered to be paved to prevent additional stone and debris from washing into the trench gate and basin. Also the amount of surface sheet flow from North Lake Drive running down the roadway should be decreased if possible. Future roadway work along North Lake Drive should include curbing with a new inlet before this roadway/driveway. The existing headwall and cross pipe should be replaced with a new inlet with a snout, cross pipe and vegetated apron and the stormwater captured should be routed to a new filtration system, namely a vegetated swale or rain garden, rather than through the driveway subbase.

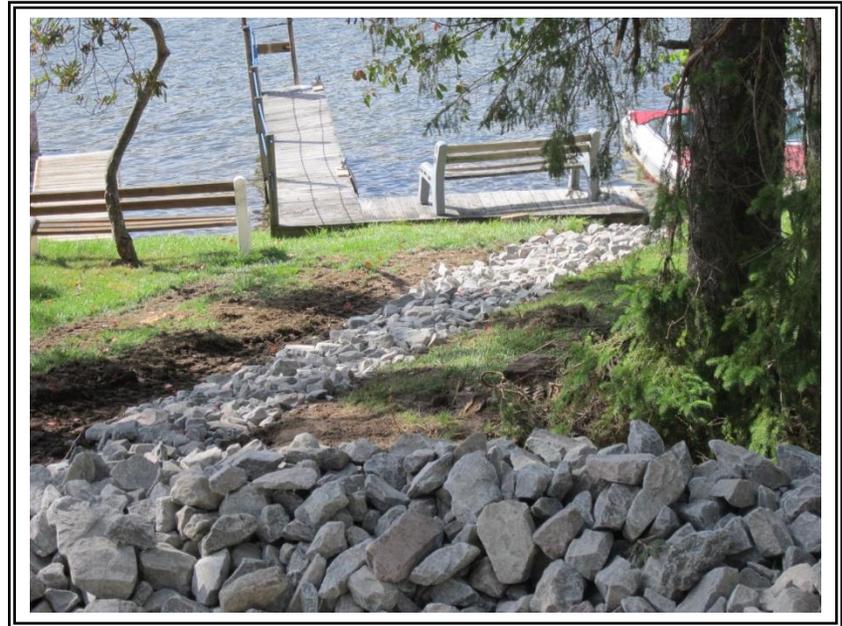
**T3-Kidder Avenue**  
Stone swale to lake

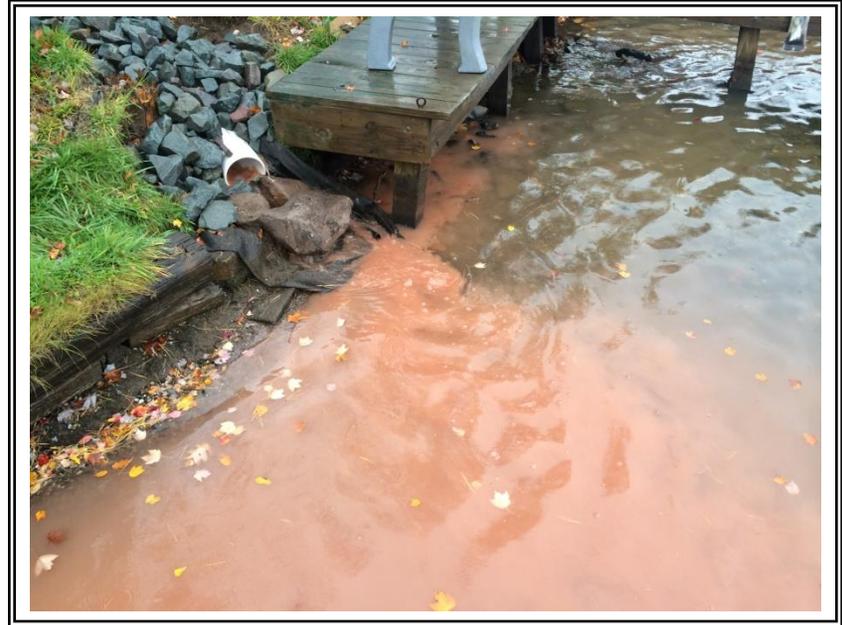
**T3-Kidder Avenue**  
Discharge pipe to the lake

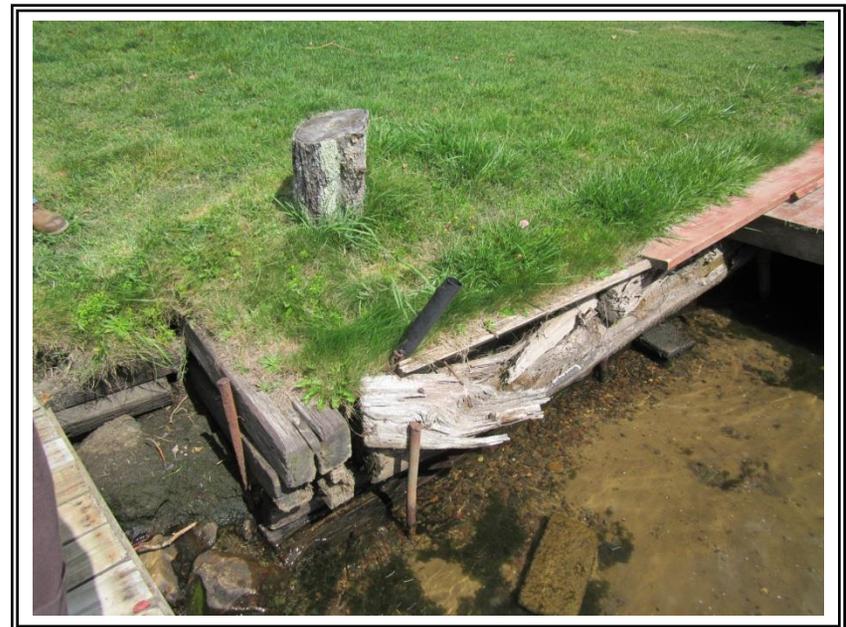
**T3-Kidder Avenue**  
Damaged Bulkhead

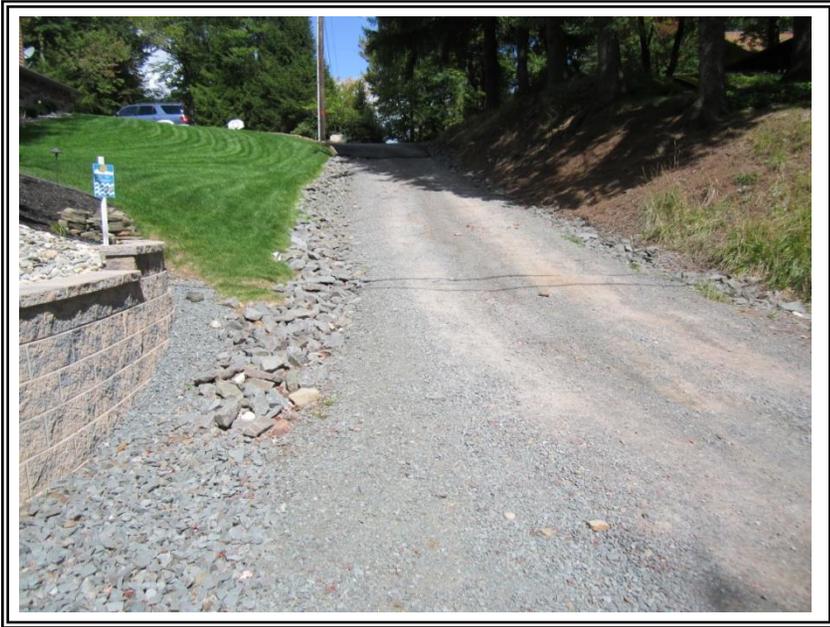
Existing Deficiency: Hartung Street is a private stone road with two stone swales running alongside the road down to North Lake Drive. A roadside infiltration trench runs on the west side of North Lake Drive. The infiltration trench does appear to be collecting and infiltrating small storms. However, during heavy rainfall runoff leaves the trench drain then crosses Hartung on the North Side, and it erodes the gutter area and transports sediment to the storm system. A headwall and storm pipe transports runoff across the street to a swale that extends halfway down Hartung Street on the south side. The swale appears to come to a dead end at an existing driveway, requiring stormwater to run through the driveway stone to a rock garden near the lake. It was observed that the rock garden is not adequately filtering runoff from large storms. An outlet pipe at the bottom of the basin is discharging to the lake.

**T4-Hartung Avenue**  
Unpaved portion of road

Recommendation: The existing headwall and cross pipe should be replaced with a new inlet, snout, pipe, and stilling basin/vegetated apron. Hartung Street should be paved to eliminate runoff from the stone surfaces. The swales on both sides of the street should be regraded and vegetated with check dams to promote infiltration, filtration, and detention of the runoff. The swale on the south side

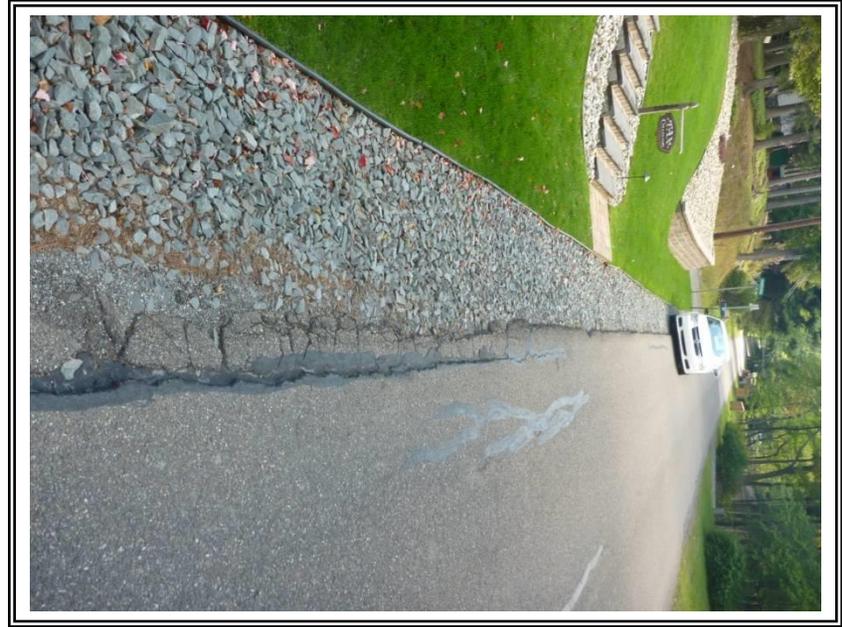
**T4-Hartung Avenue**  
Infiltration trench

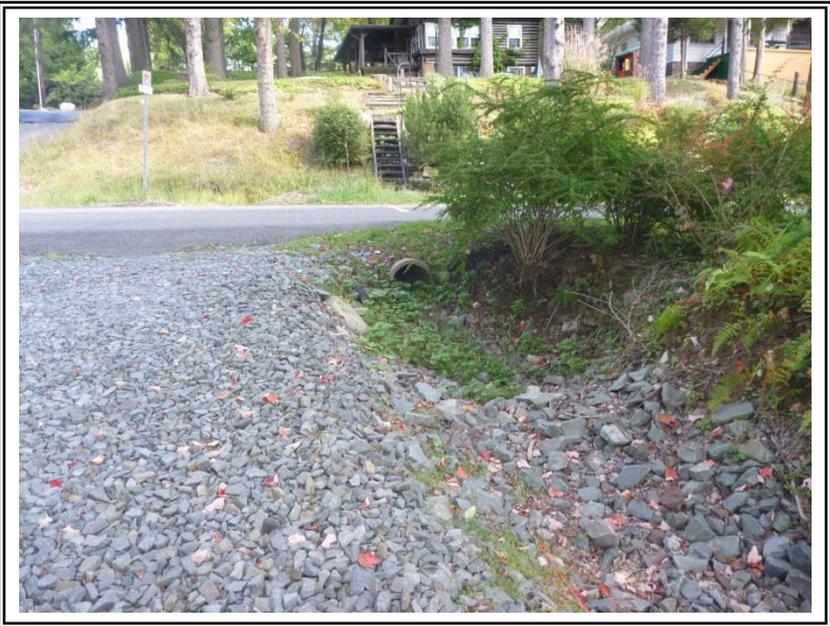
**T4-Hartung Avenue**  
Swale discharge

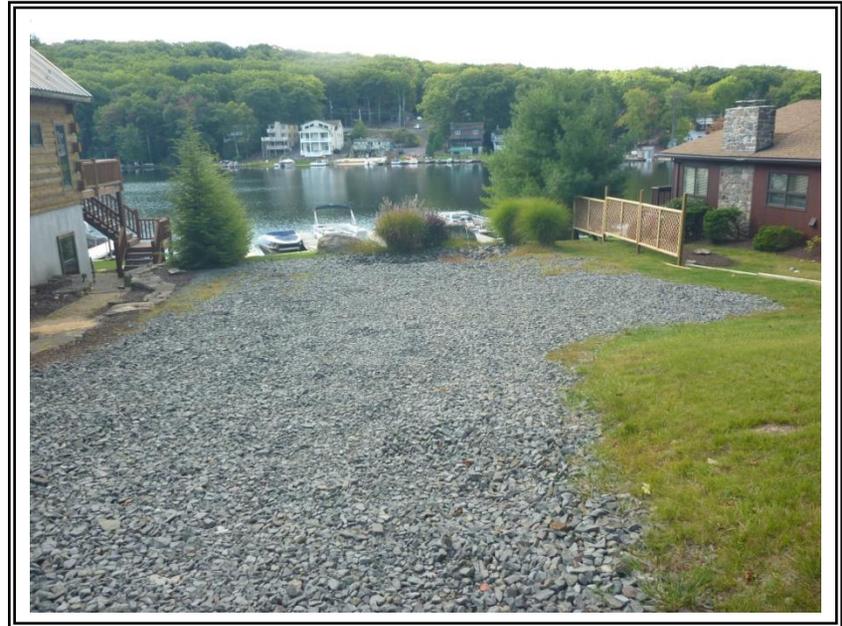
**T4-Hartung Avenue**  
Stone rain garden

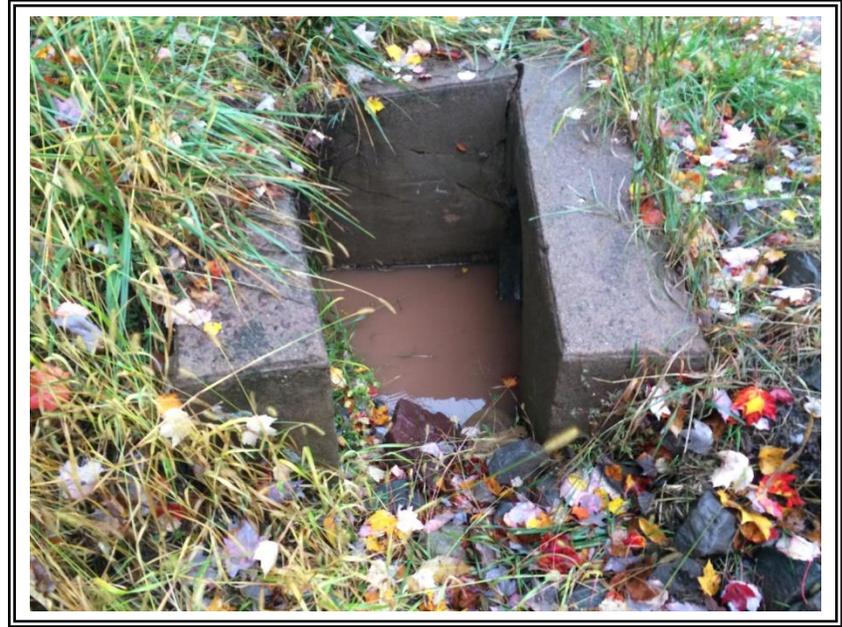
**T4-Hartung Avenue**  
Headwall

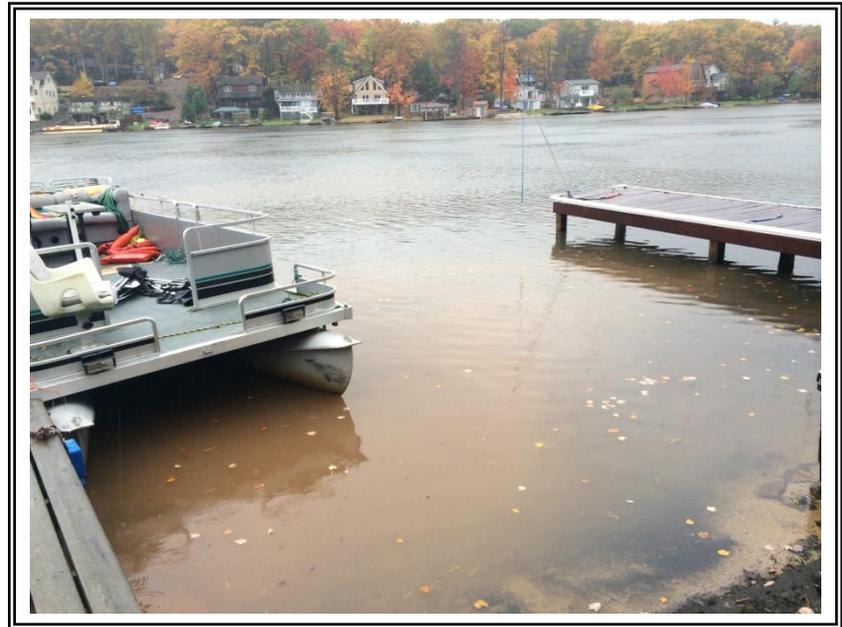
**T4-Hartung Avenue**  
Lake below discharge pipe

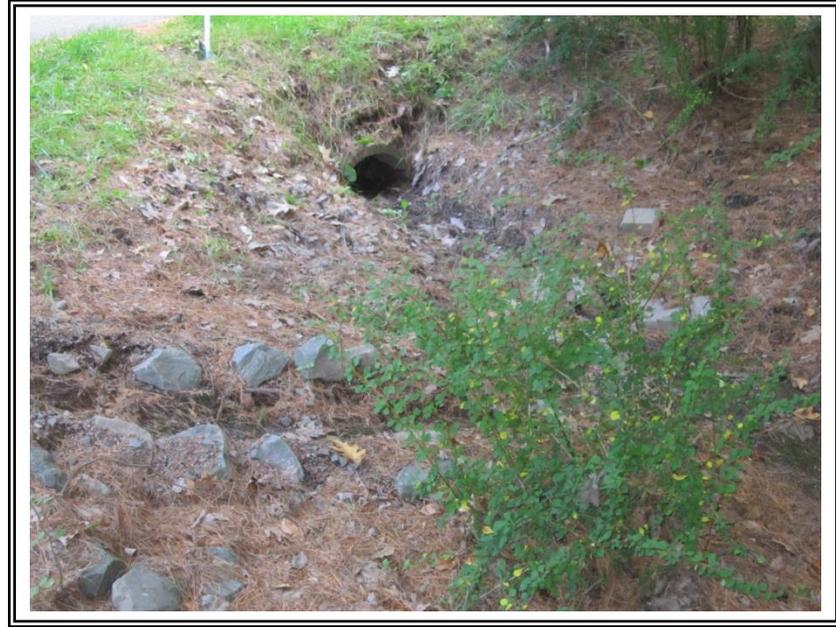
Existing Deficiency: Drainage to the Marina is divided into two sections prior to converging into a discharge pipe into the marina. A storm sewer system at the intersection of North Lake Road and Harmony Avenue collects water through two inlets which then discharge to a swale. The piping system appears new and is in good condition. The water drains down an eroded swale to a junction pipe to the marina.

**T5 - Marina**  
Crosspipe discharge

Recommendation: The existing swales should be modified, widened, and reconstructed as vegetated swales with check dams. Additionally a swale, inlet, and rolled curb to direct runoff to the storm system should be considered in future planning for when the roadway is to be re-paved.

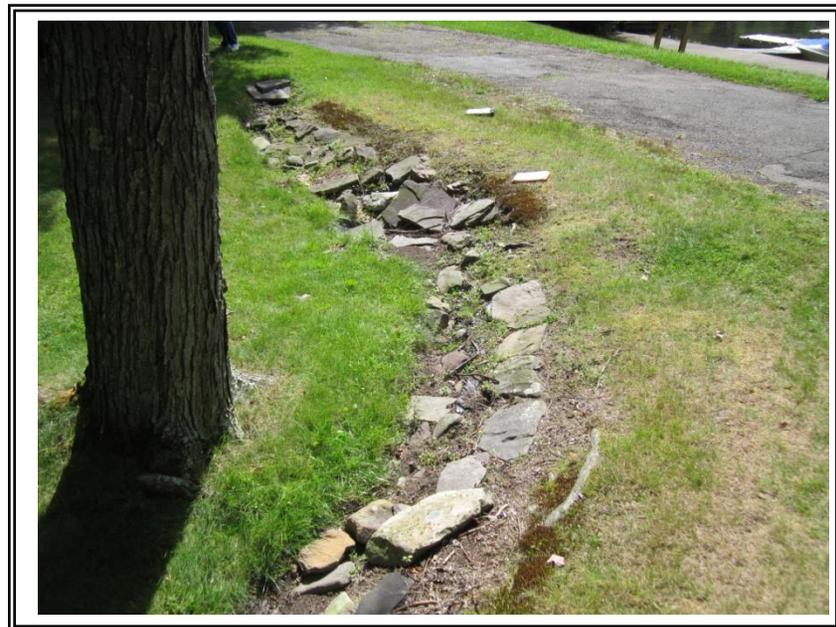
**T5 - Marina**  
Swale to upstream marina discharge

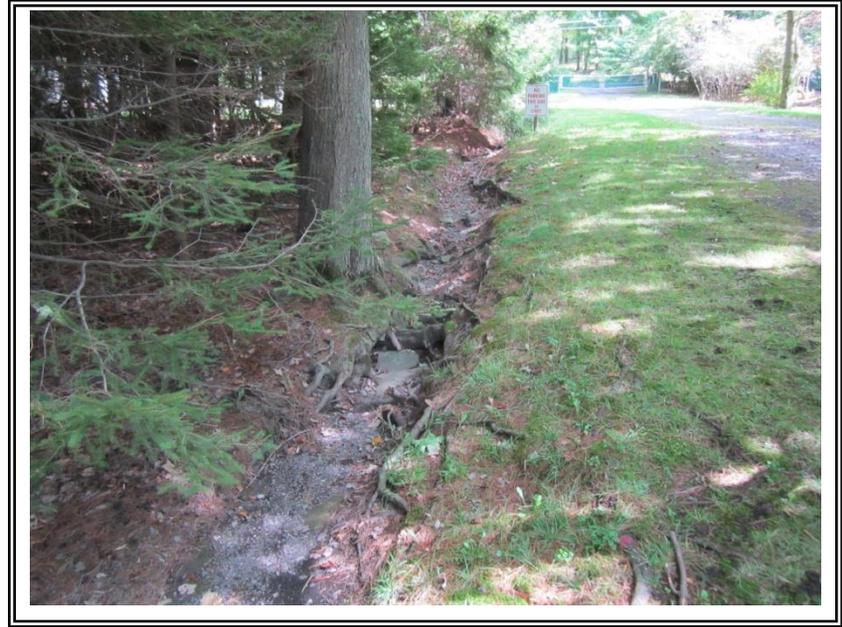
**T5 - Marina**  
Eroded swale east of marina

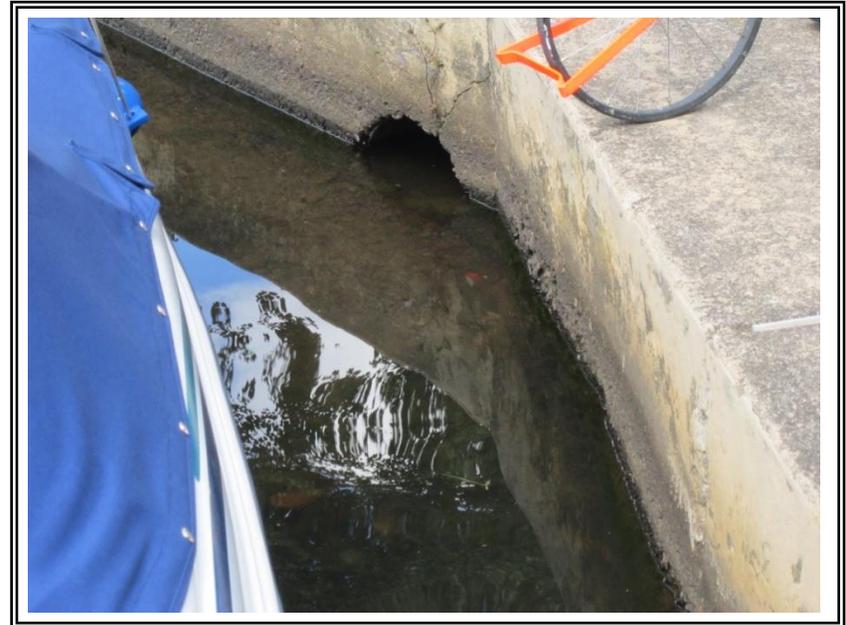
**T5 - Marina**  
Marina discharge

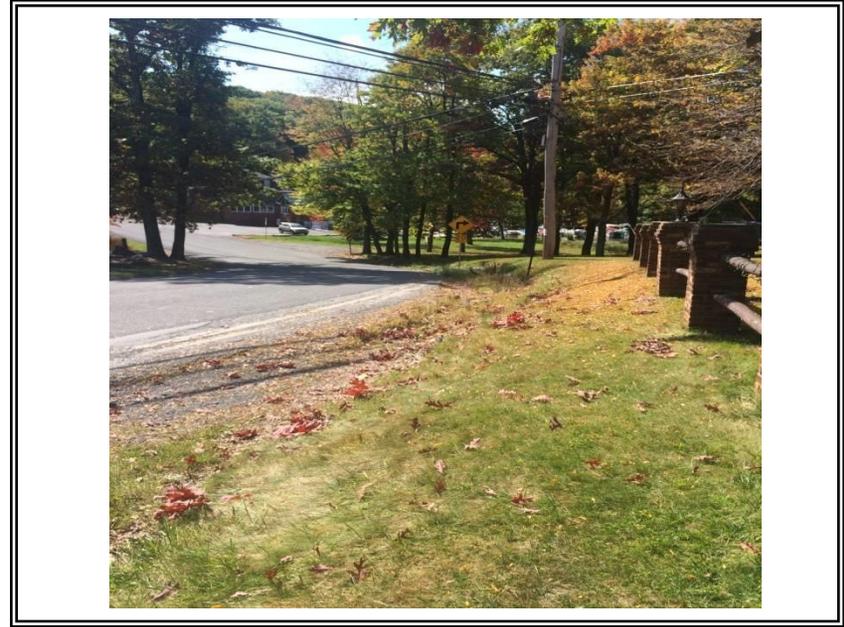
Existing Deficiency: Downstream of the South Lake and North Lake Drive intersection mentioned above runoff that either enters the conveyance system or flows through the intersection down the north edge of North Lake Drive is eroding the side of the road and severely damaging the bituminous pavement. In addition the construction of the parking area for the dry hydrant redirects runoff flowing along the north gutter line across South Lake Drive.

**T7 – North Lake Drive**  
Looking South

Recommendation: The improvements noted for area T6, if constructed, will remove a majority of the water from affecting this area and will help with future erosion problems. However, if run-off is left to run along the north side of North Lake drive and conveyed directly to the receiving stream, a paved gutter or swale to a pipe cross culvert outletting to the receiving stream should be installed or a new swale around the dry hydrant to the concrete spillway.

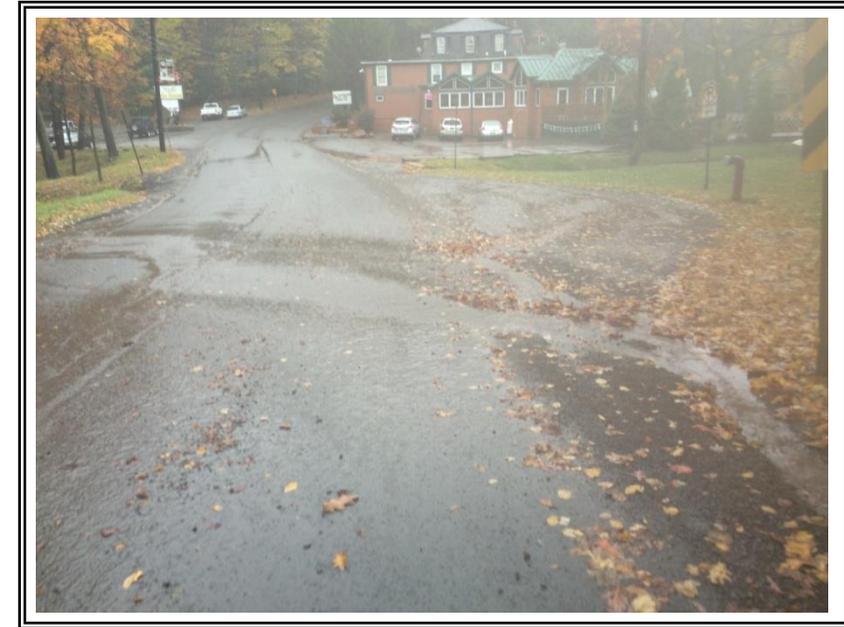
**T7 – North Lake Drive**  
Sheet flow across roadway

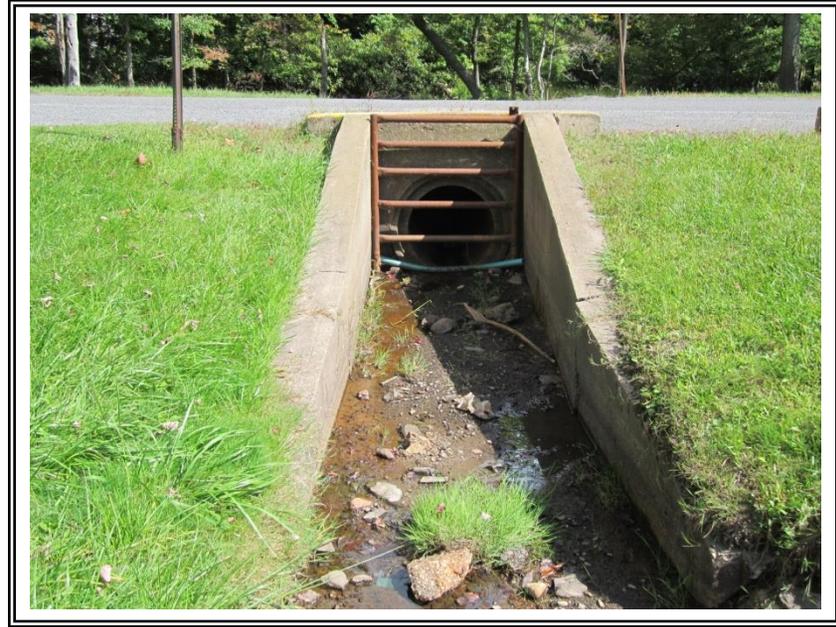
Existing Deficiency: A 30 inch culvert crosses South Lake Drive and is the overflow for Lake Harmony. The upstream concrete swale is generally in good condition with surface spalling. The downstream swale is vegetated with erosion alongside the road shoulder and at the discharge.

**T8-Discharge at Nicks**  
Headwall

Recommendation: The downstream swale and erosion should be repaired with riprap to stabilize the shoulder and swale banks.

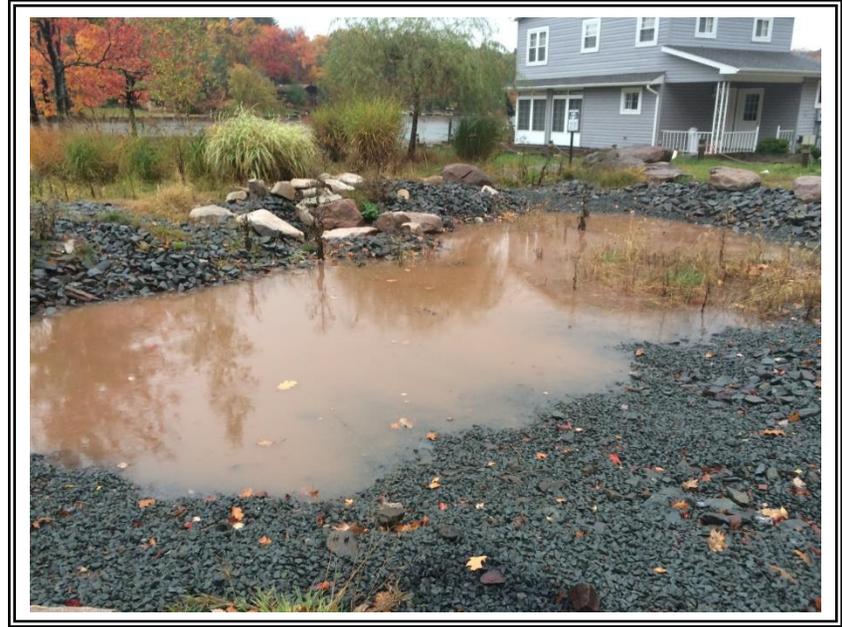
**T10-Church Street**  
Rock rain garden during heavy rain

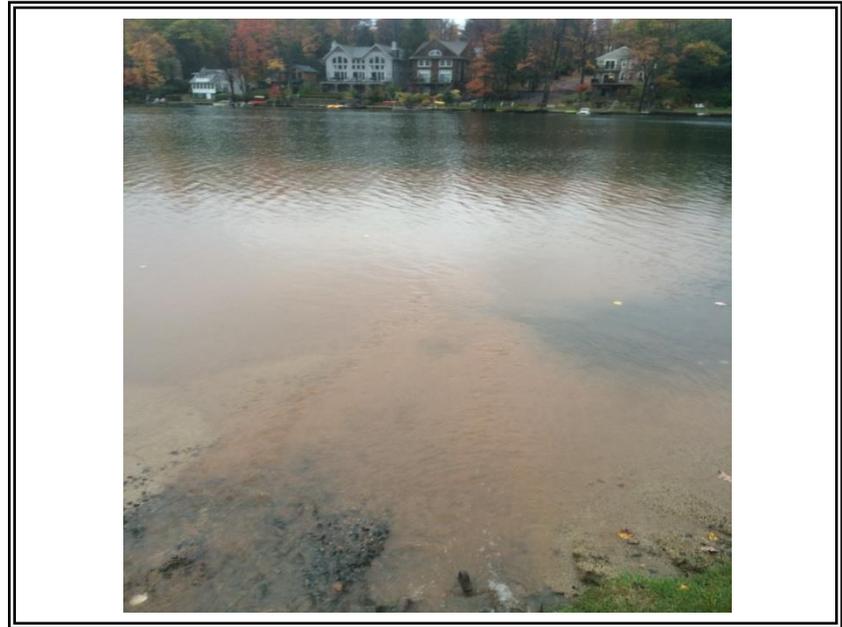
**T10-Church Street**  
Lake below rock rain garden during heavy rain

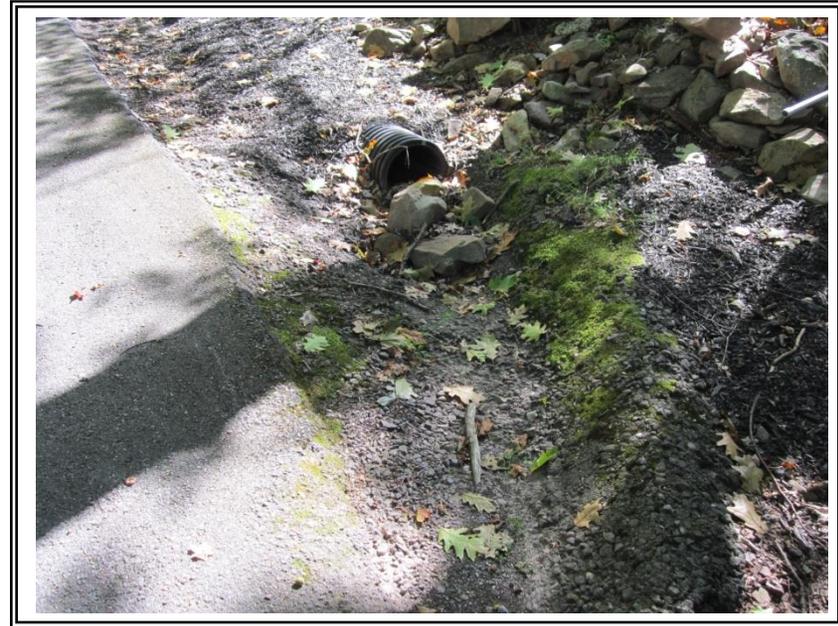
**T11-South Lake Drive**  
Swale discharge

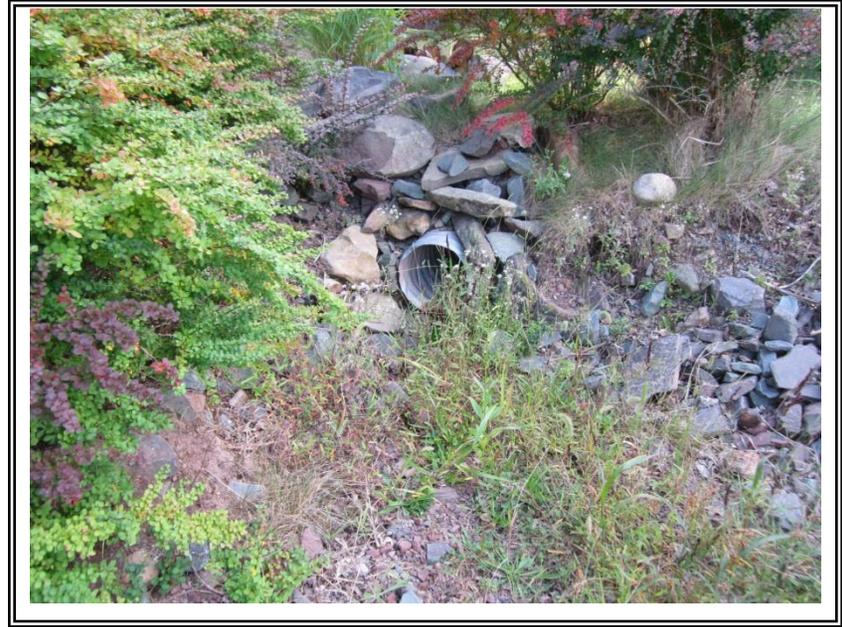
**T12-Pine Street**  
Discharge to rain garden

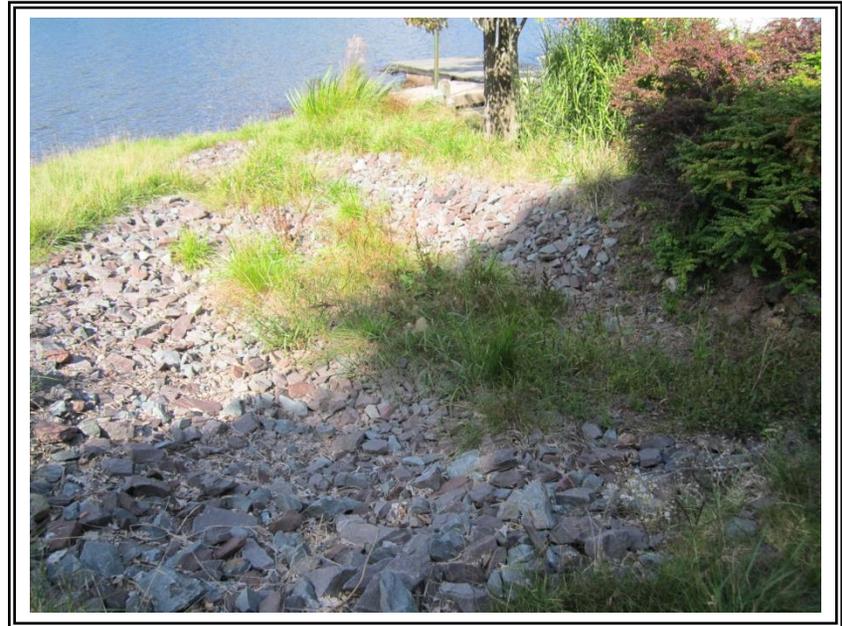
**T12-Pine Street**  
Rock rain garden

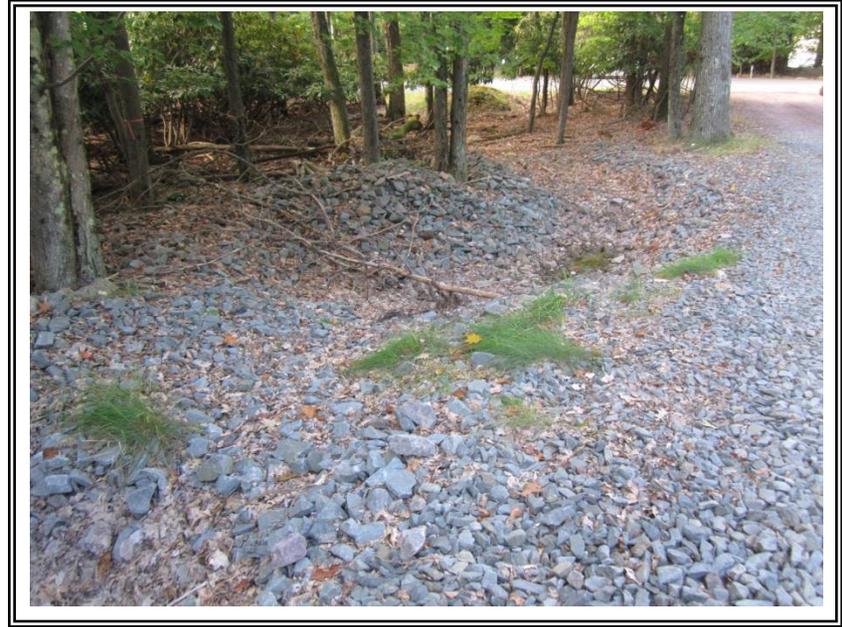
**T14-Chestnut Street**  
Rain garden discharge path

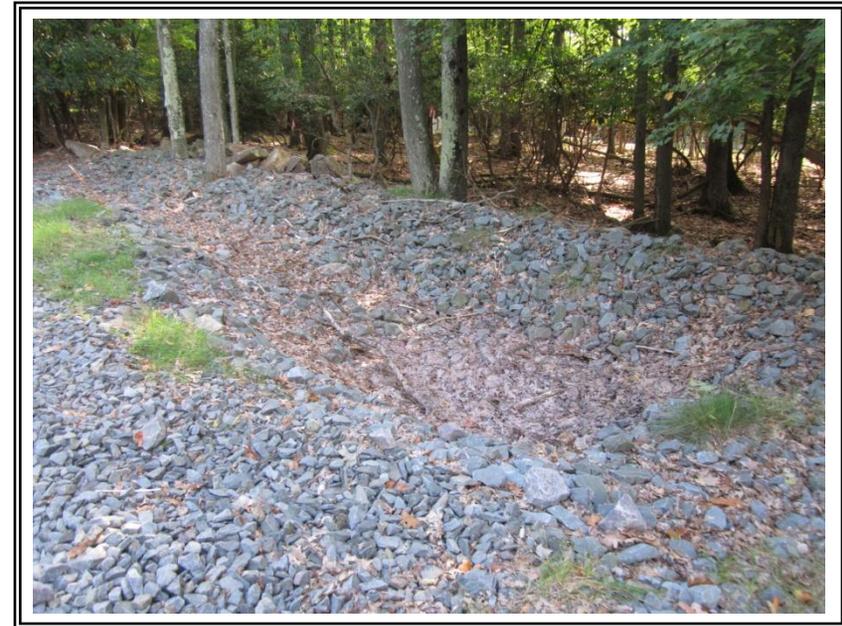
**T14-Chestnut Street**  
Rock rain garden

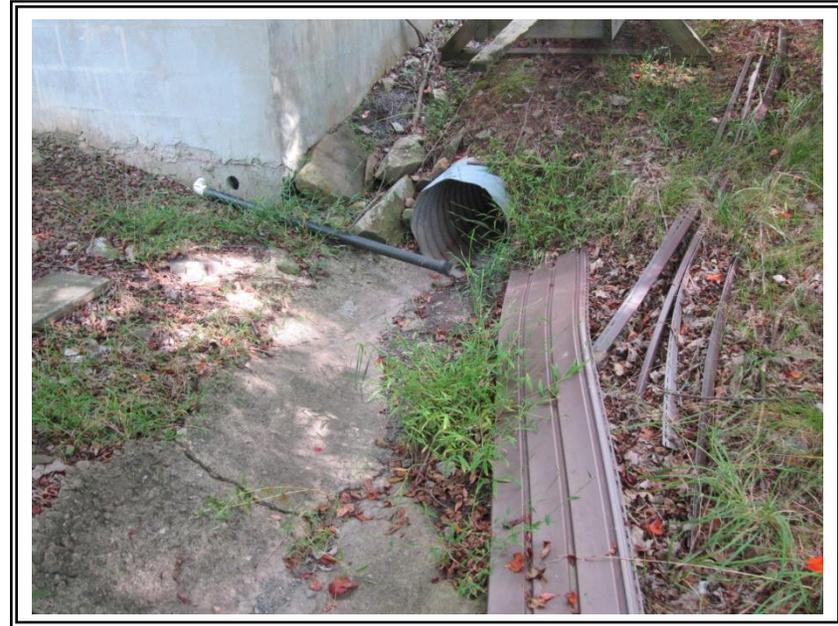
**T16-Between Houses 246 & 248**  
Inlet discharge pipe

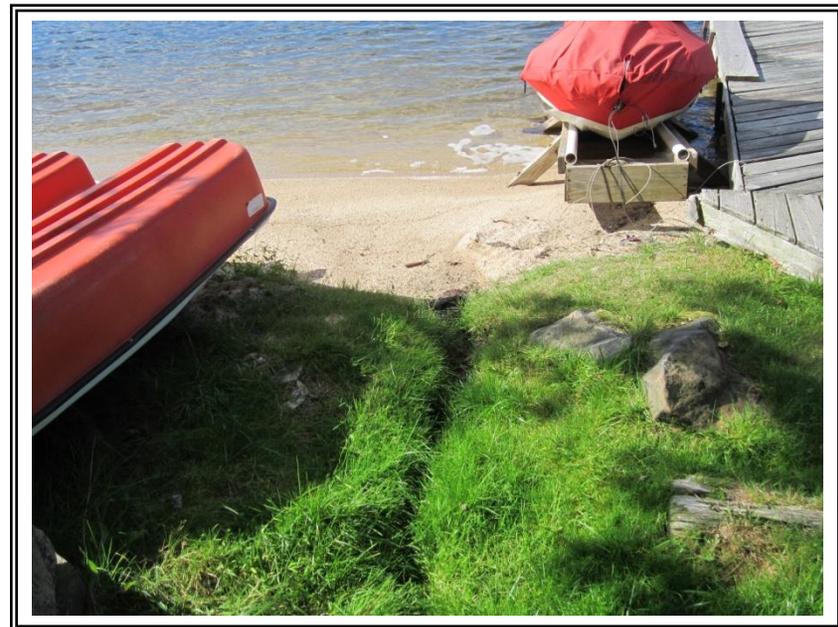
**T16-Between Houses 246 & 248**  
Eroded channel to lake

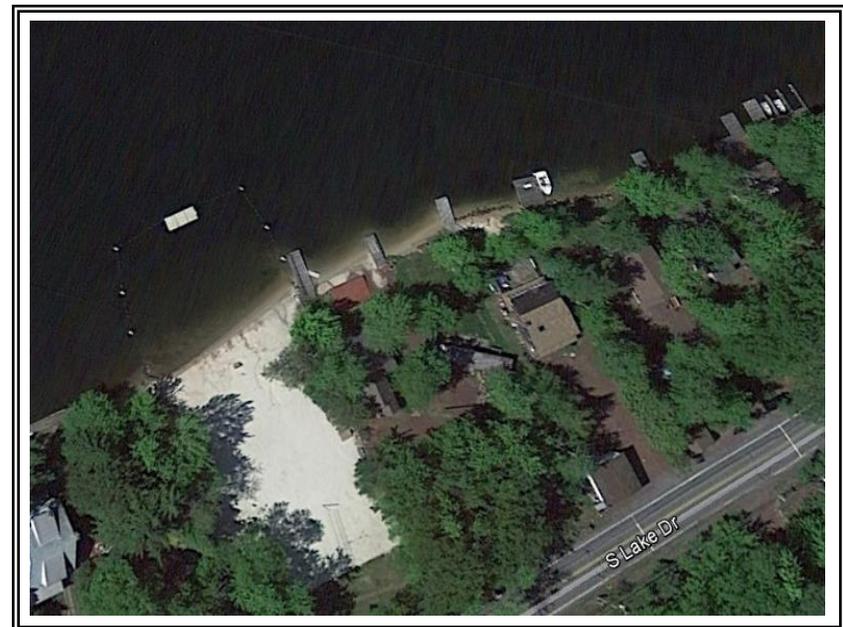
**T17-Beach**  
Aerial Photo of Beach washing to adjoining properties

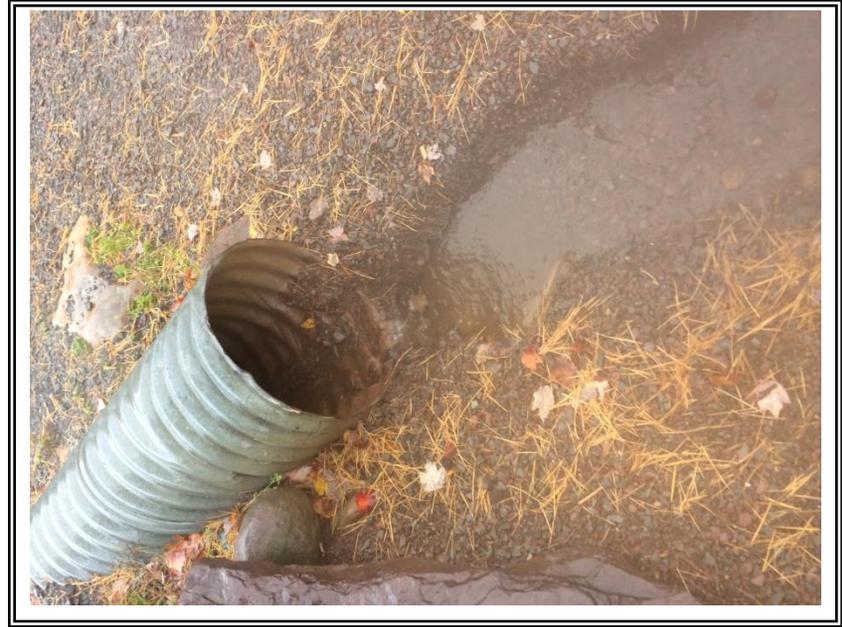
**T18-Boat Access at Wood**  
Discharge pipe at Lake

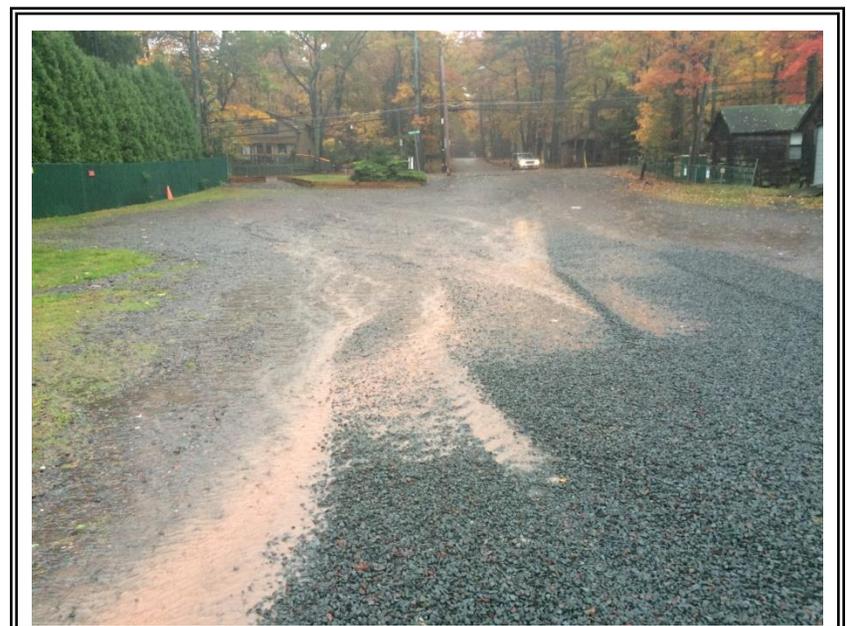
**T18-Boat Access at Wood**  
Looking up towards South Lake  
Drive

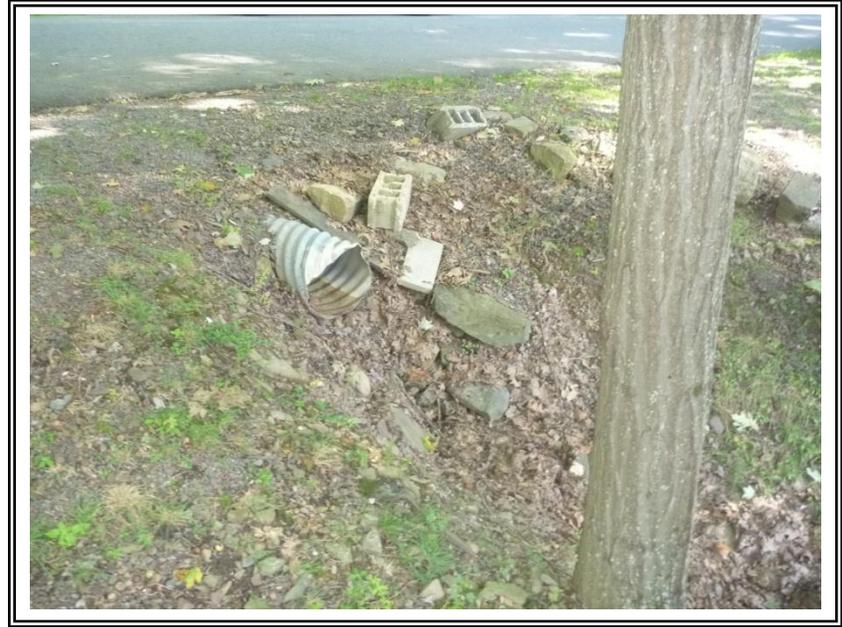
**T19-Skye Drive**  
Discharge to eroded swale

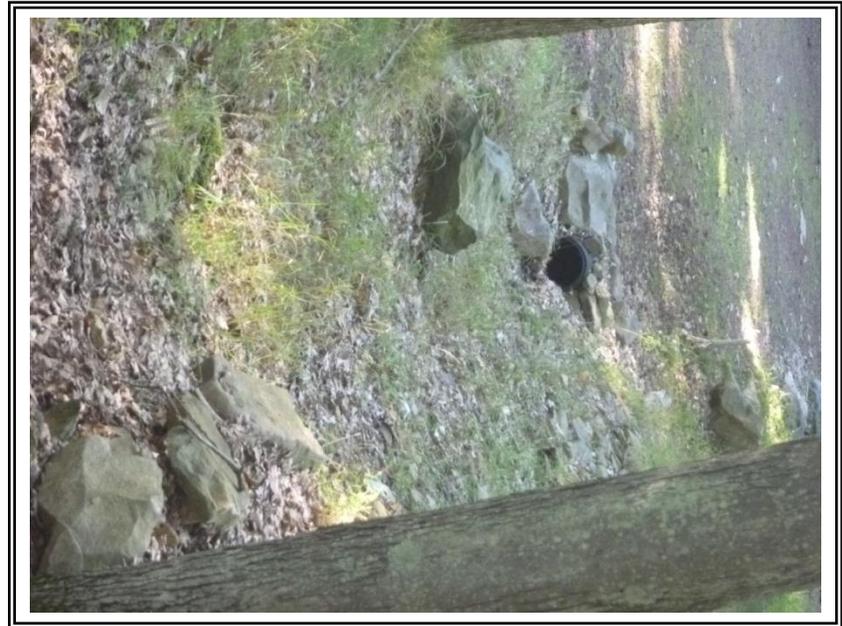
**T19-Skye Drive**  
Discharge pipe to woods

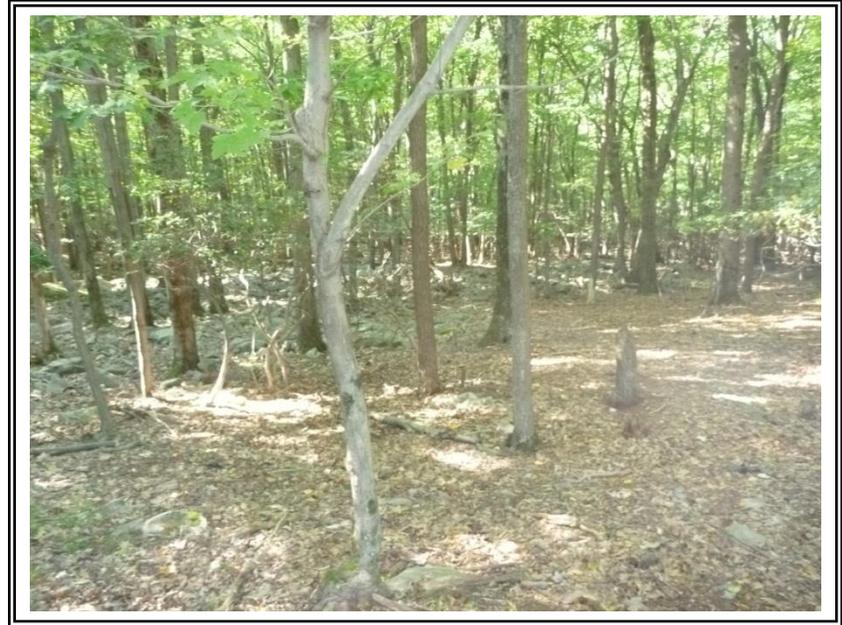
**T19-Skye Drive**  
Flow path through woods
