MAY 2015

Kidder Township  
Stormwater Concept Plan  
Project No. 10635.13

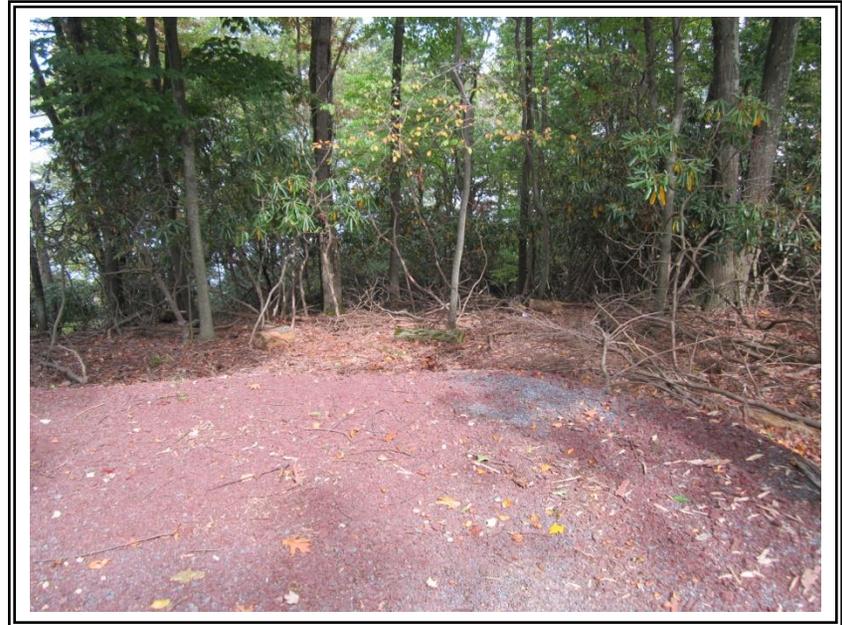
**T21-Spring Street**  
Wooded area between lake and S.  
Lake Drive

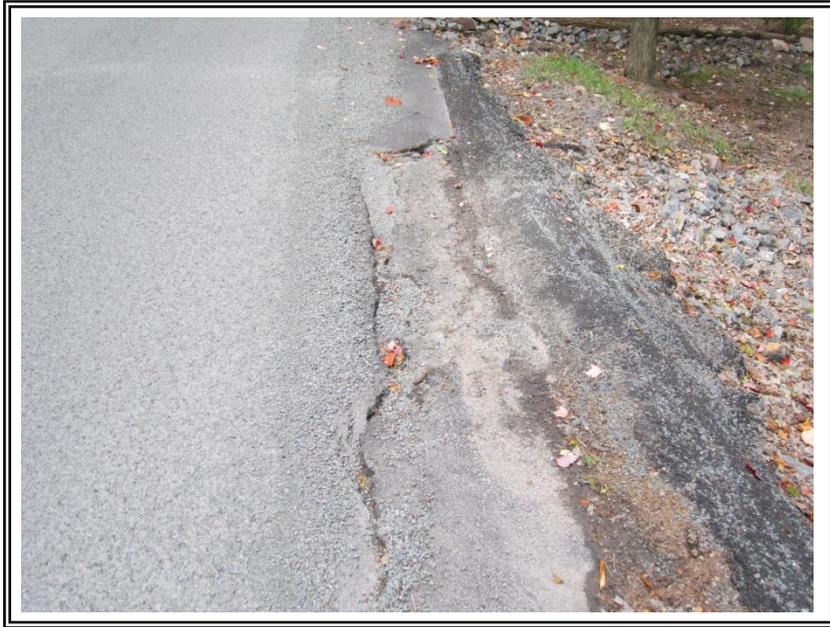
**T23-Henning Street**  
Deteriorated road condition

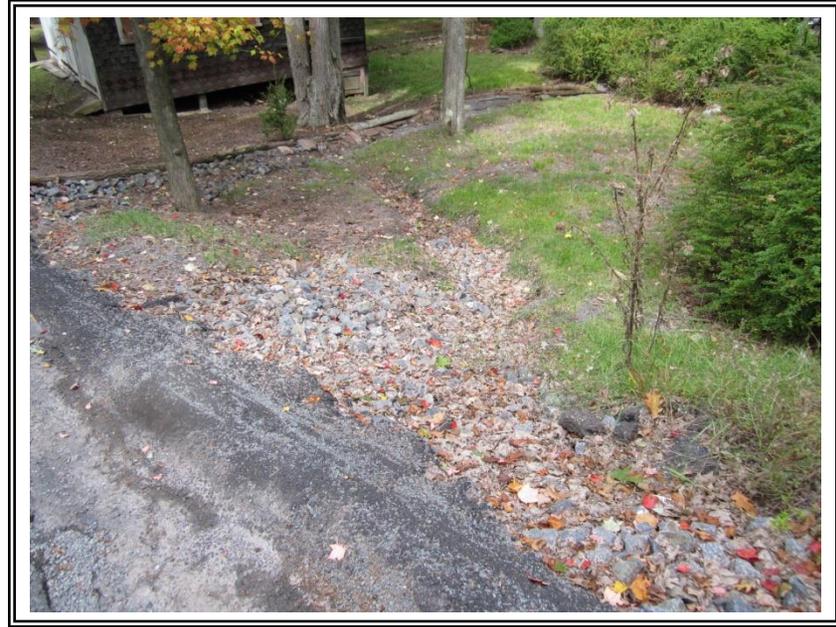
**T23-Henning Street**  
Riprap for runoff

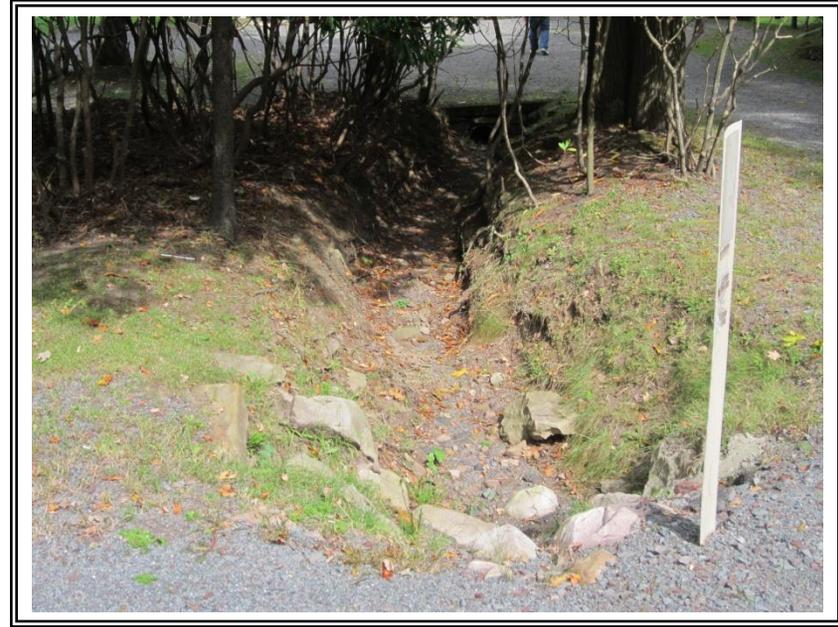
**T23-Henning Street**  
Channel system to lake

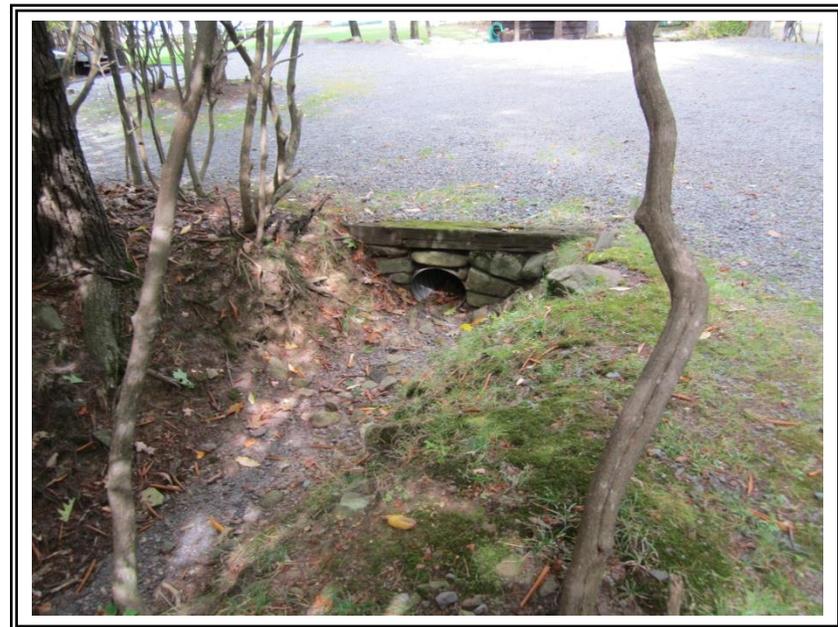
**T23-Henning Street**  
Channel system to lake

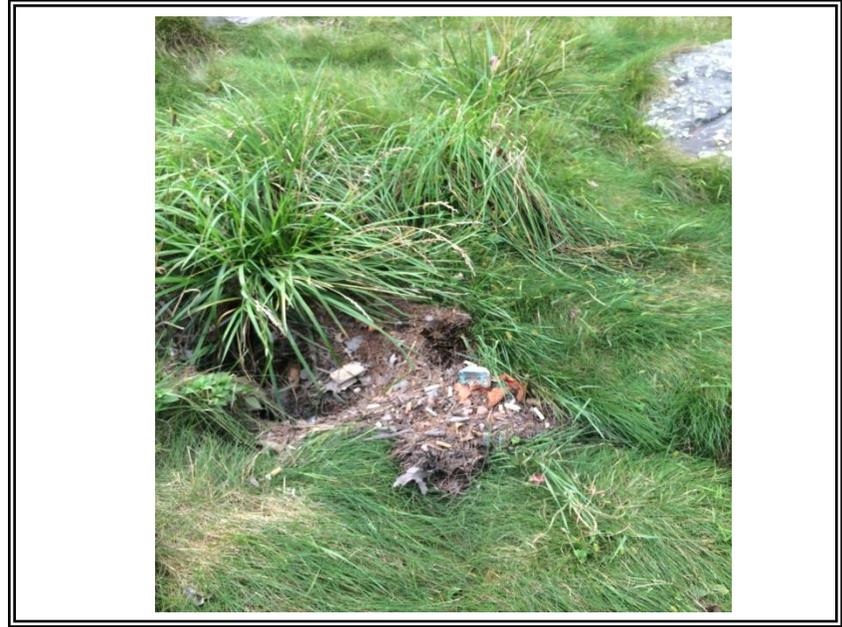
**T25-Split Rock Parking Lot**  
Garbage below parking lot discharge

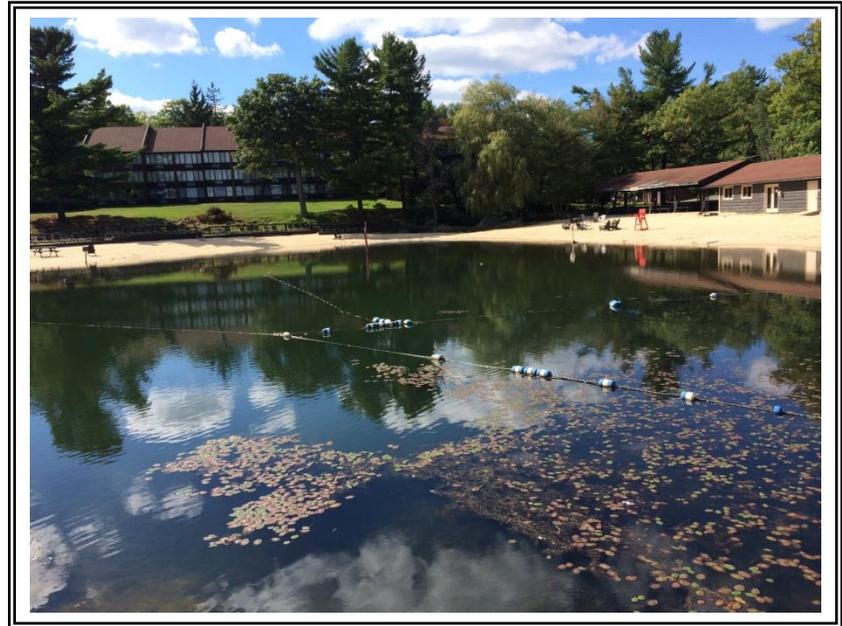
**T26-Split Rock Lagoon**  
Looking towards bathrooms away from lake

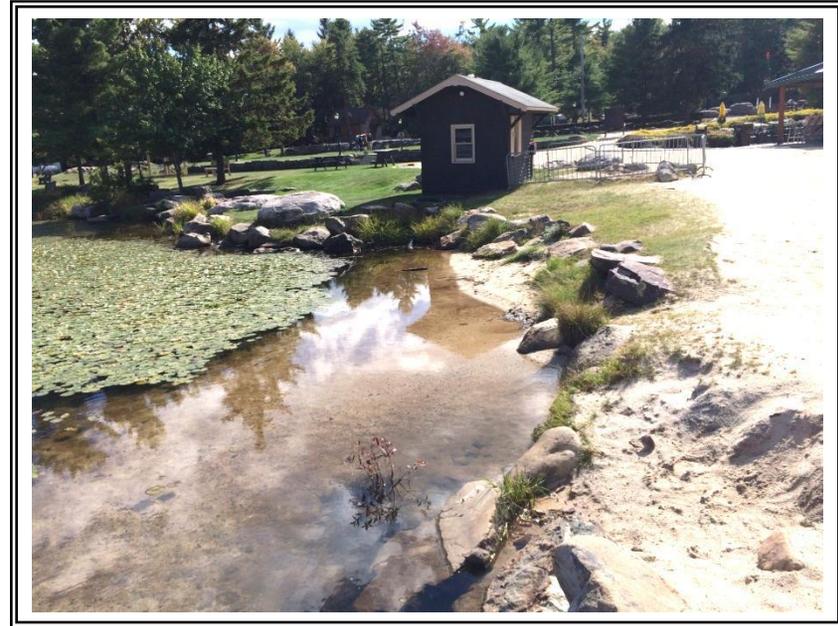
**T26-Split Rock Lagoon**  
Lake side of berm, heavy sand deposits

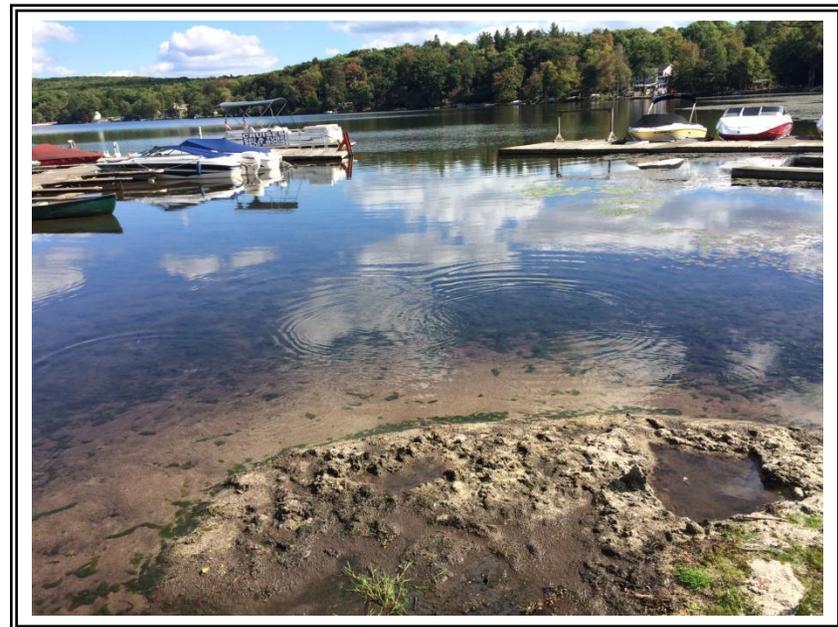
**T26-Split Rock Lagoon**  
Heavy deposits at docks

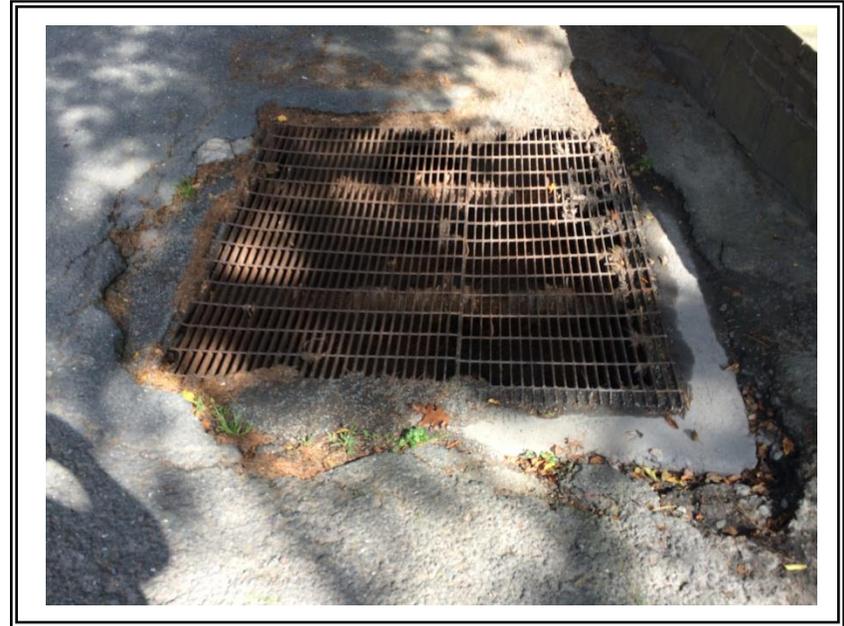
**T27-S.Lake & Estates Drive**  
Heavy sediment and settling inlet

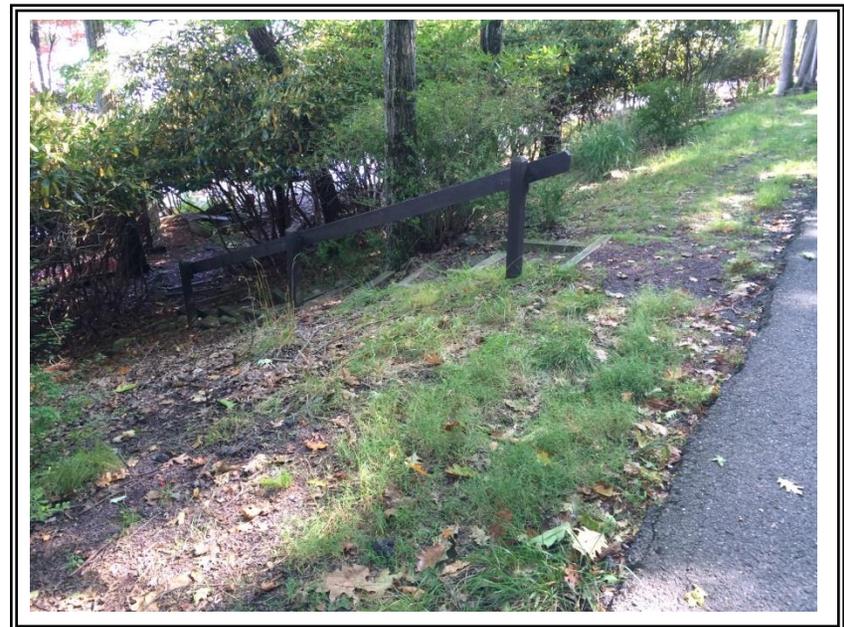
**T28-S.Lake Drive to Cove**  
Short, steep and developed slopes  
between roadway and lake

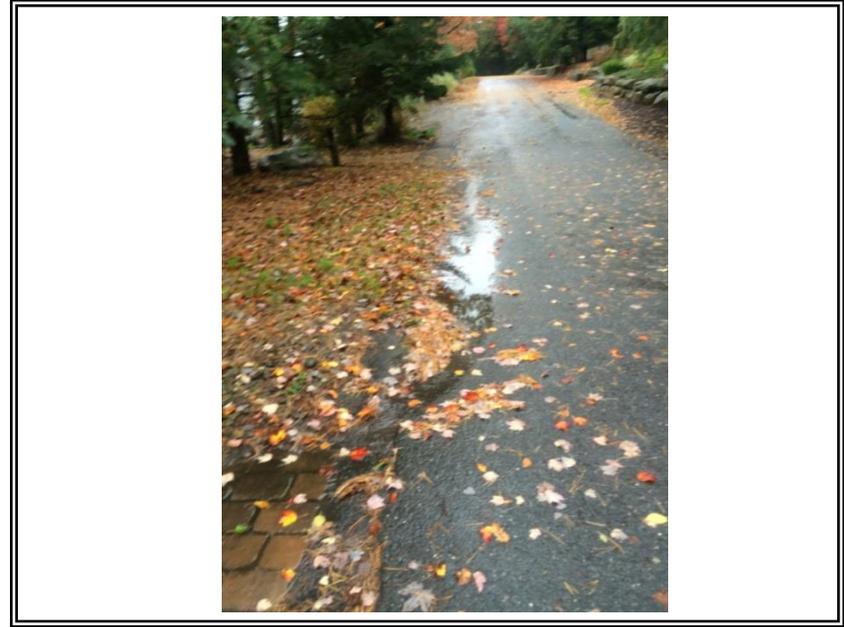
**T29-South Lake and Mosseywood**  
**Intersection**  
Road run-off to walking path

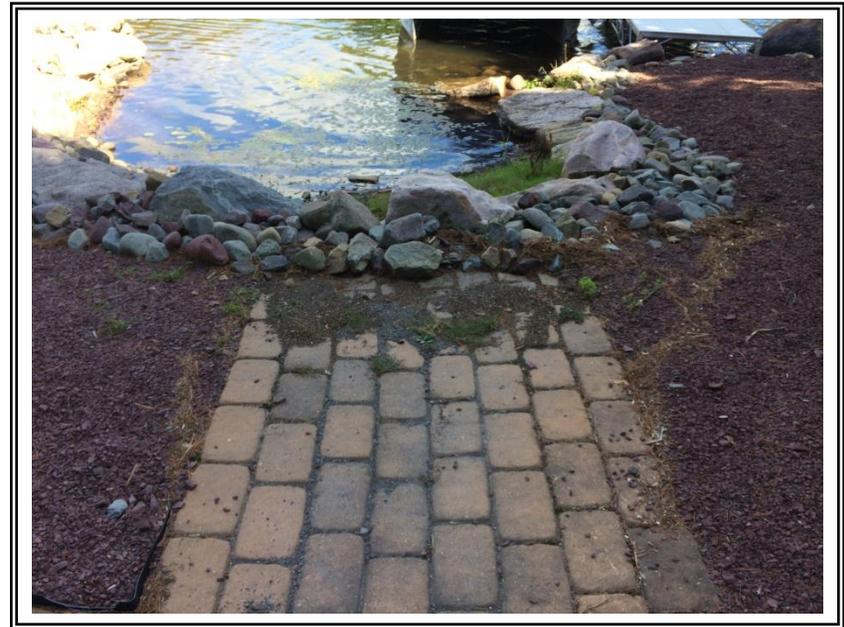
**T29-South Lake and Mosseywood**  
**Intersection**  
Walking Path to Lake

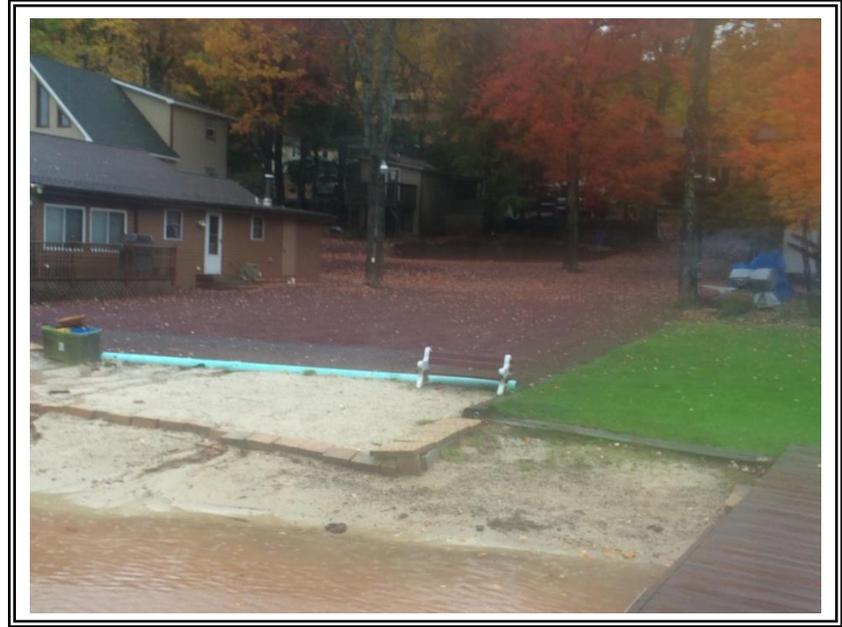
**T32-S. Lake Driveway**  
Driveway during heavy rain

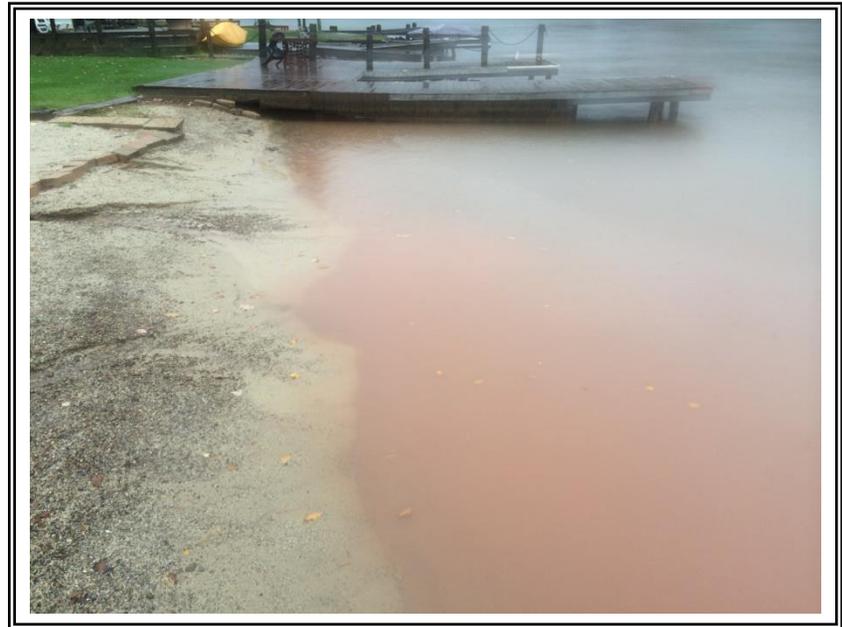
**T32-S.Lake Driveway**  
Lake during heavy rain

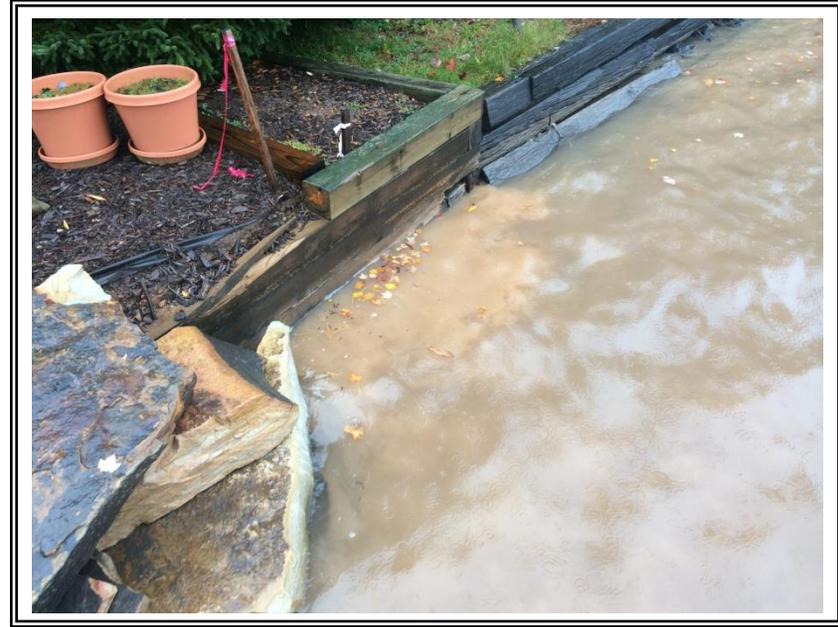
**T32-Bulkhead Weep hole**  
Necessary to relieve water behind wall but drains in sediment

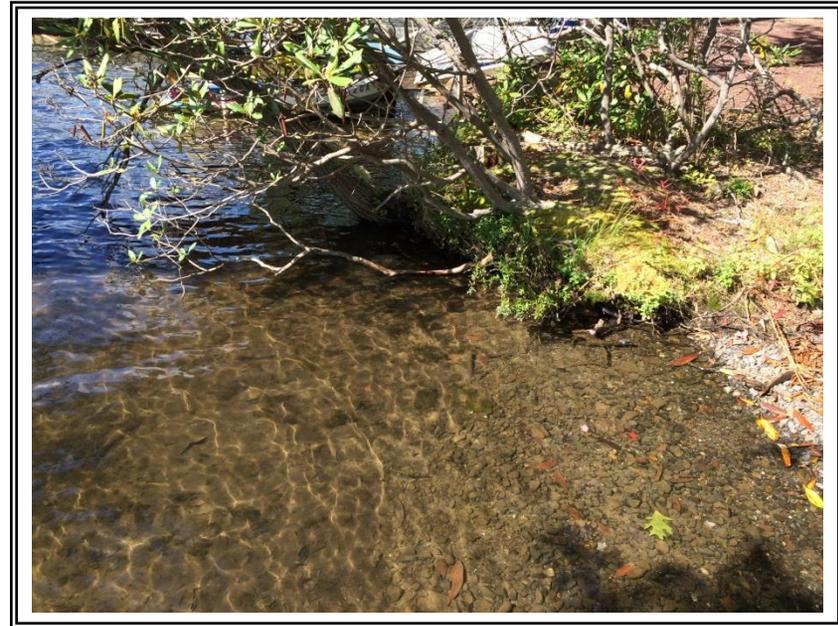
**T32-Unprotected Shoreline**

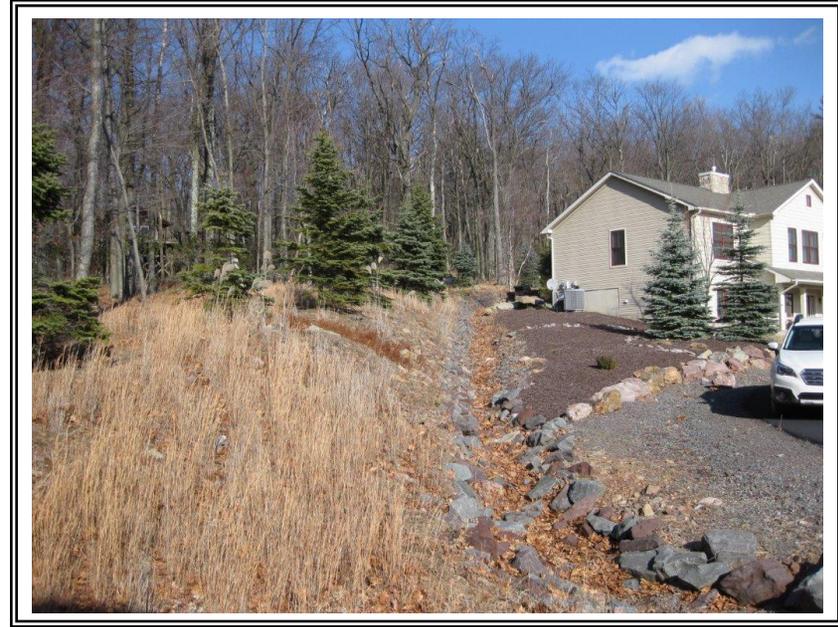
**T35-Laurel Woods**  
Rock lined swale to divert Estates runoff

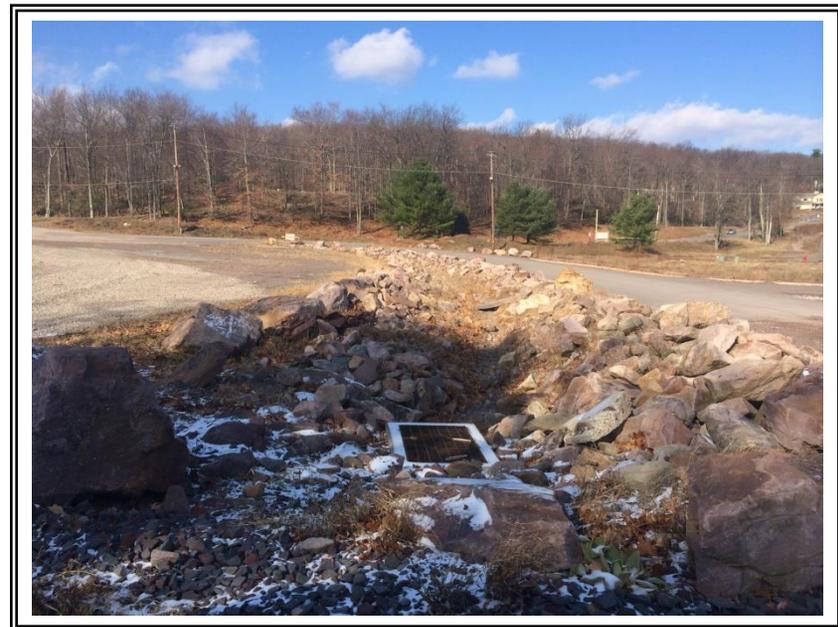
**T36-Big Boulder Parking Lot**  
Rock lined swale and rain garden

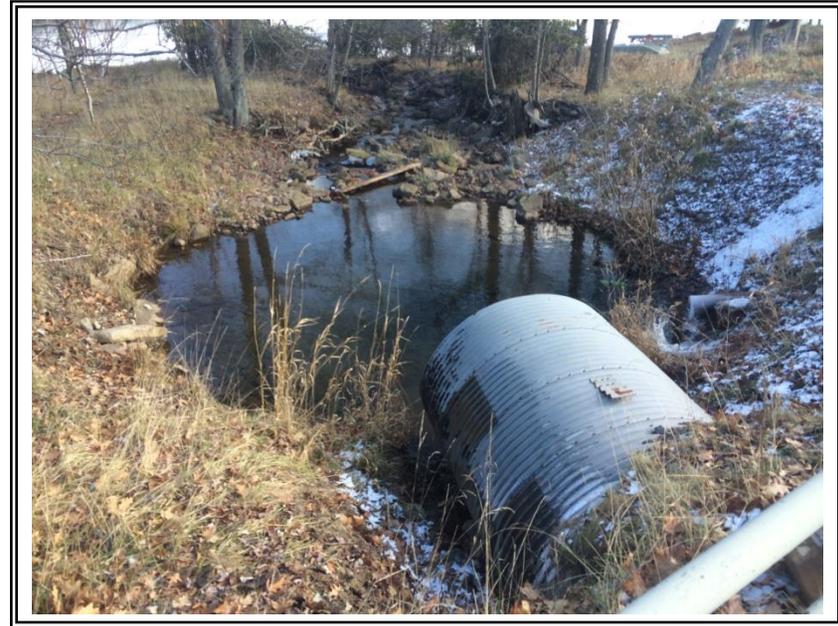
**T36-Big Boulder**  
Drainage Pipe discharge

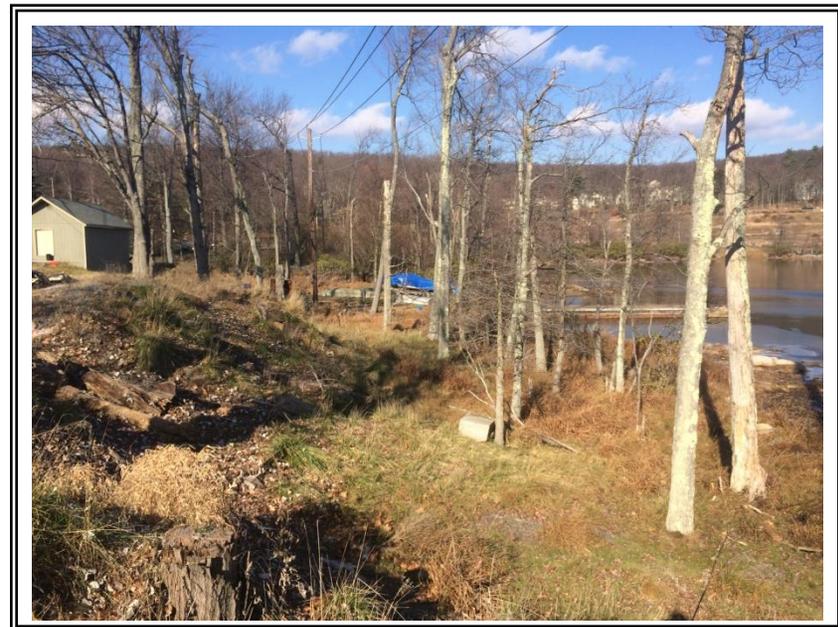
**T37-Big Boulder Employee Parking Lot**  
Short vegetated area between lot and lake

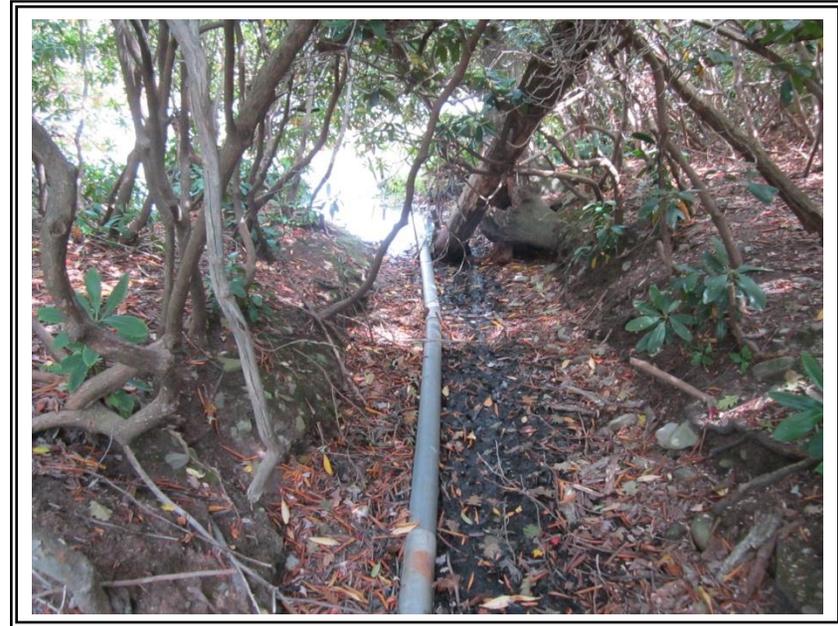
**T38-Swale from Round Pond**  
Note beaver pipe

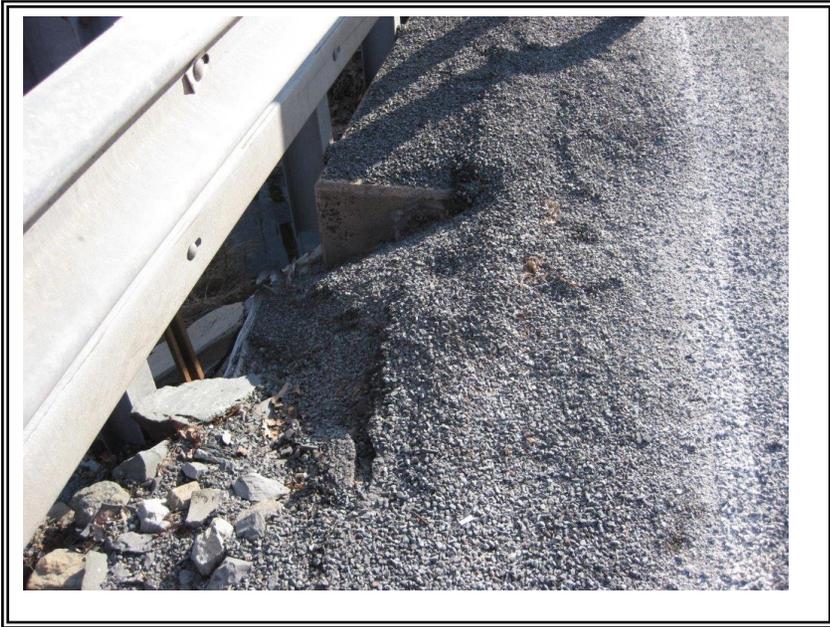
**T39-Lake Harmony Road Culvert**  
Large accumulation of anti-skid & stone  
wearing surface on headwall

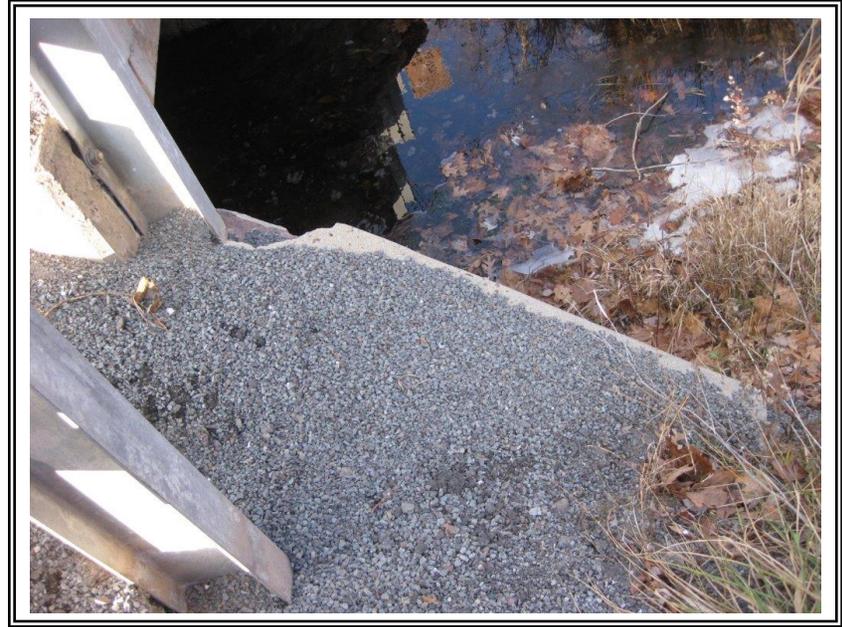
**T39-Lake Harmony Road Culvert**  
Stone and debris on wingwall

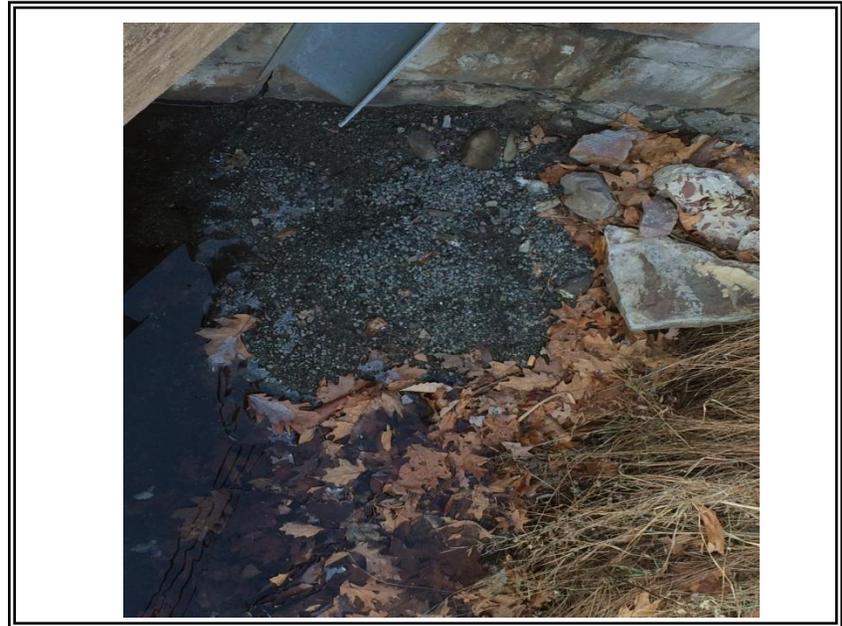
**T39-Lake Harmony Road Culvert**  
Sediment deposit next to stream below  
roadway

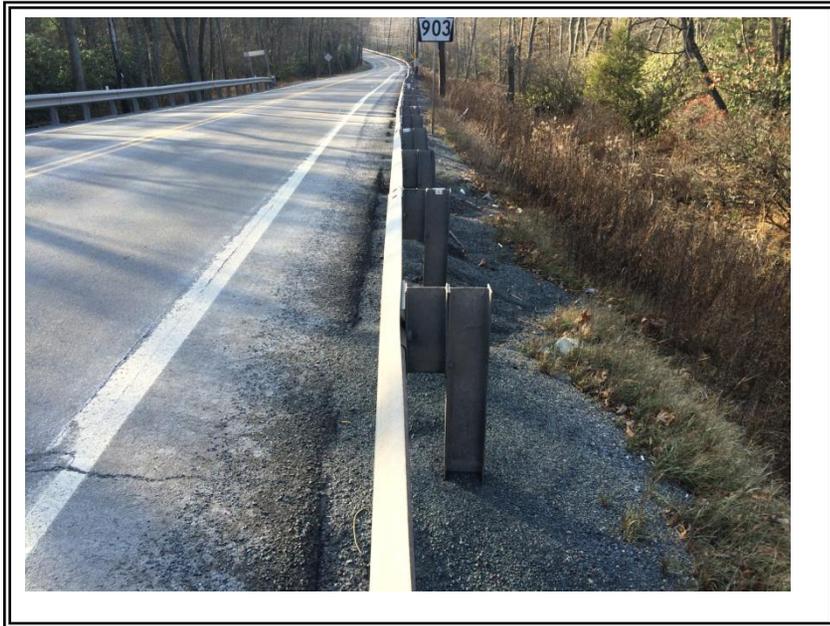
**T40-SR 903**

Large accumulation of anti-skid & stone wearing surface along shoulder

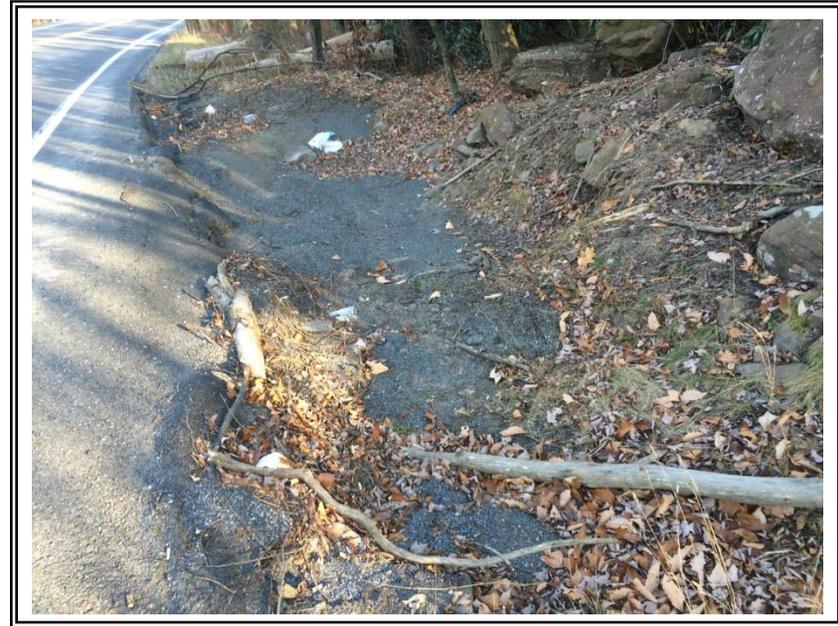
**T40-SR 903**

Blocked Pipe and/or inlet

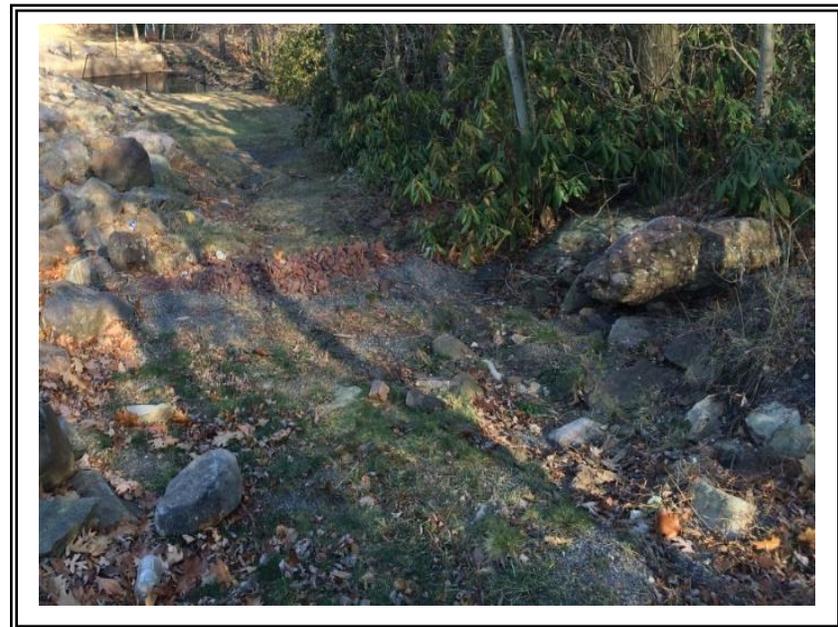
**T40-Big Boulder Dam**

Check dams to contain roadway sediment before going into stream
