MAY 2015

Kidder Township  
Stormwater Concept Plan  
Project No. 10635.13

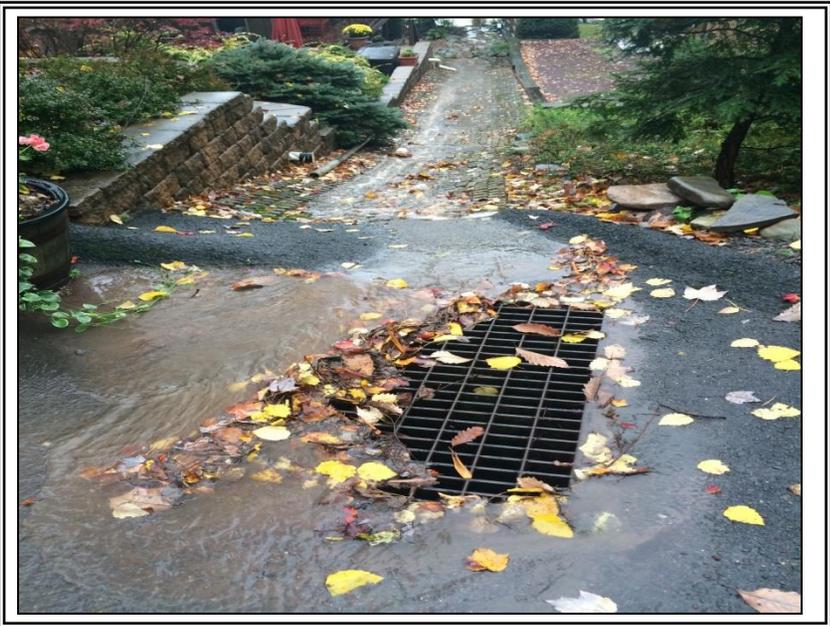
**T1-Labarre Drive**  
Inlet on south side of road and  
overflow channel to lake

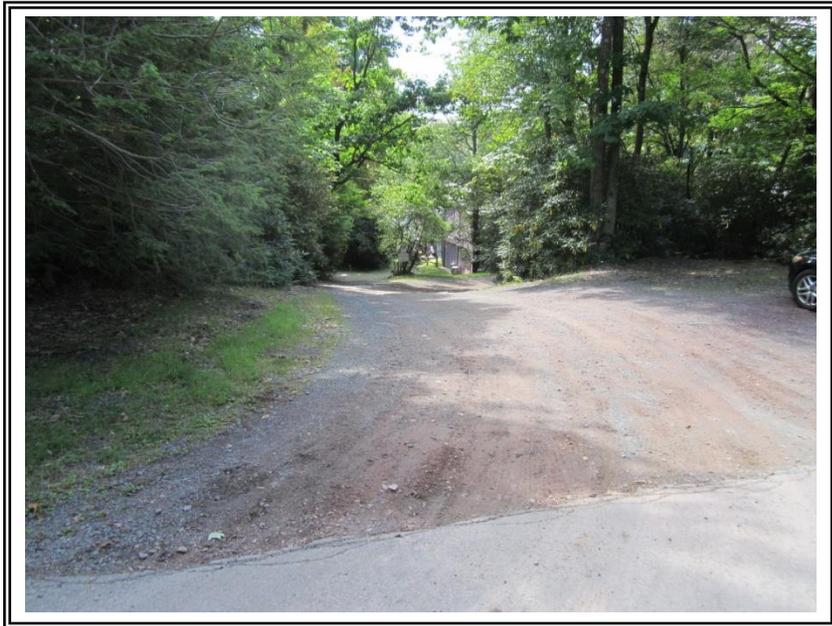
**T2 – Summit Avenue**  
Intersection with North Lake Drive

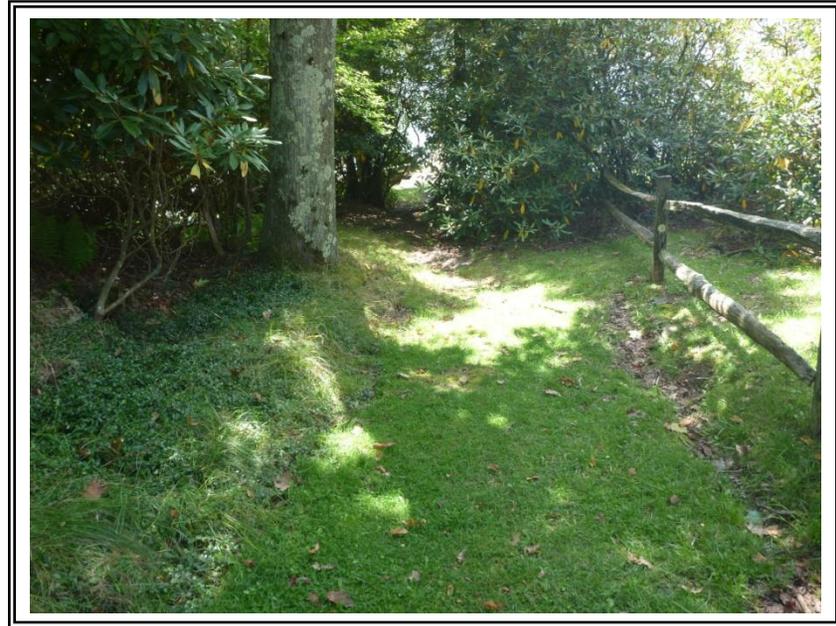
**T2 – Summit Avenue**  
Drainage path to Lake

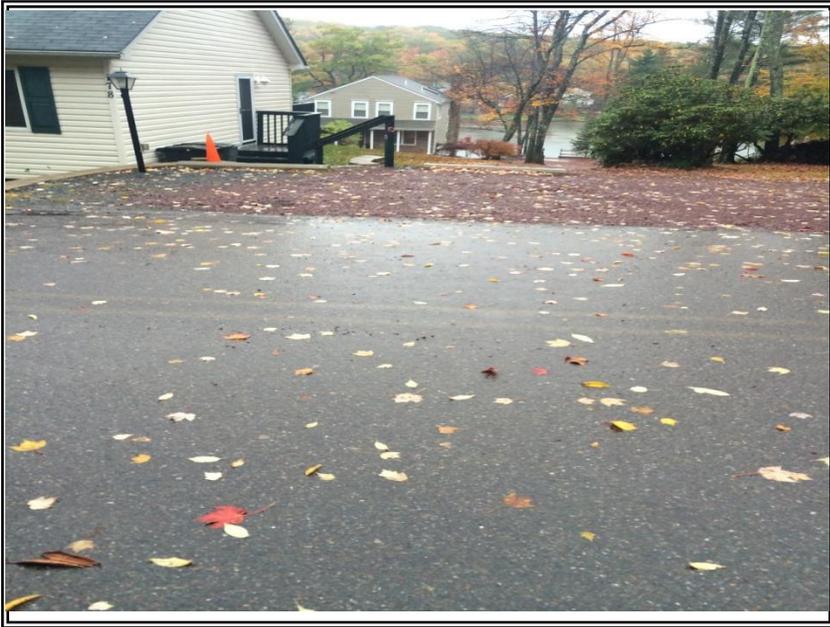
**T3-Kidder Avenue**  
Parking area across from headwall  
in outlet location

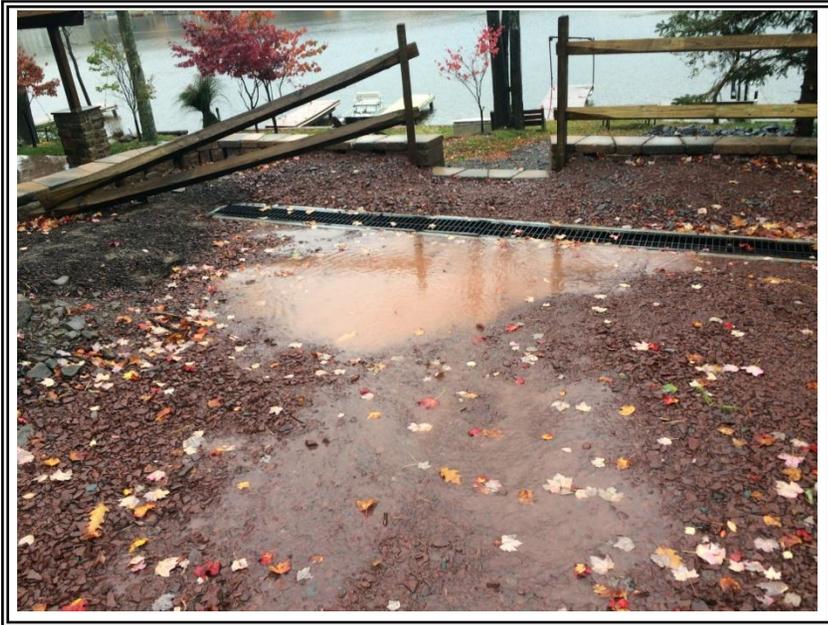
**T3-Kidder Avenue**  
Trench Drain during Heavy Rain

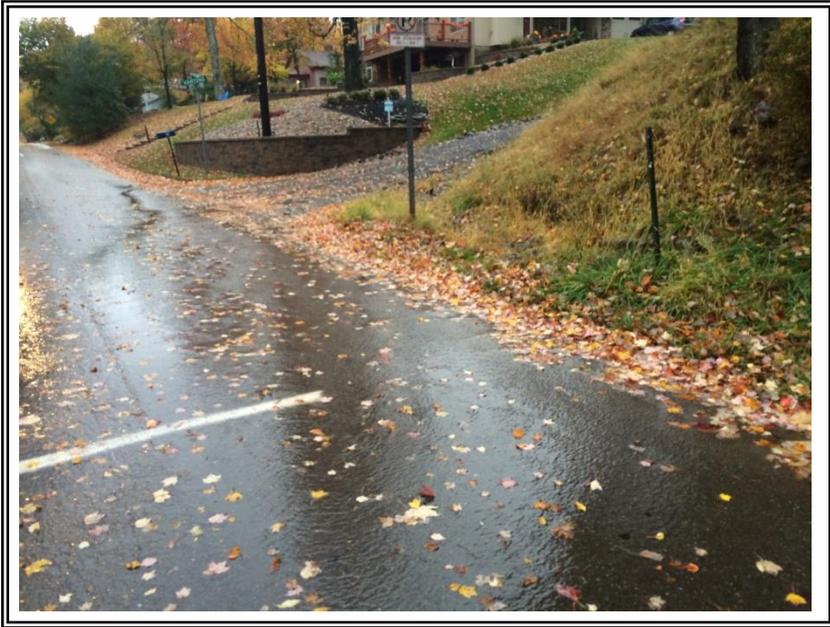
**T4-Hartung Avenue**  
Gutter spread through driveway

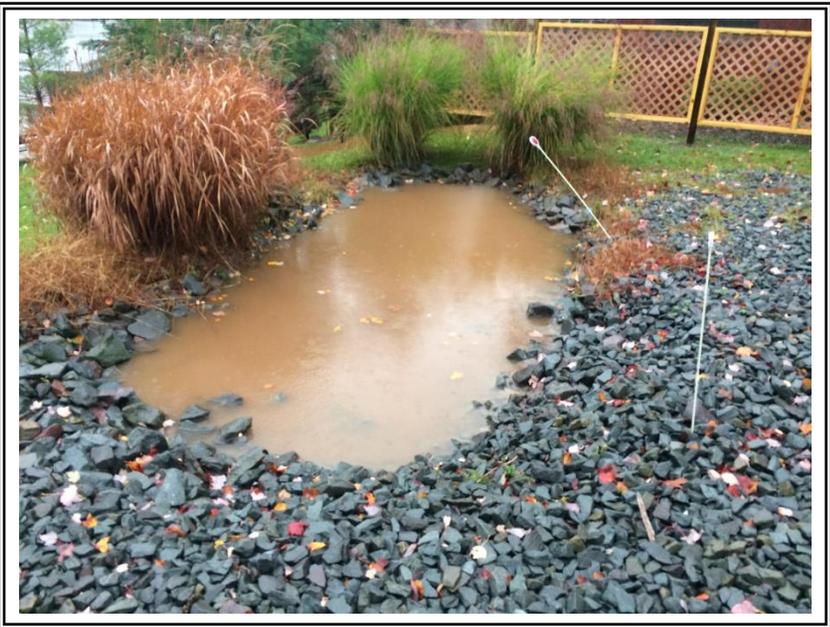
**T4-Hartung Avenue**  
Rock Garden during heavy rain

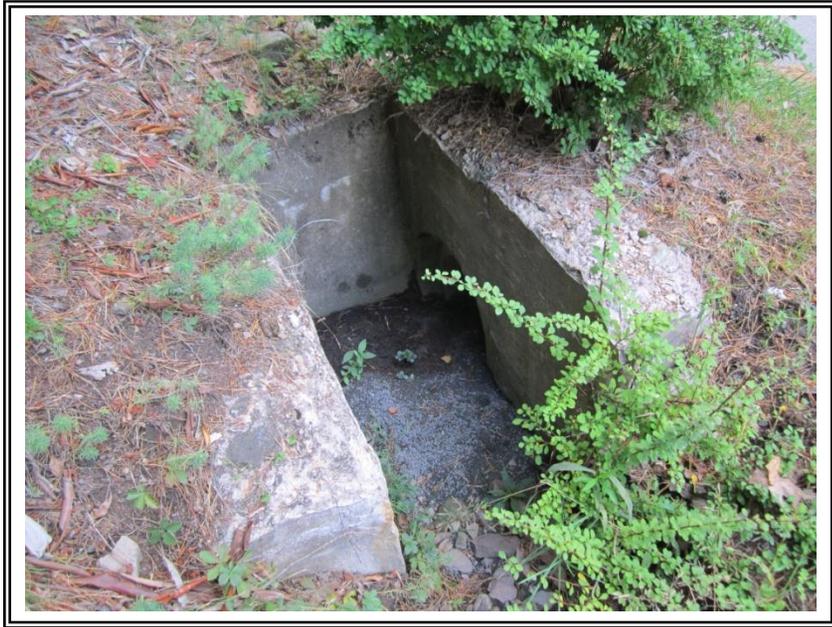
**T5 - Marina**  
Debris at headwall

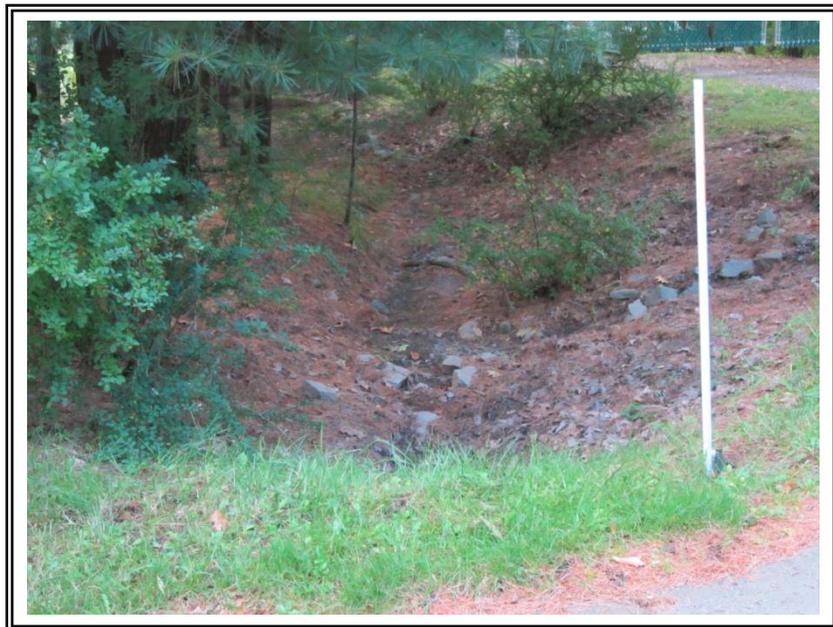
**T5 - Marina**  
Swale to marina

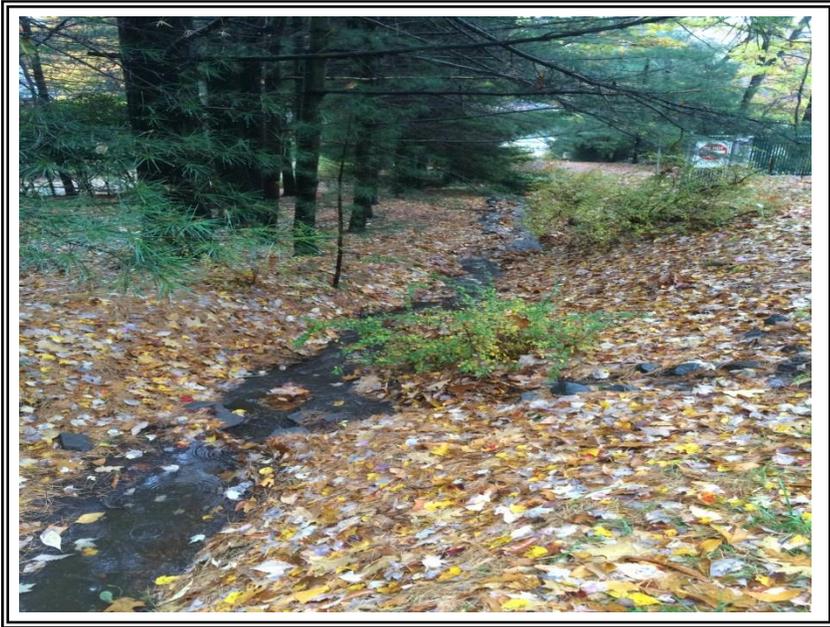
**T5 - Marina**  
Swale during heavy rain

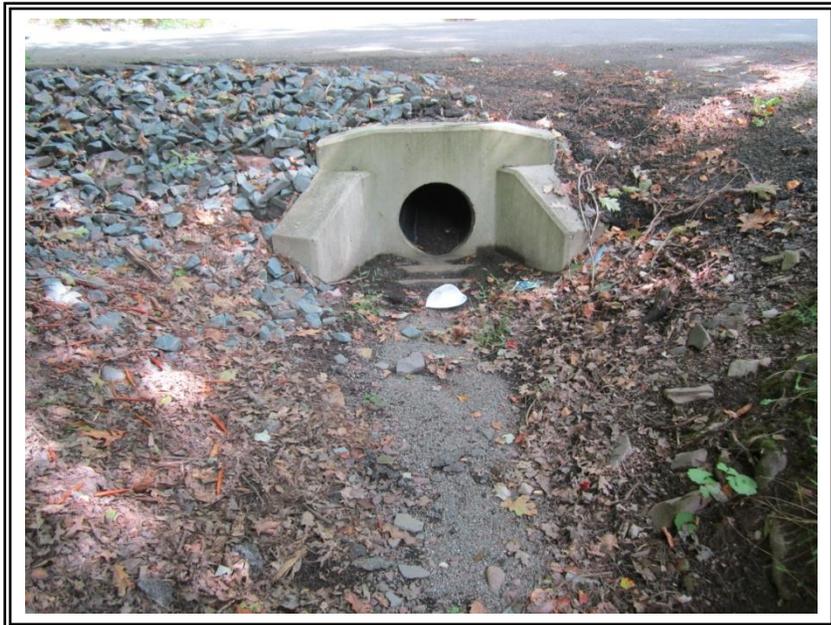
**T5 - Marina**  
Stormsewer system east of marina

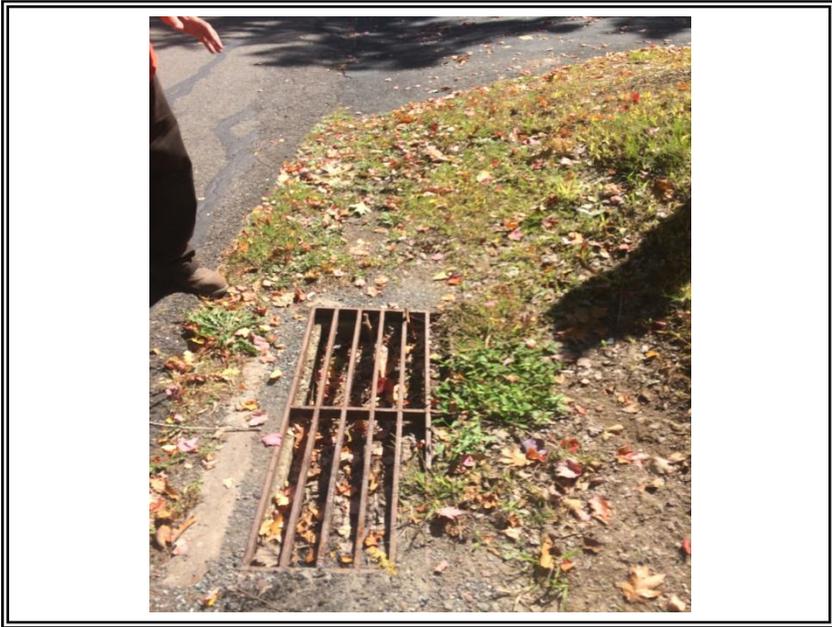
**T6 – South Lake Drive**  
Clogged Inlet

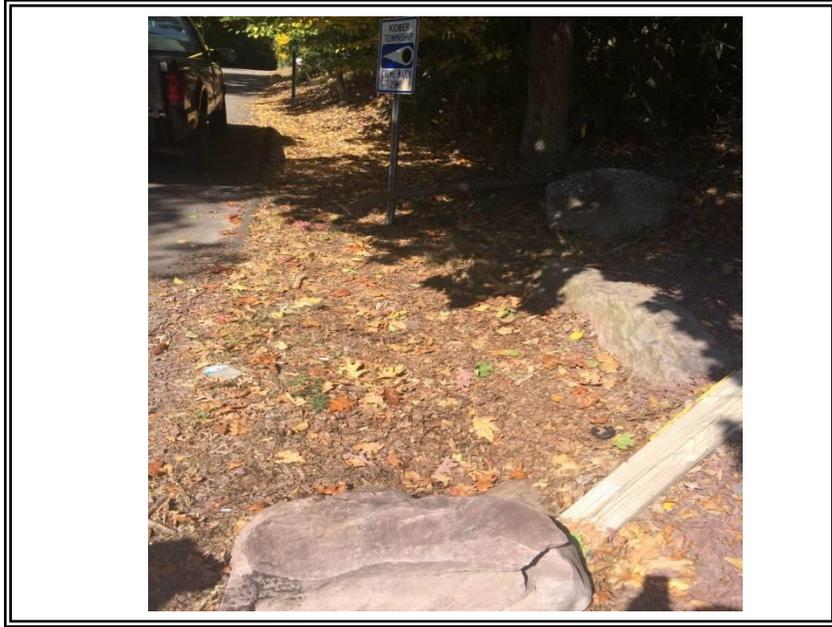
**T6 – Piggy Driveway**  
Blocked Inlet

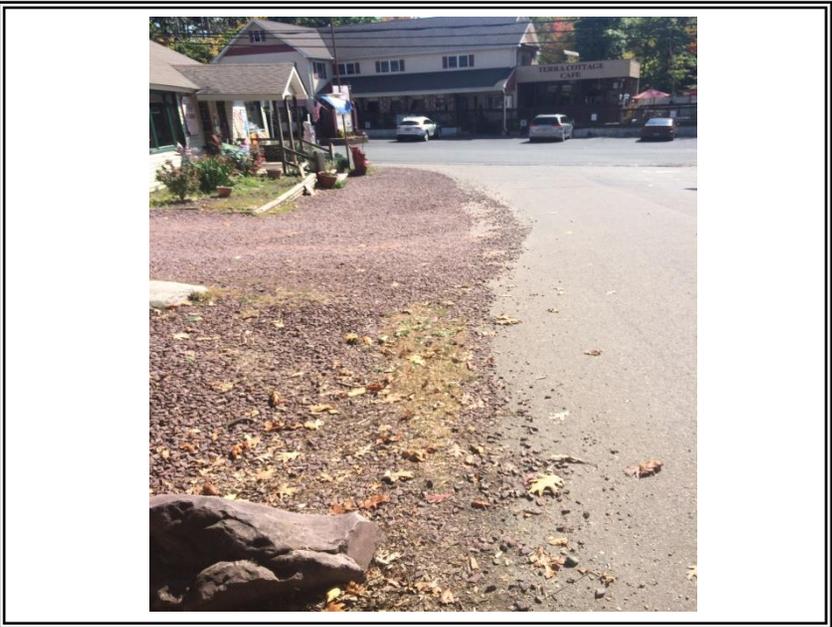
**T6 – S. & N. Lake Drive Intersection**  
Piggy Driveway

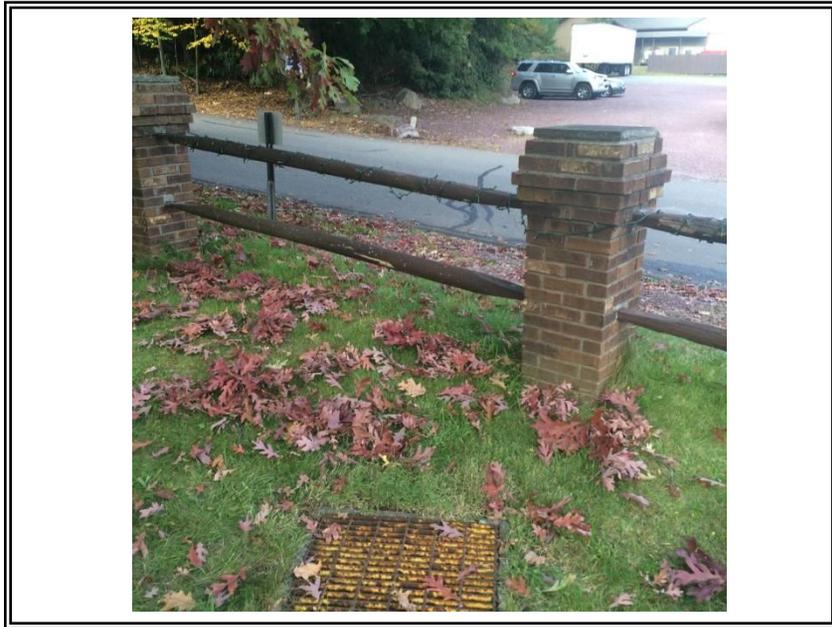
**T6 – S. & N. Lake Dr. Intersection**  
Inlet on motel property

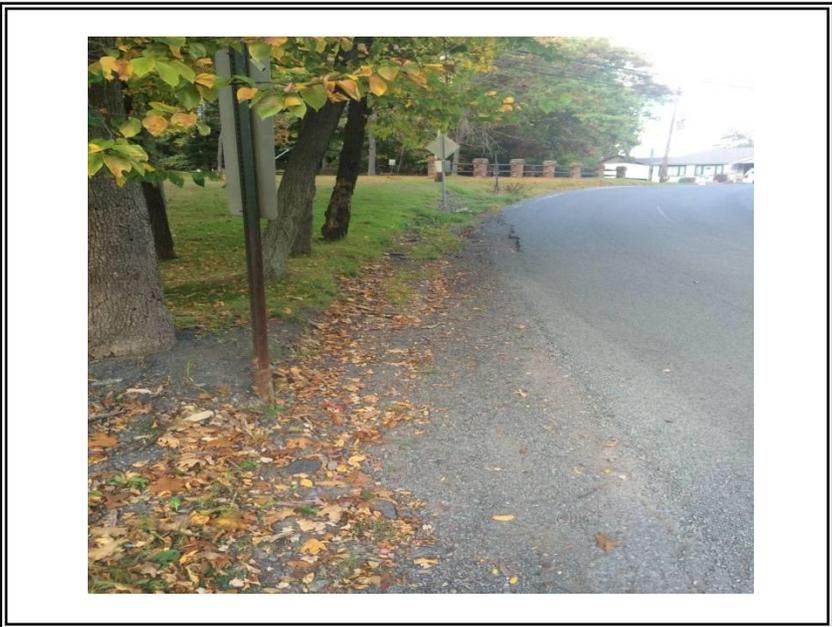
**T7 – North Lake Drive**  
Looking North

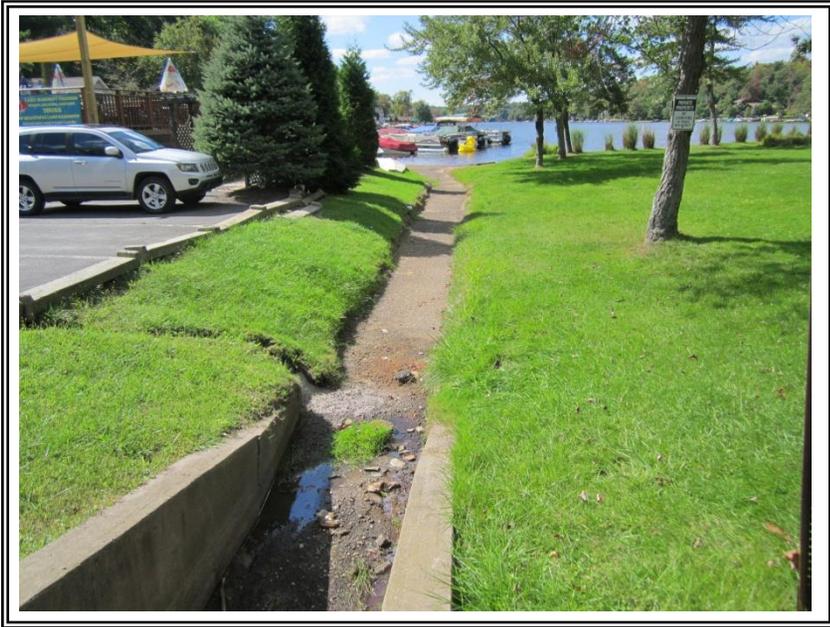
**T8-Discharge at Nicks**  
Discharge channel from Lake

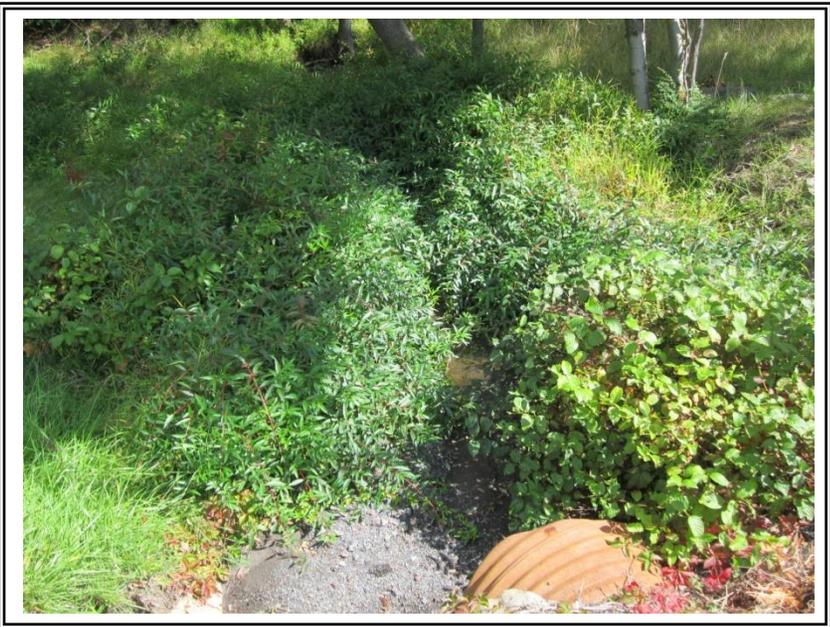
**T8-Discharge at Nicks**  
Downstream channel

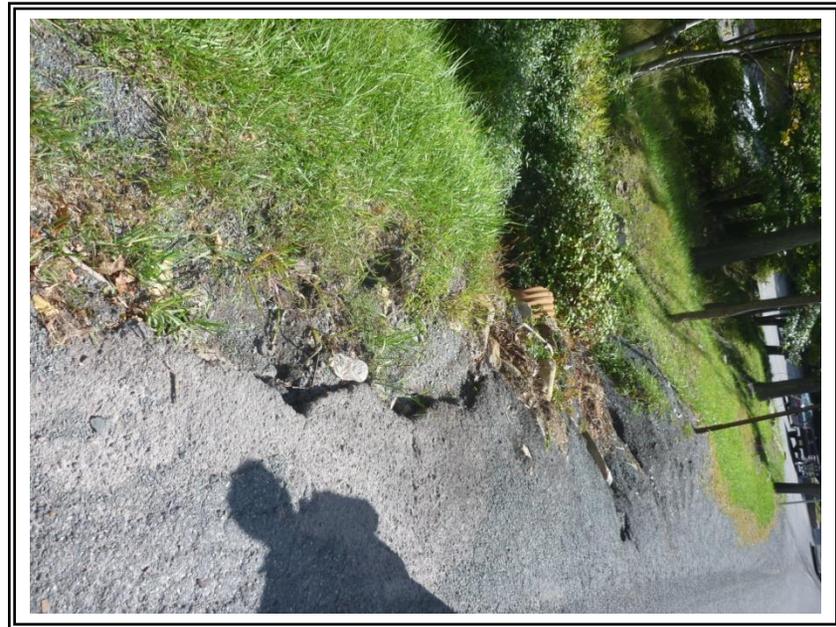
**T8-Discharge at Nicks**  
Downstream bank erosion

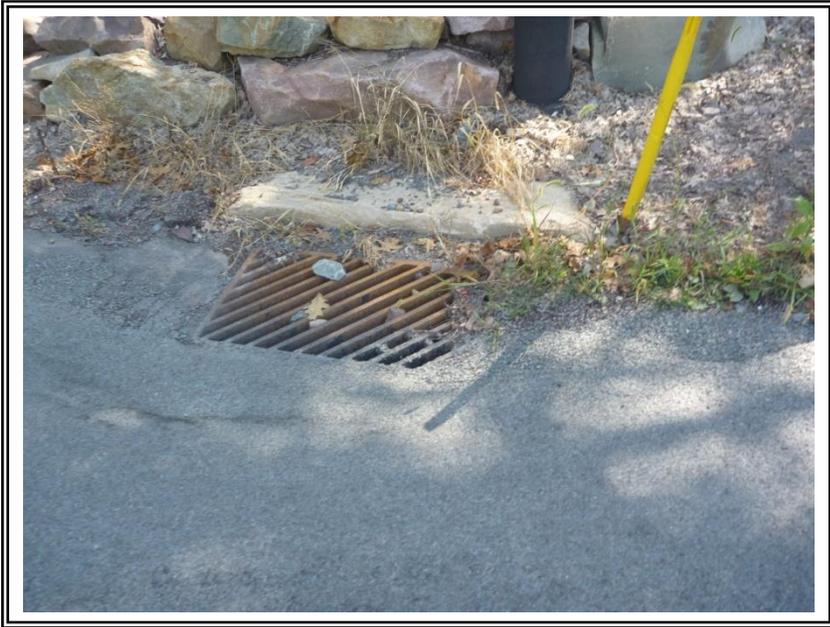
**T9-Osceola Street**  
Inlet on south side of street

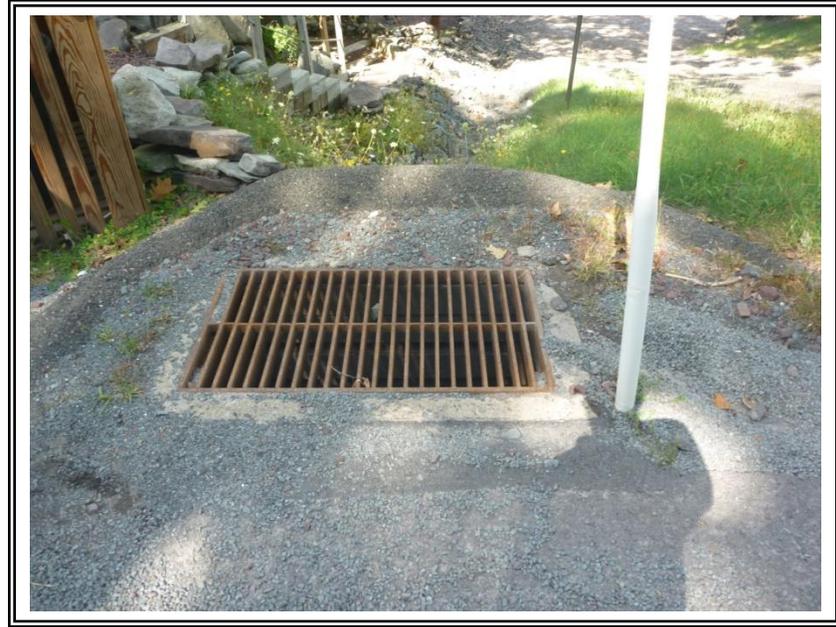
**T9-Osceola Street**  
Inlet on north side of road

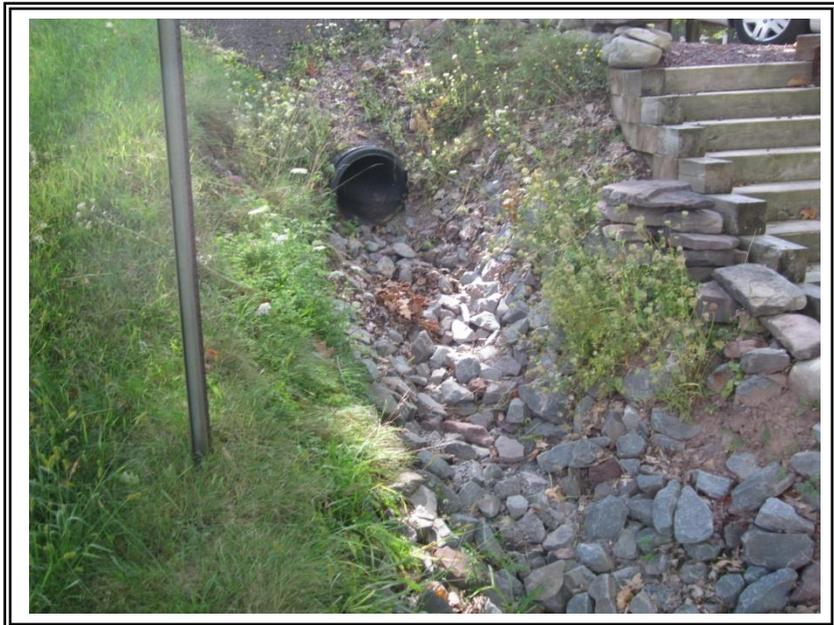
**T9-Osceola Street**  
Inlet discharge

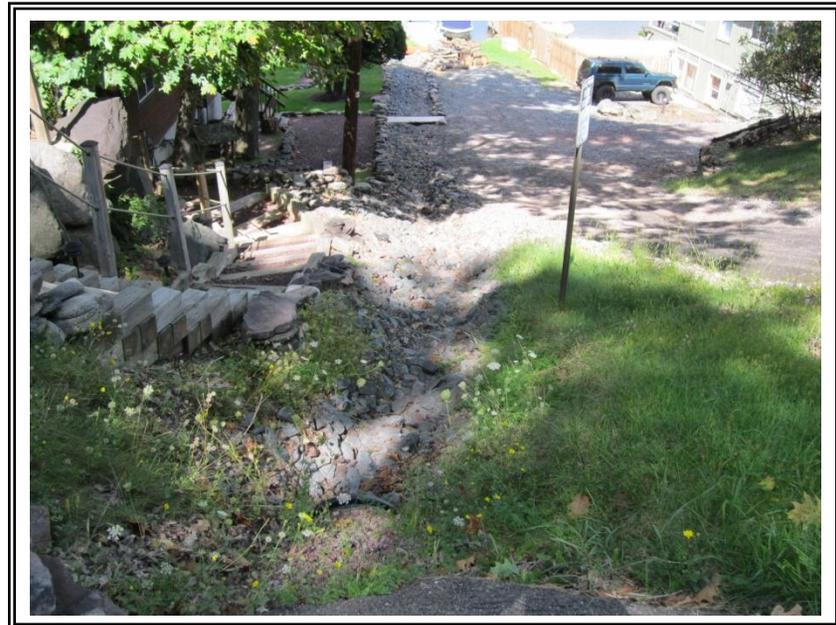
**T9-Osceola Street**  
Stone swale to lake

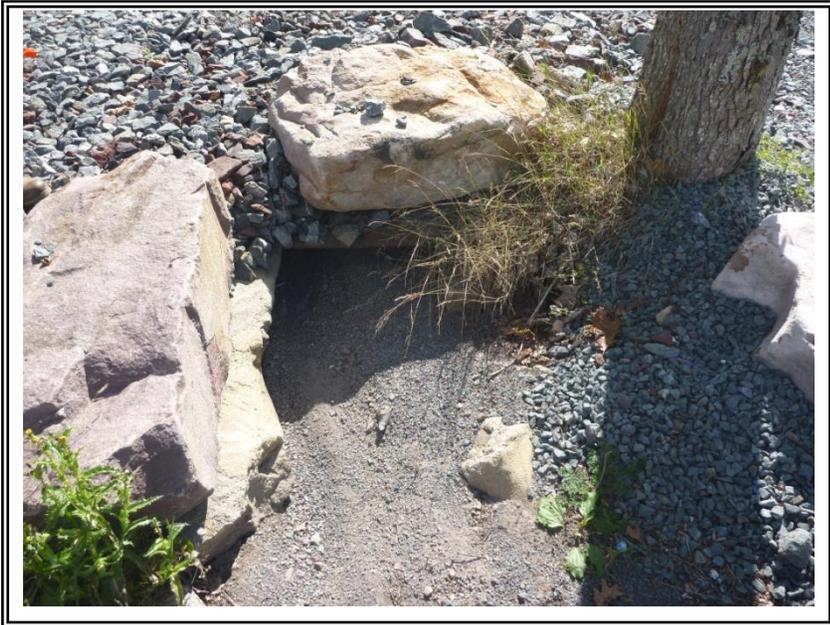
**T10-Church Street**  
Steel plate covering discharge

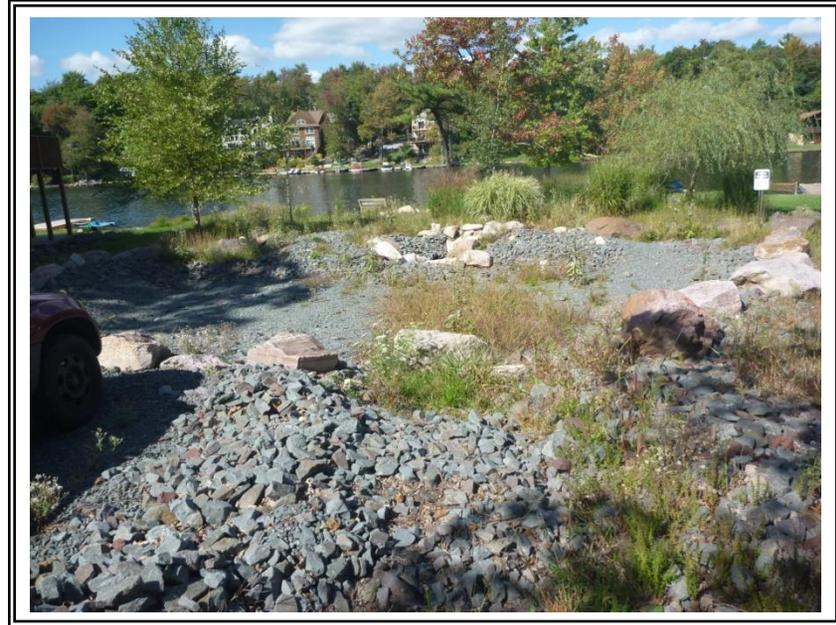
**T10-Church Street**  
Rock rain garden

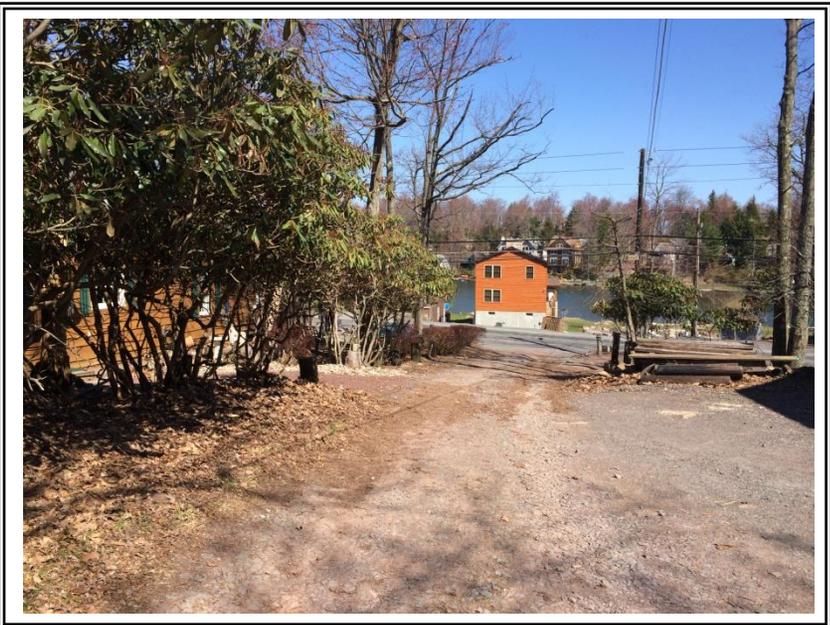
**T10-Church Street**  
Unpaved roads from L.H. Estates uphill of  
Church Street intersection with South Lake

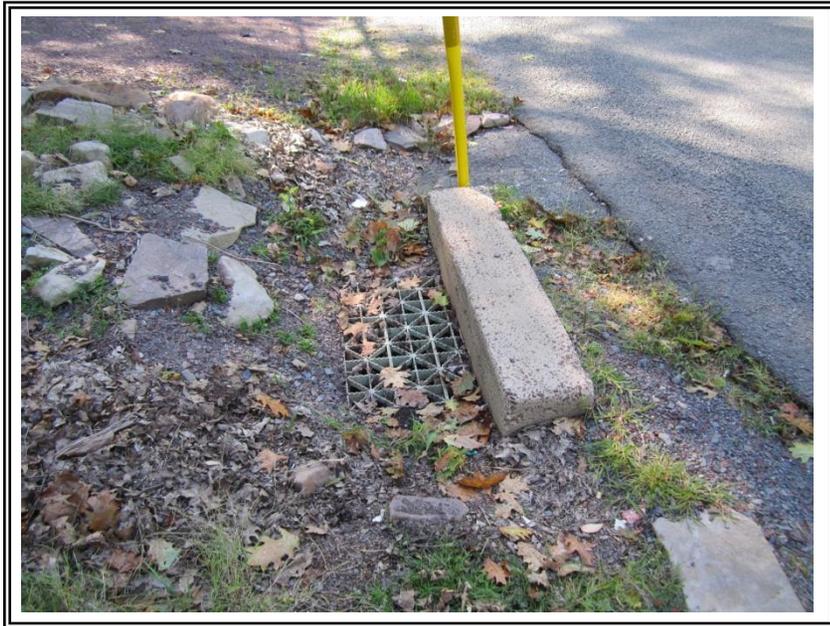
**T11-South Lake Drive**  
Upstream inlet

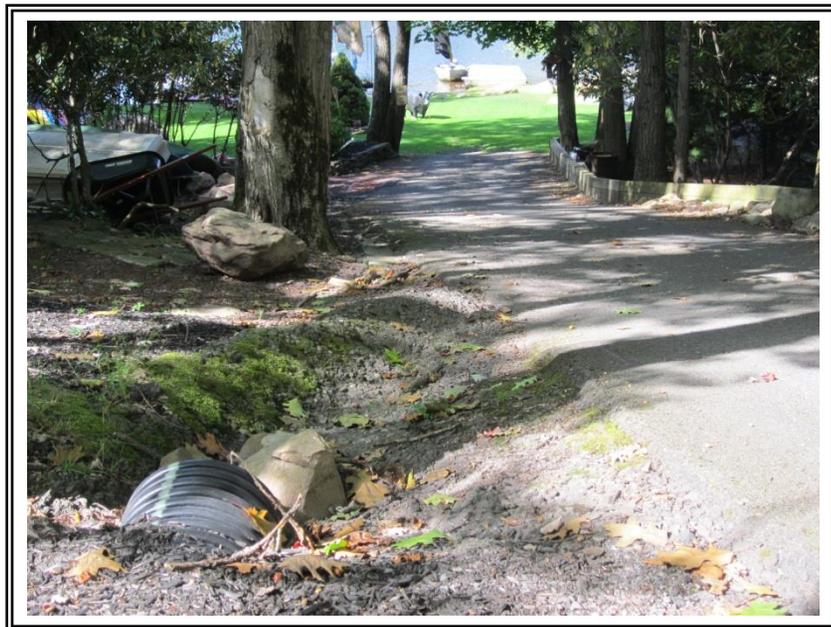
**T11-South Lake Drive**  
Overland flow path to lake

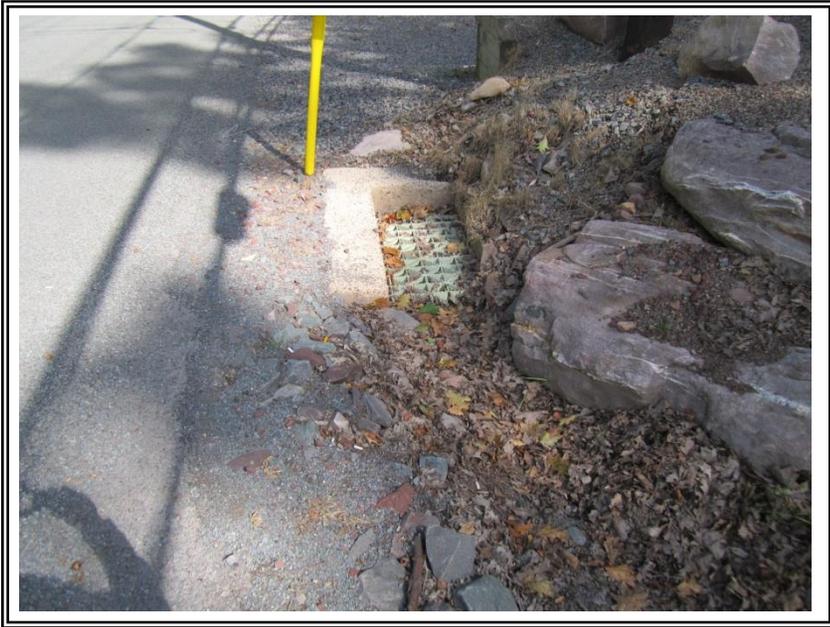
**T12-Pine Street**  
Inlet on South Lake Drive

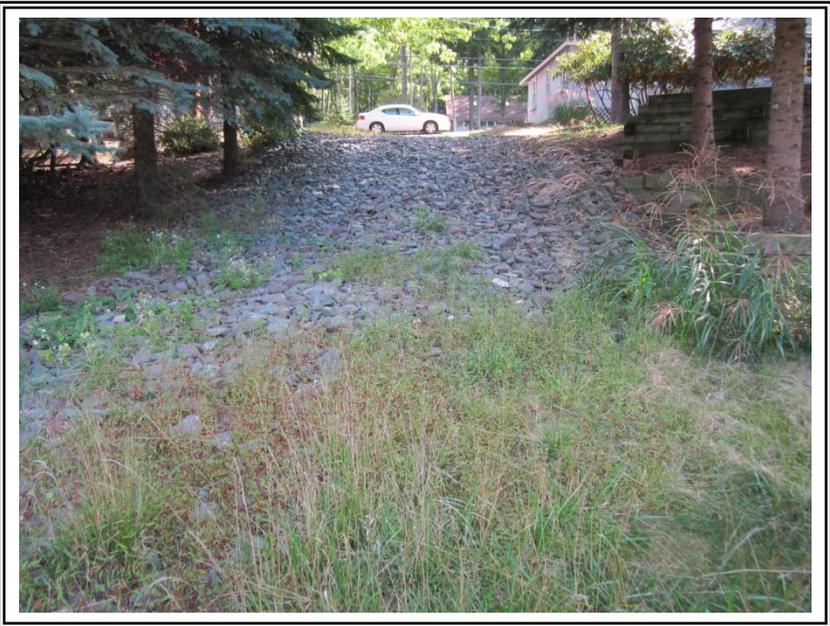
**T12-Pine Street**  
Upstream of rain garden

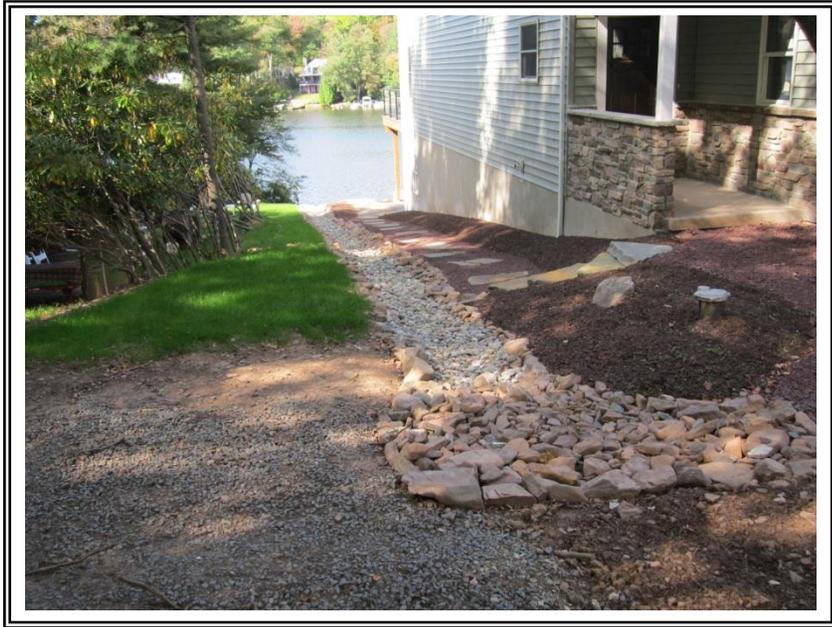
**T13-South Lake Drive**  
Private swale to lake

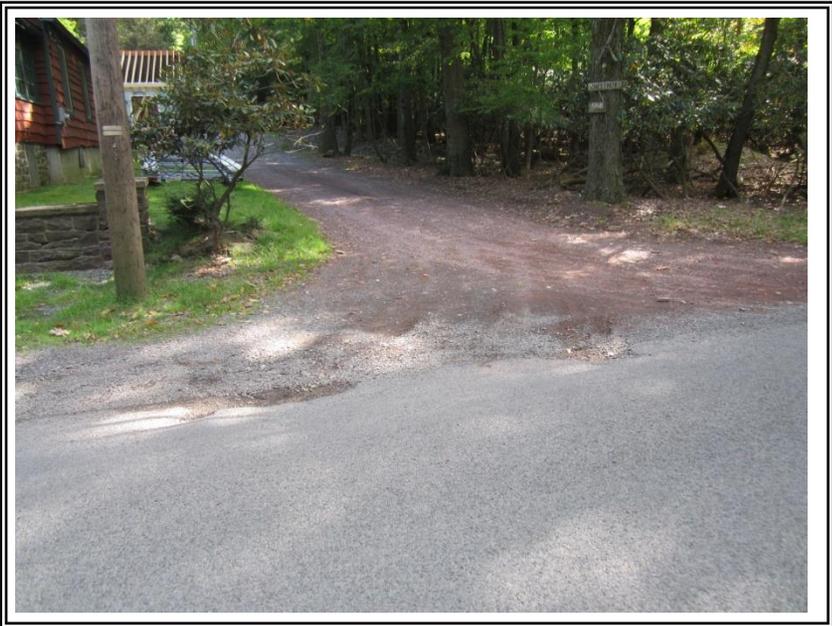
**T14-Chestnut Street**  
Eroded stone road

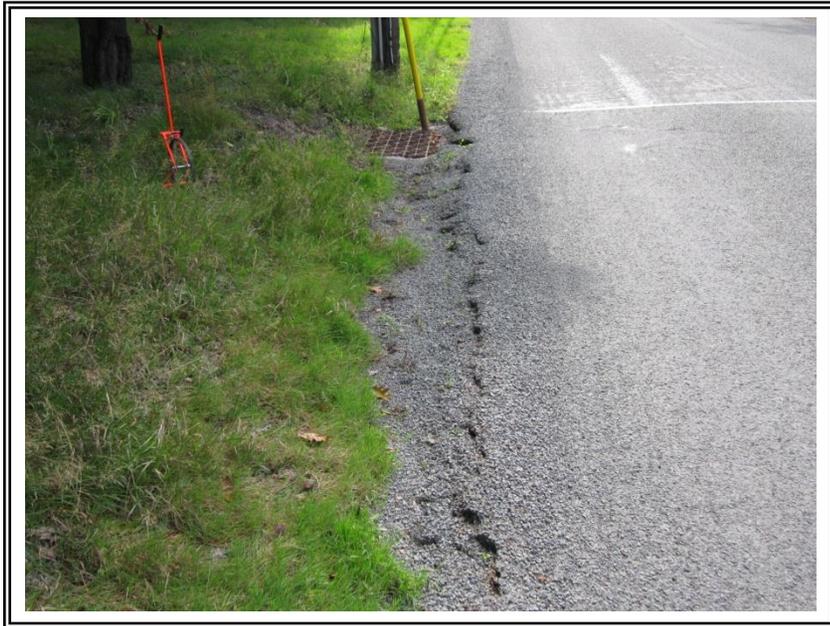
**T16-South Lake**  
Roadside erosion at inlet

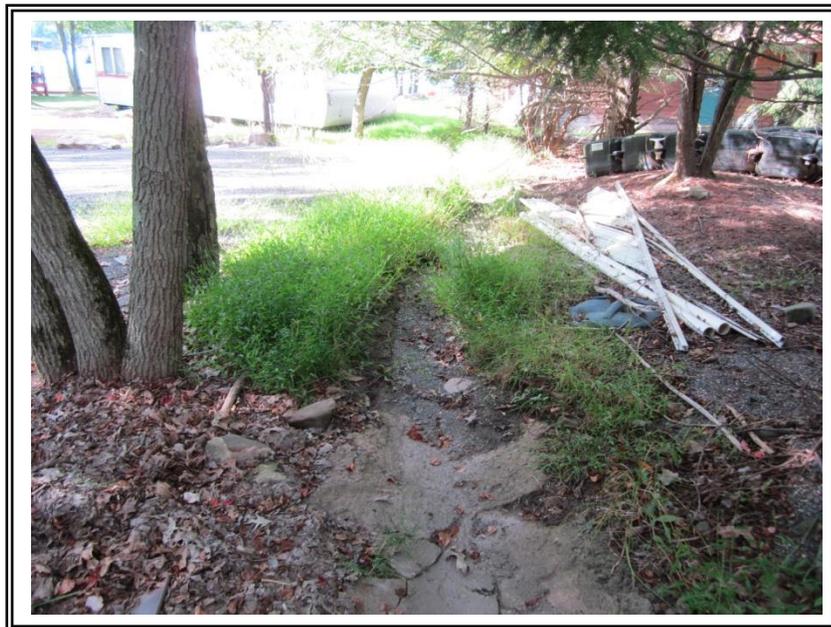
**T16-Between houses 246 & 248**  
Eroded swale

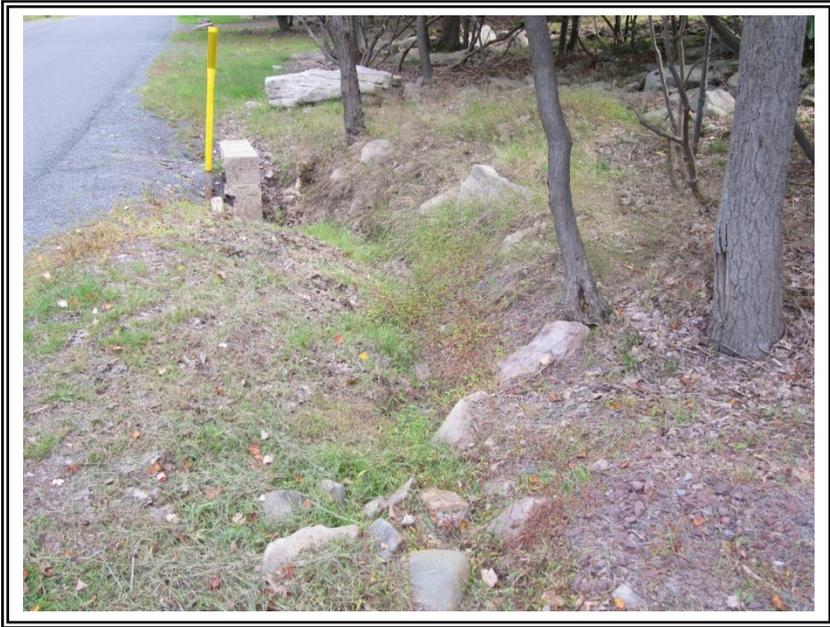
**T17-Beach**  
Upstream headwall

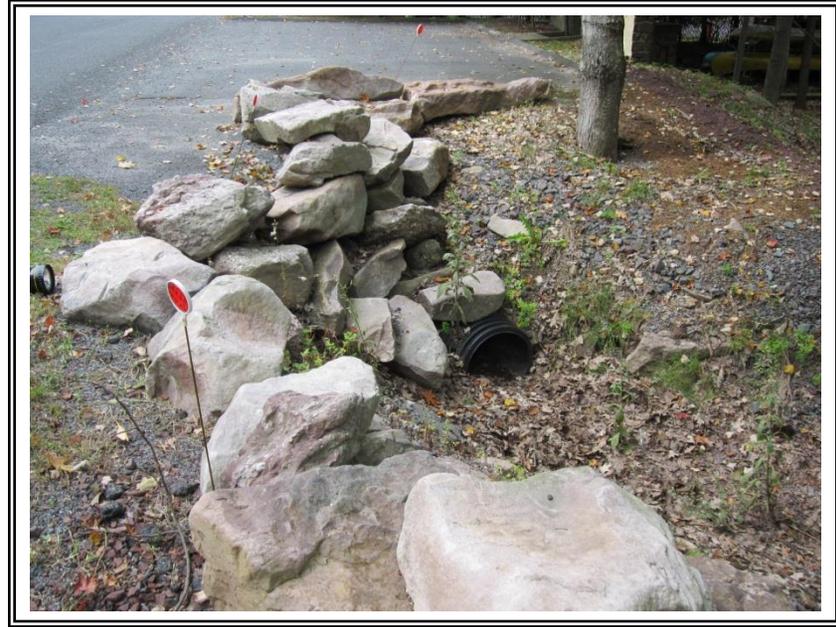
**T17-Beach**  
Crosspipe discharge

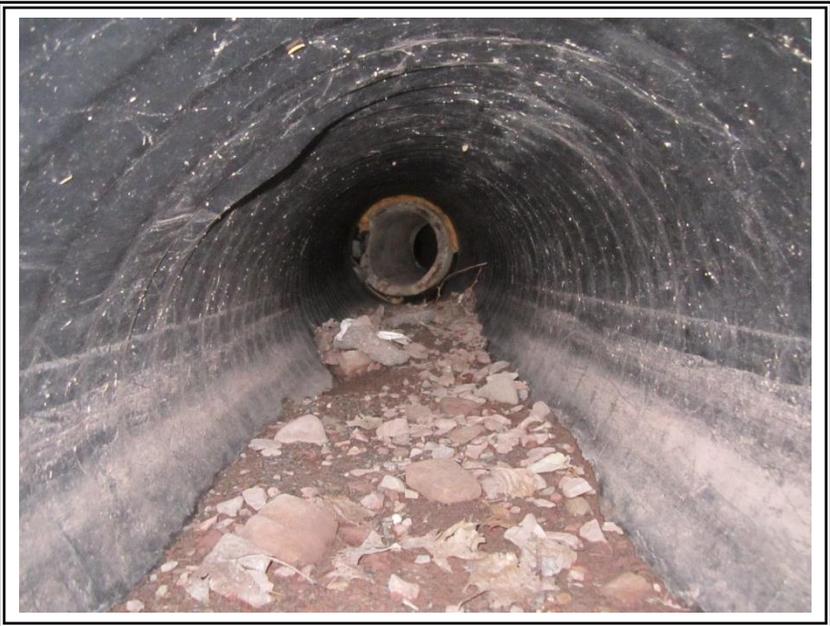
**T17-Beach**  
Debris in interior of crosspipe

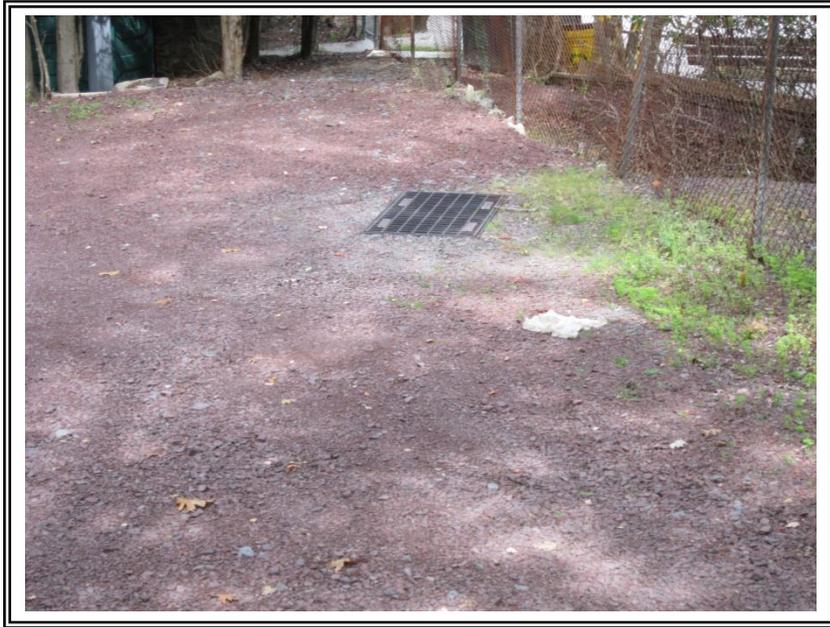
**T17-Beach**  
Beach stormsewer system

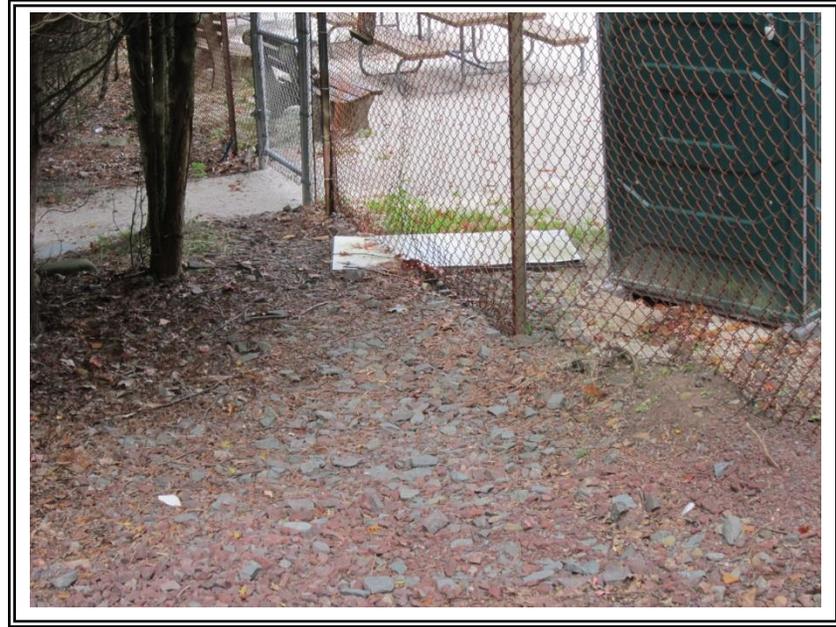
**T17-Beach**  
Covered inlet on beach property

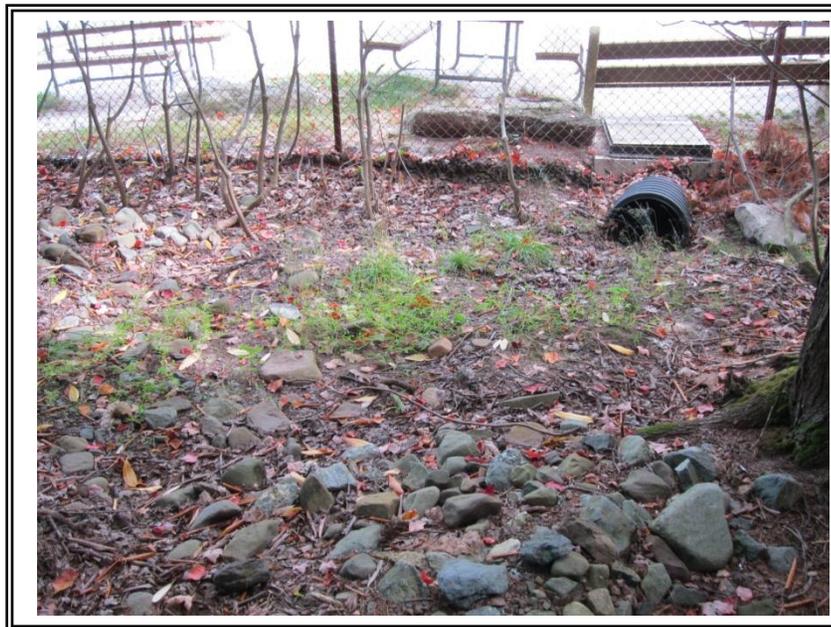
**T17-Beach**  
Discharge to settling pond/rain garden

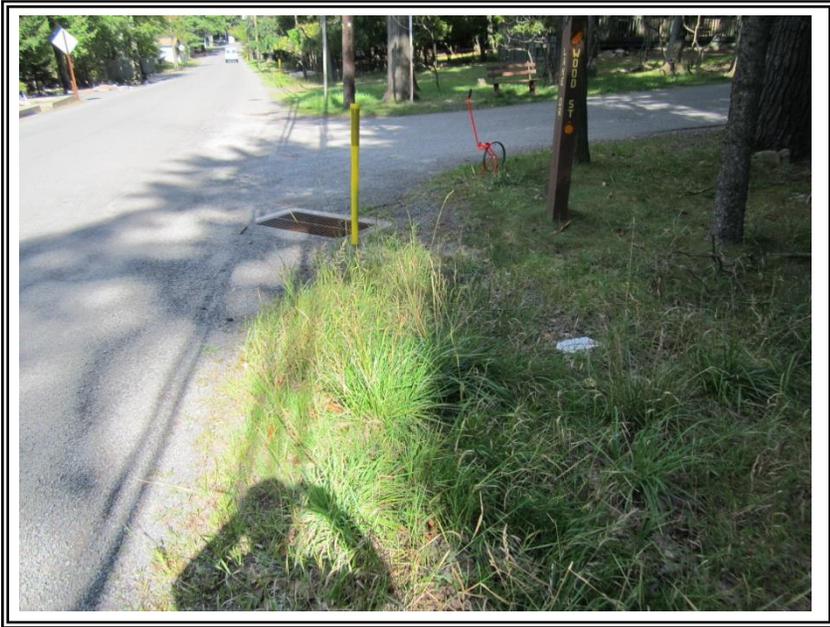
**T18-Boat Access at Wood**  
Inlet at Wood Street

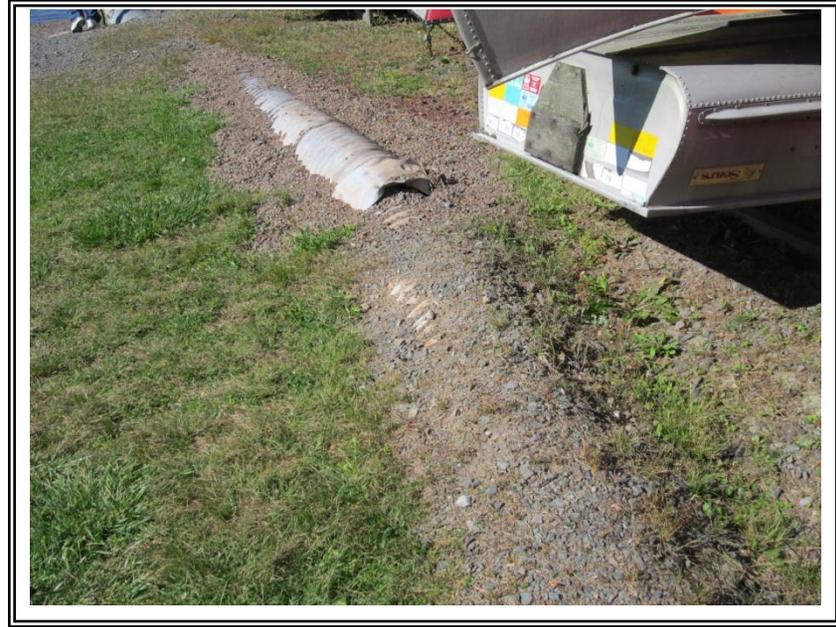
**T18-Boat Access at Wood**  
Exposed discharge pipe

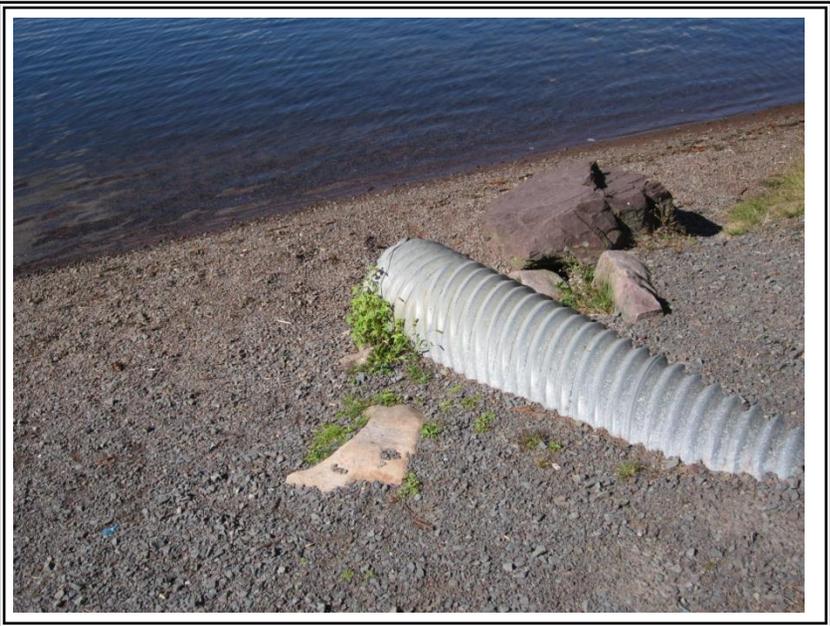
**T18-Boat Access at Wood**  
Discharge to lake
