MAY 2015

Kidder Township  
Stormwater Concept Plan  
Project No. 10635.13

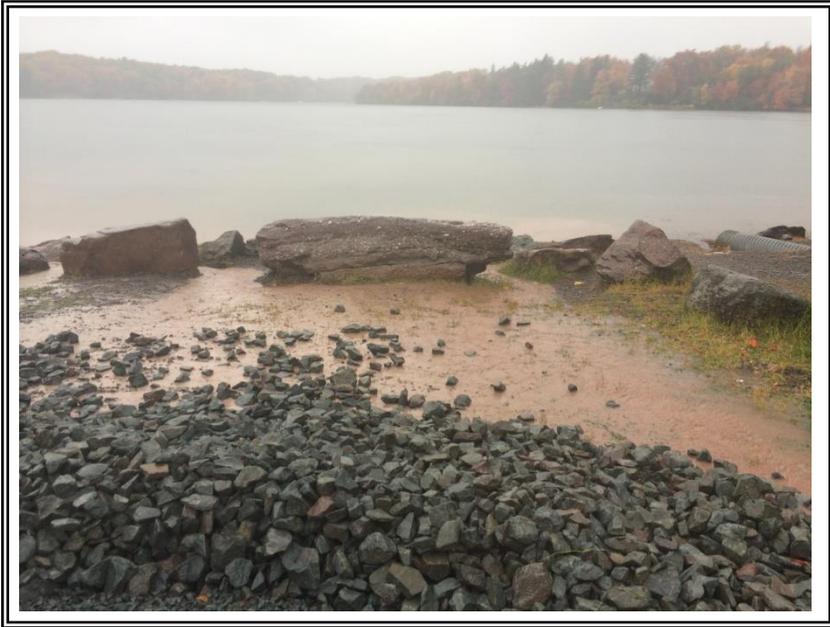
**T18-Boat Access at Wood**  
Run-off into Lake During heavy rains

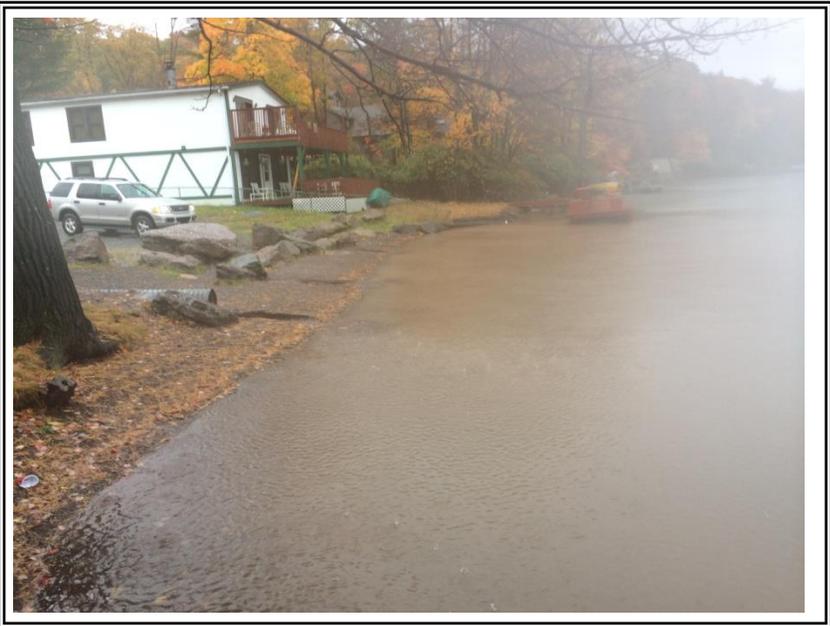
**T18-Boat Access at Wood**  
Discharge to lake

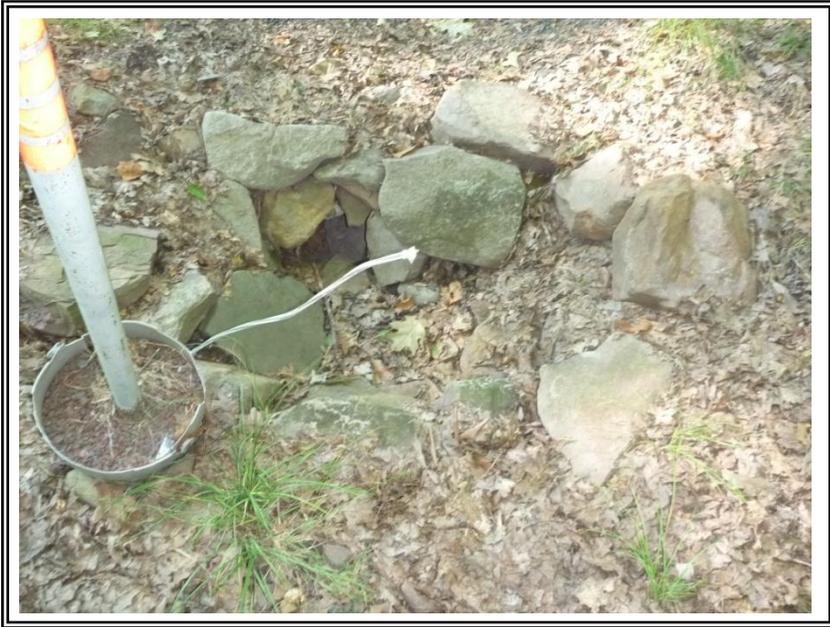
**T19-Skye Drive**  
Upstream crosspipe

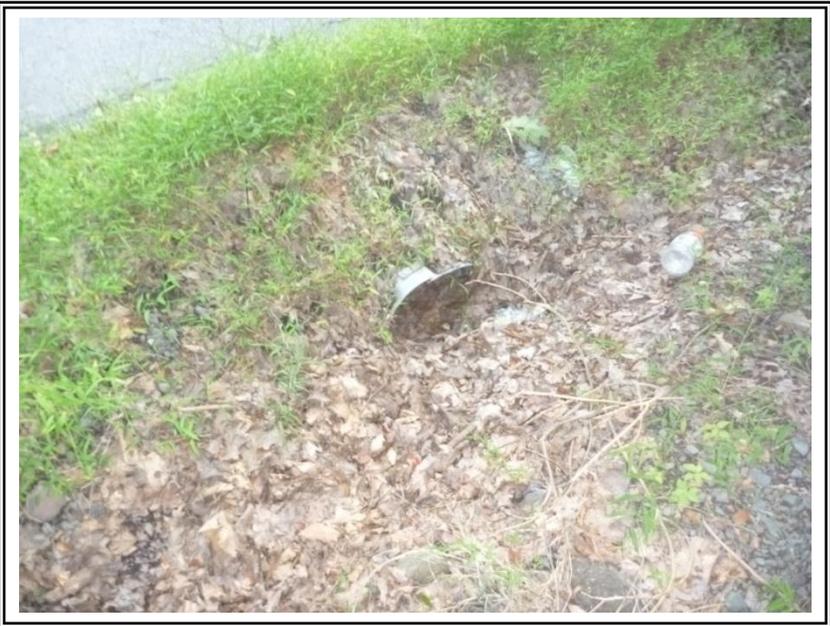
**T19-Skye Drive**  
Discharge to swale

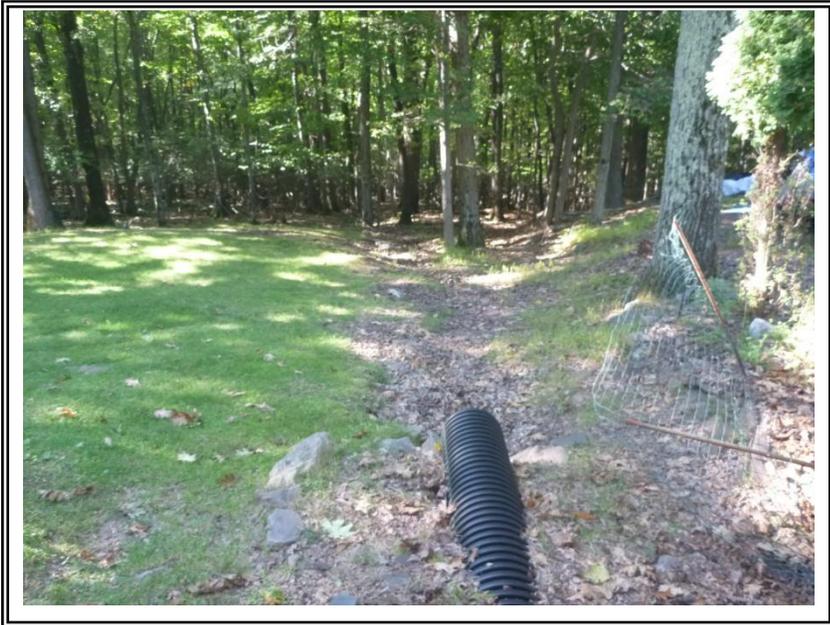
**T19-Skye Drive**  
Discharge to woods

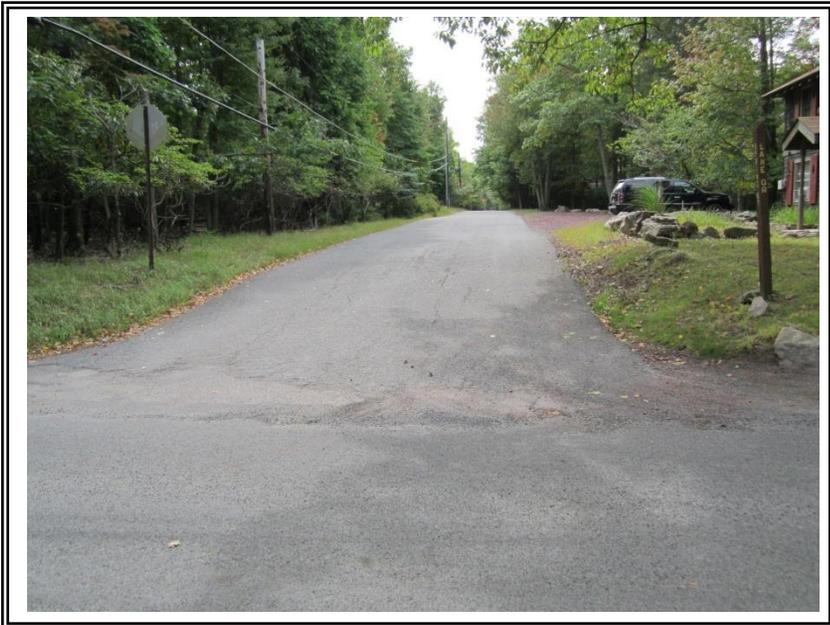
**T21-Spring Street**  
Looking up Spring Street

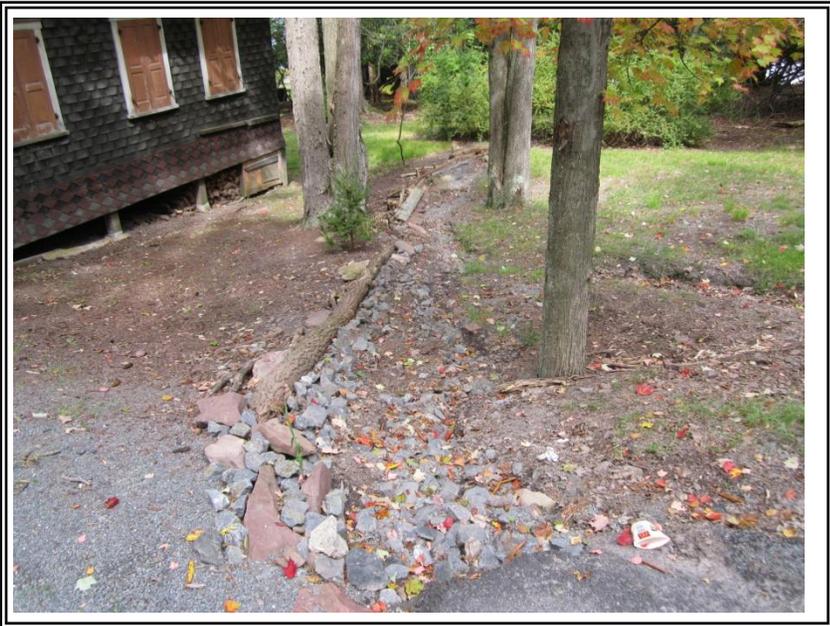
**T23-Henning Street**  
Constructed swale to lake

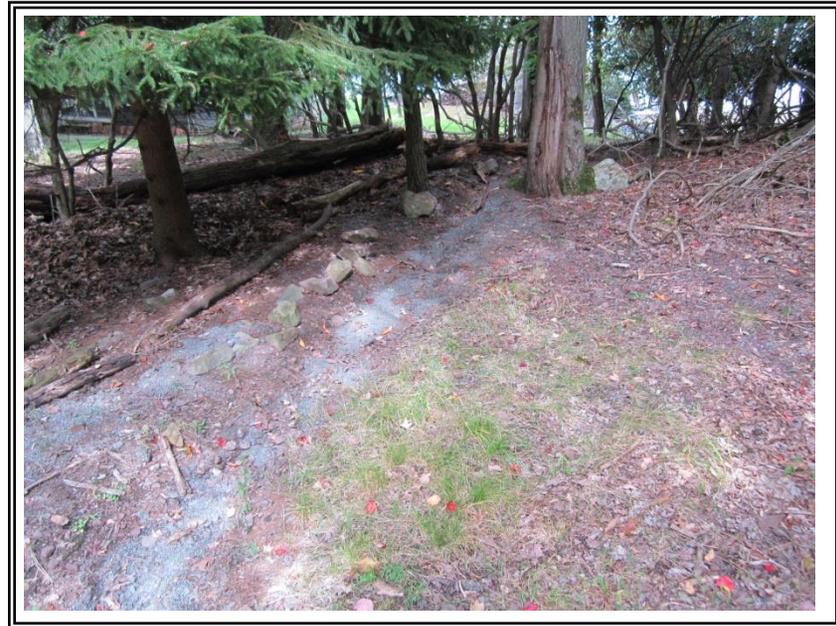
**T23-Henning Street**  
Downstream portion of swale

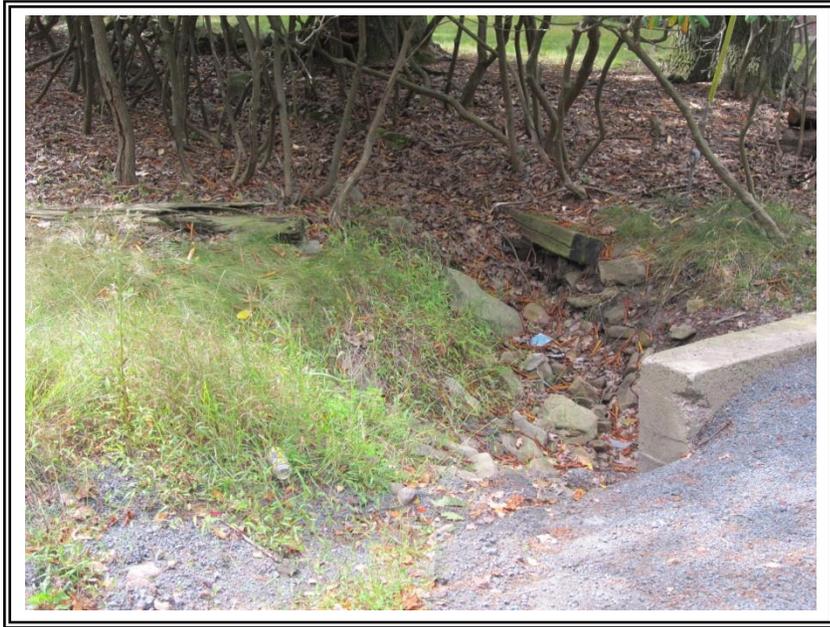
**T23-Henning Street**  
Stormsewer west of swale

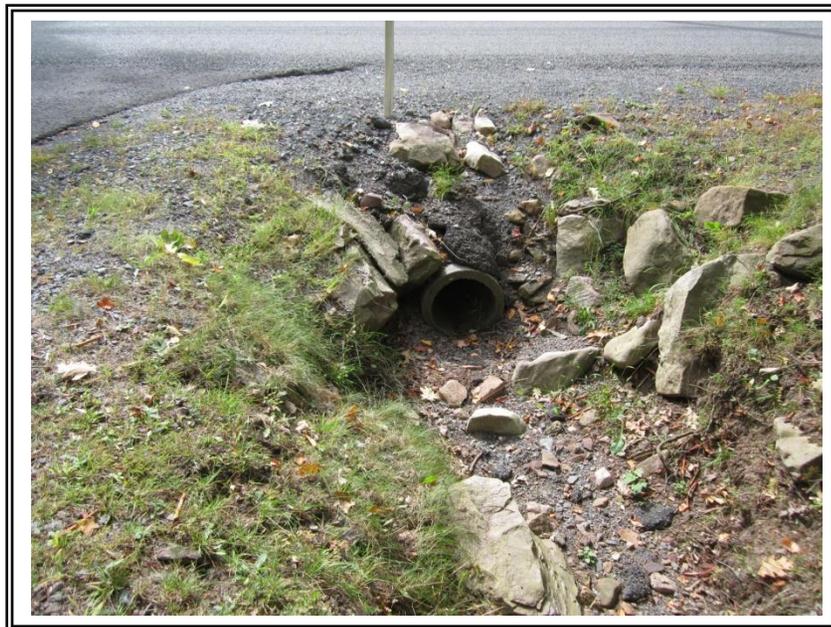
**T23-Henning Street**  
Channel system to lake

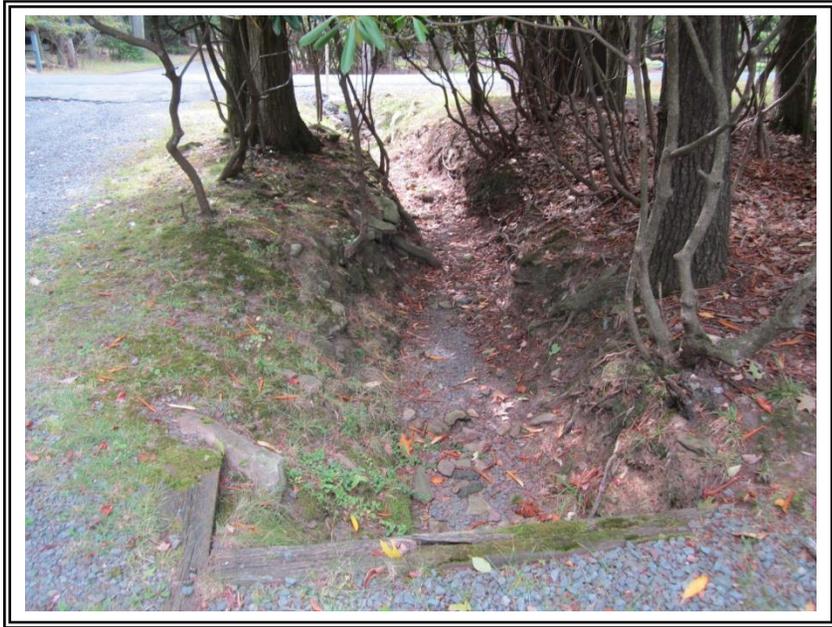
**T23-Henning Street**  
Channel system to lake

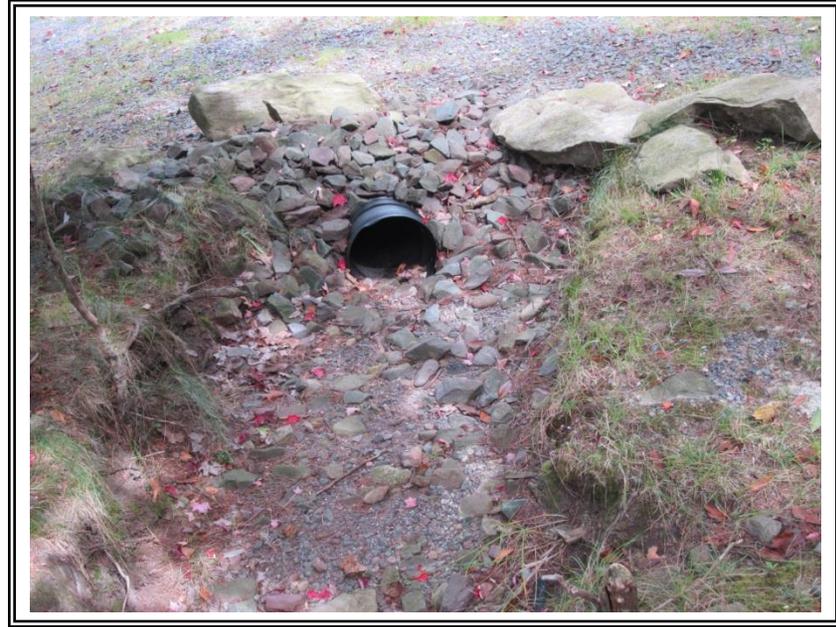
**T23-Henning Street**  
Channel system to lake

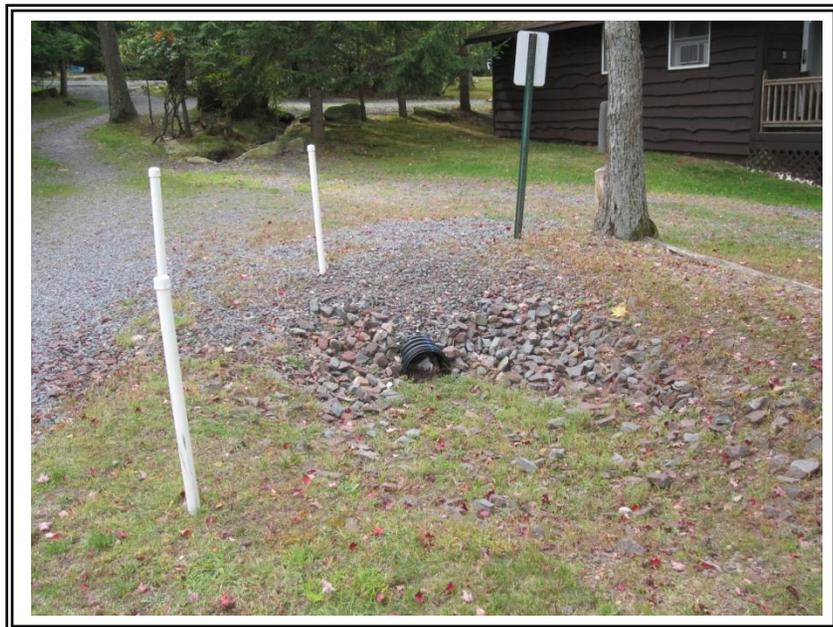
**T23-Henning Street**  
Discharge to settling pond prior to  
lake discharge

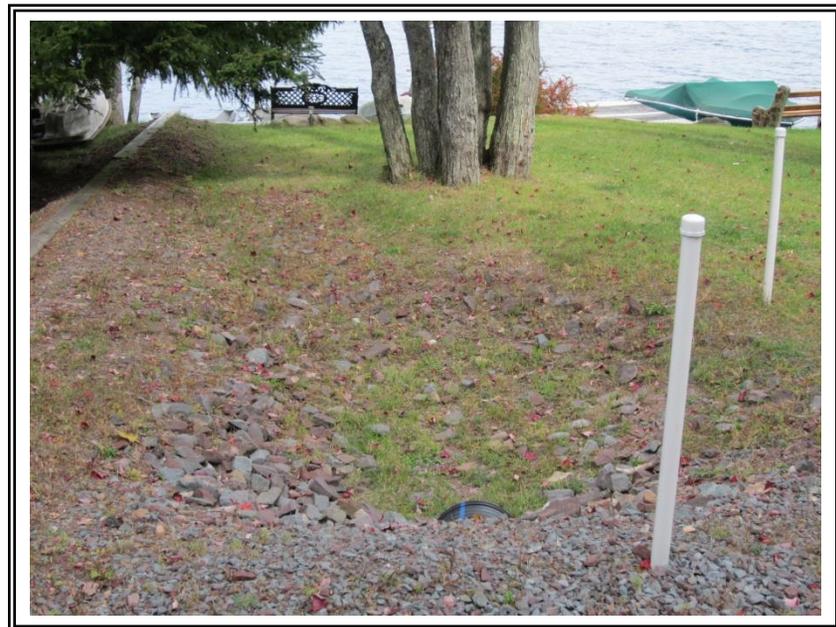
**T23-Henning Street**  
Settling pond

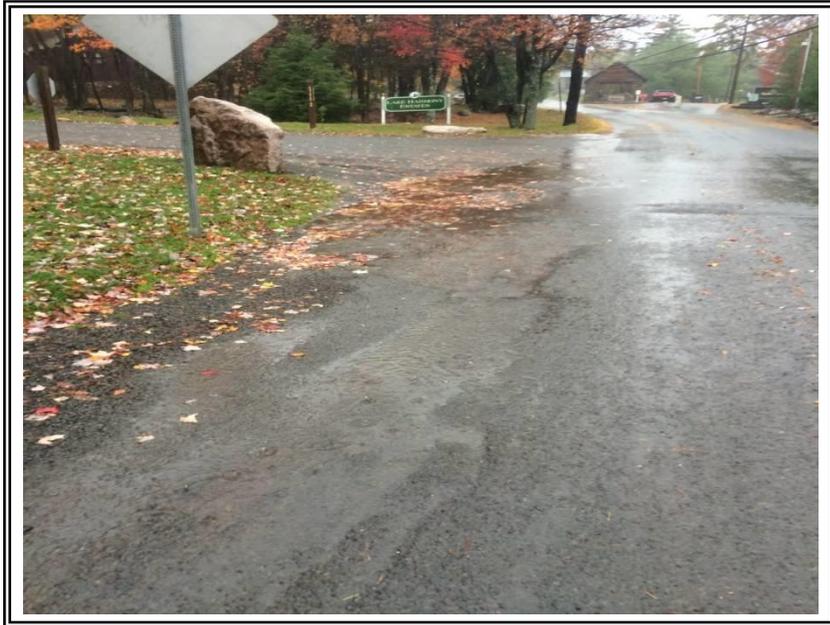
**T24-S.Lake & Estates Drive**  
Upstream run-off north side of road

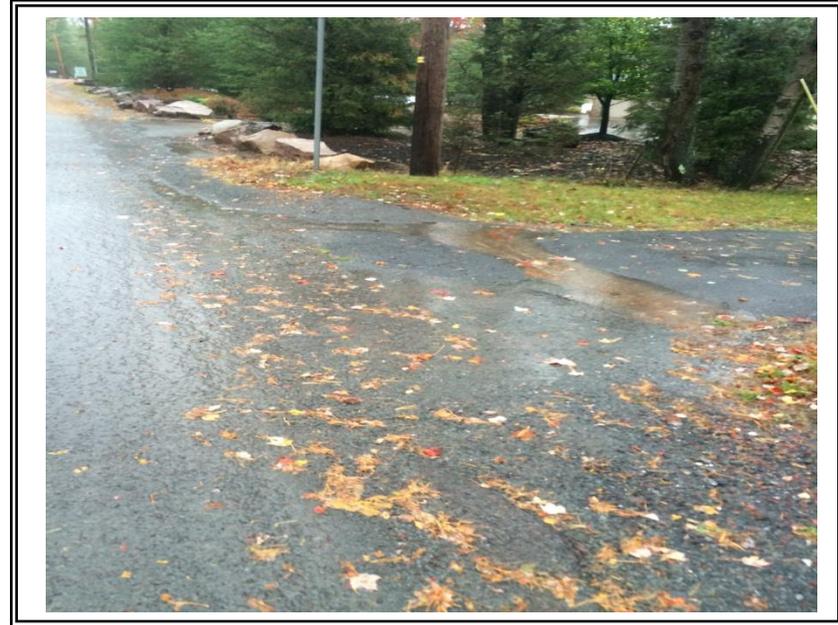
**T24-S.Lake & Estates Drive**  
Runoff South side of road

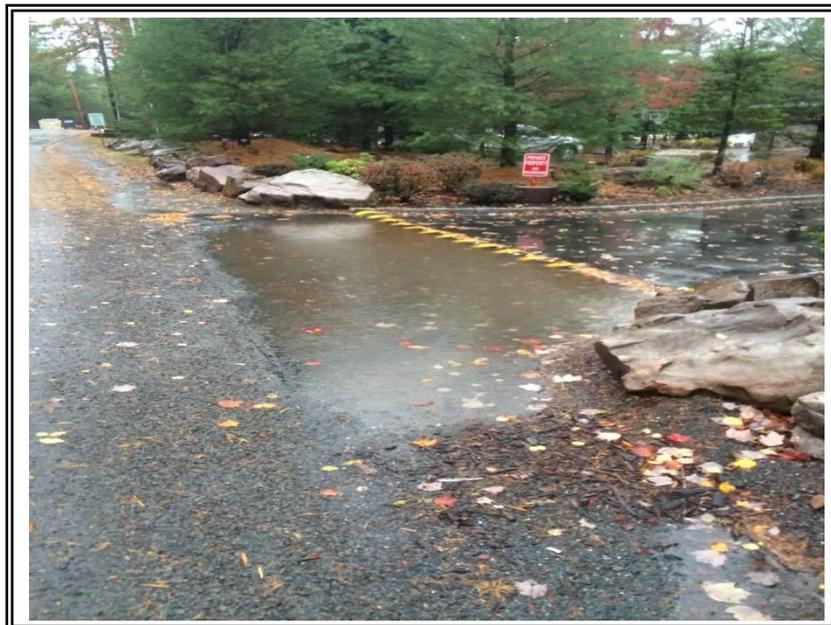
**T24-S.Lake & Estates Drive**  
Ponding at Residential Driveway

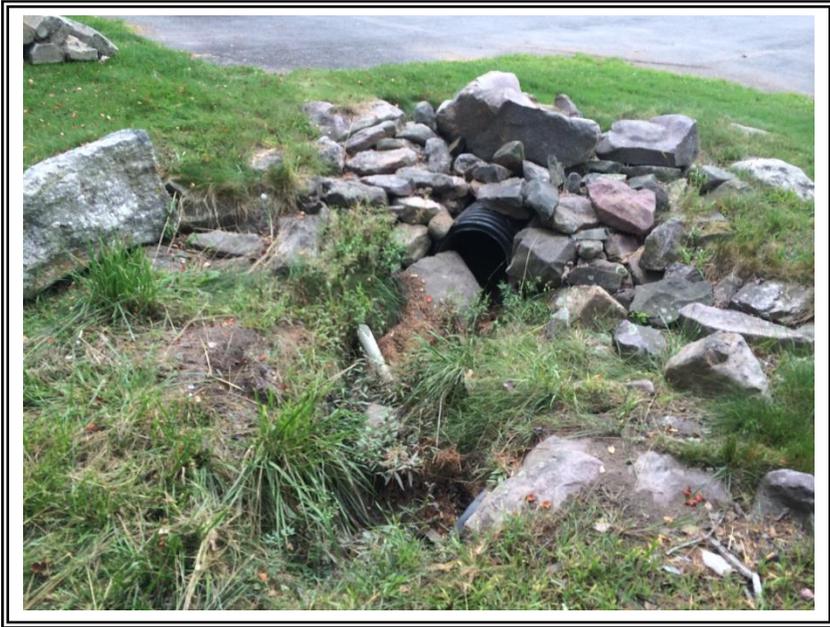
**T25-Split Rock Parking Lot**  
Stormsewer discharge

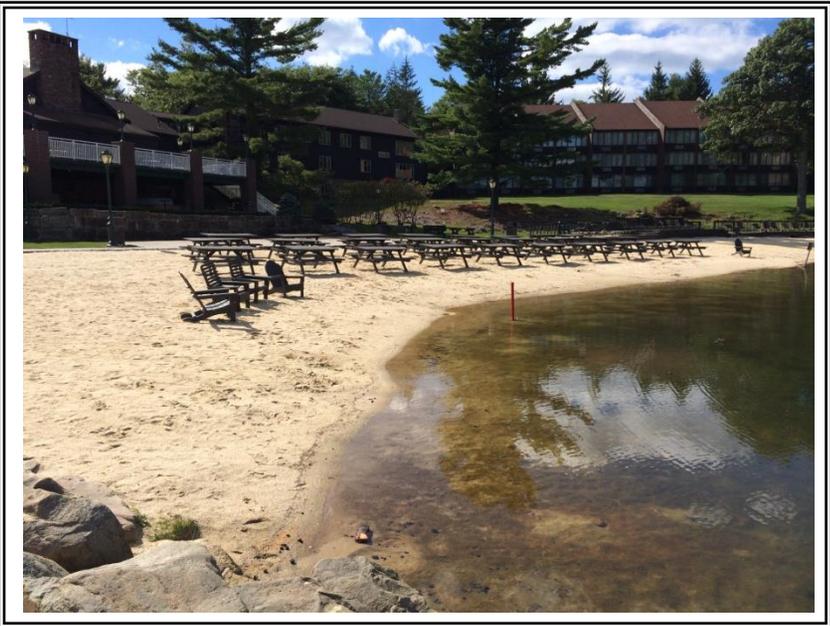
**T26-Split Rock Lagoon**  
Looking towards lodge away from lake

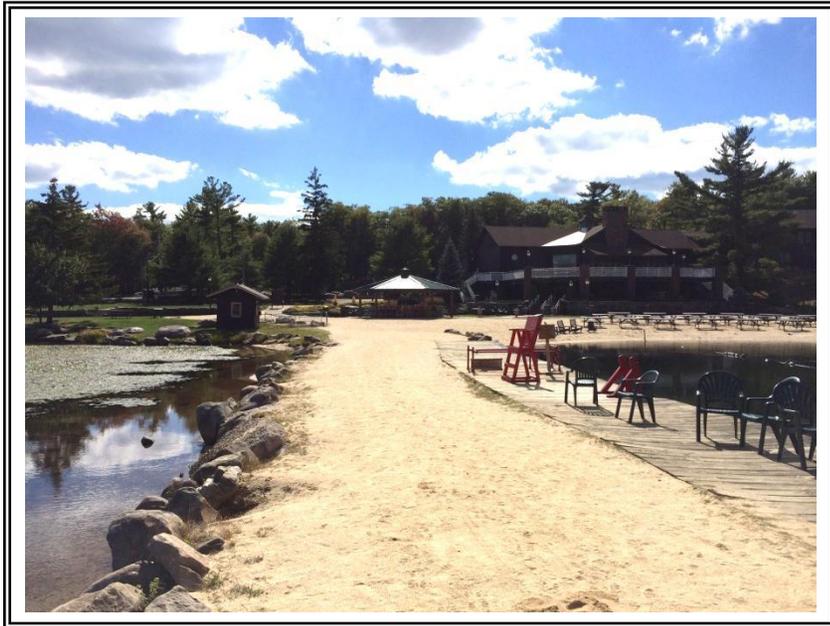
**T26-Split Rock Lagoon**  
Berm between lagoon and lake

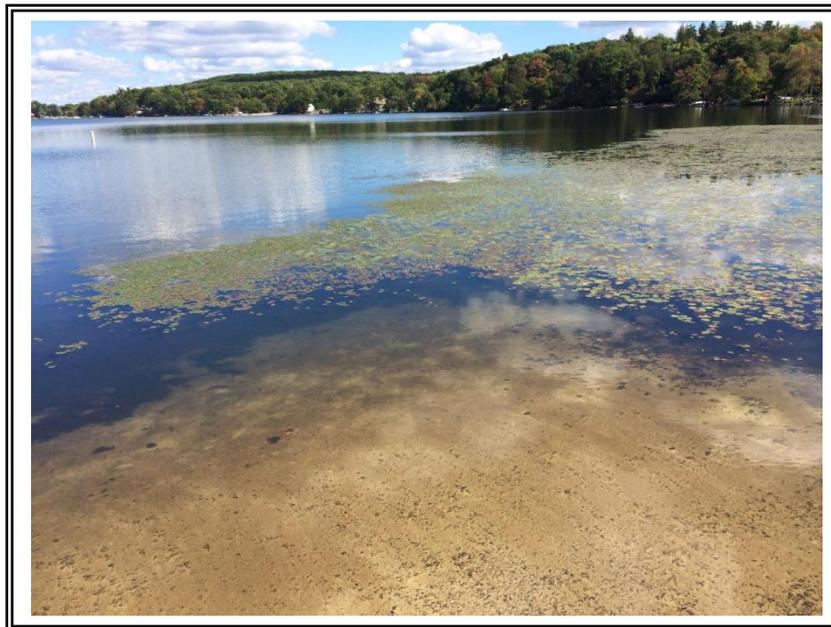
**T26-Split Rock Lagoon**  
Lake side of berm, heavy sand deposits

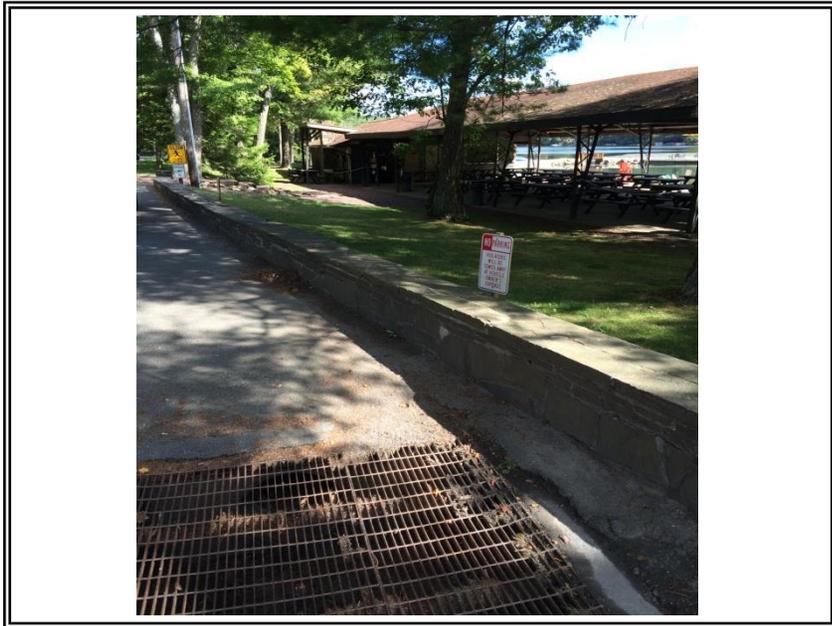
**T27-S.Lake at Split Rock Lodge**  
Inlet with discharge pipe directly to  
Lake

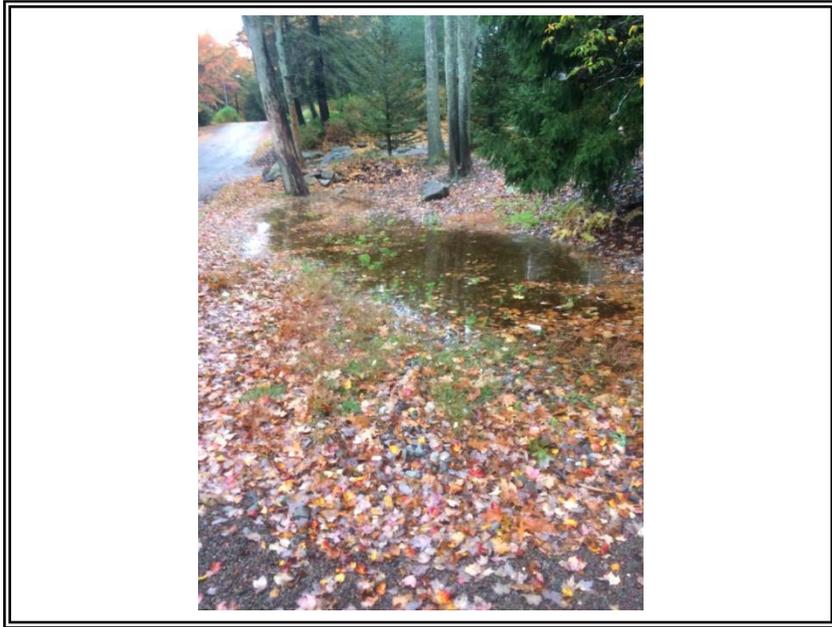
**T29-South Lake and Mosseywood**  
**Intersection**  
Ponding run-off

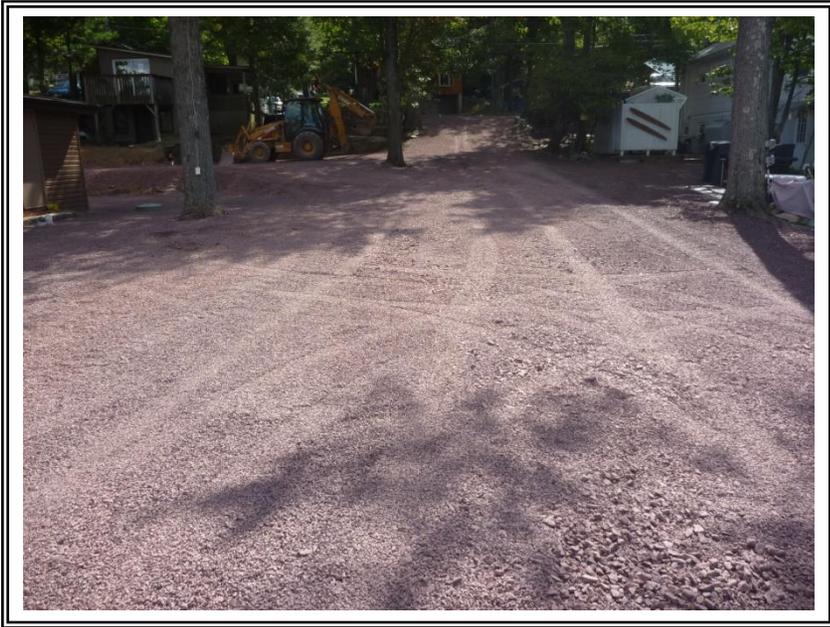
**T32-S. Lake Driveway**  
Stone Driveway

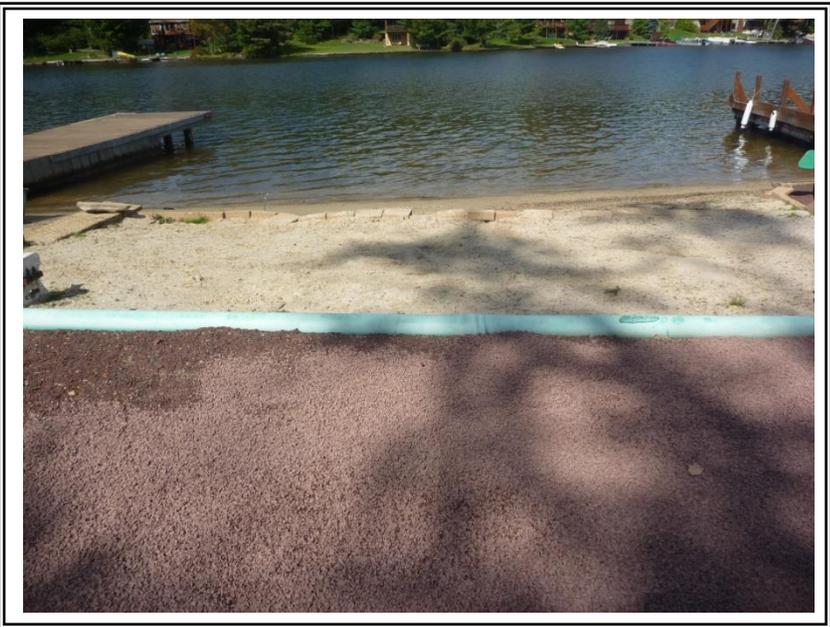
**T32- S.Lake Driveway**  
Stone driveway and sand beach

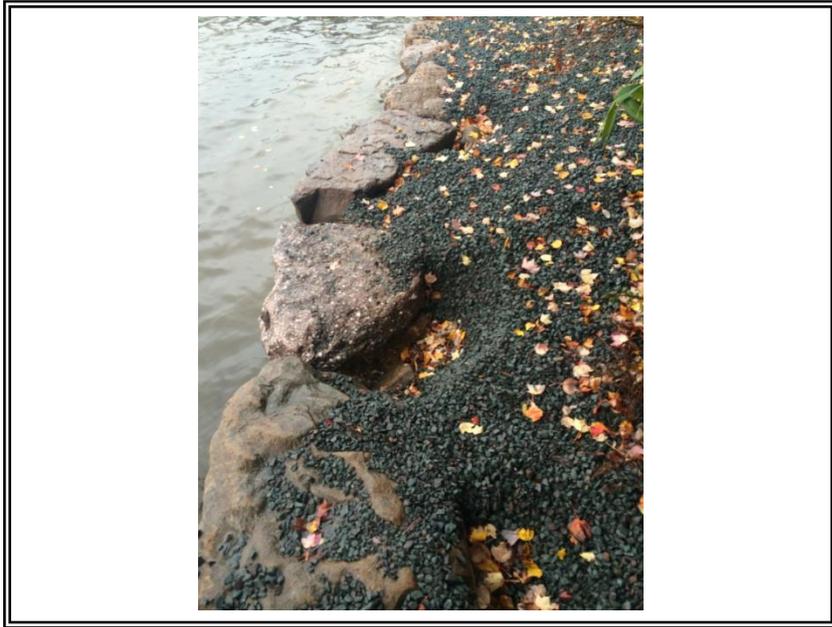
**T32-S. Lake Driveway**  
Residential use of stone and sand

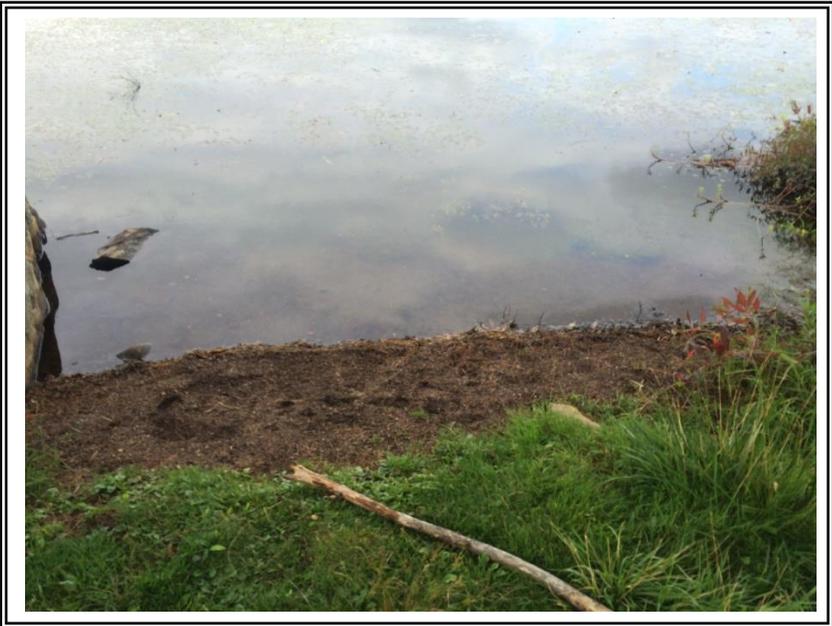
**T32- S.Lake Driveway**  
Boat Launch Areas

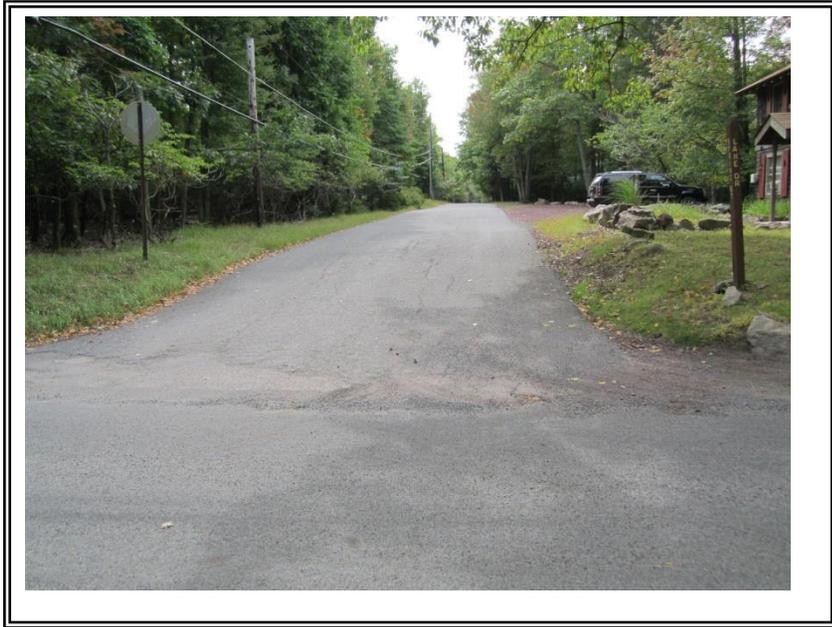
**T33-Lake Harmony Estates**  
Paved roads no crown, roadside  
swales or inlets at South Lake Drive

| Problem Area | Location | | Item Description | Quantity | Unit | Unit Cost | Price |
|---|---|---|--|---|---|---|---|
| T33<br>(H) | Lake Harmony Estates | | Road Repair (6" 2A stone, 4" Base Course, 1-1/2" Wearing Course) | 14500 | SY | \$ 55.00 | \$ 797,500.00 |

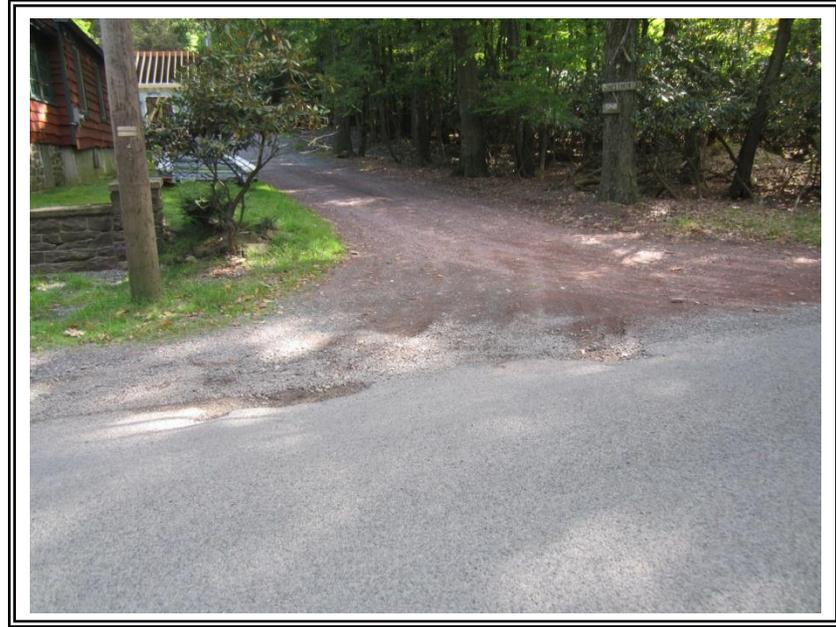
**T33-Lake Harmony Estates**  
Unpaved Roads Intersecting South Lake Drive

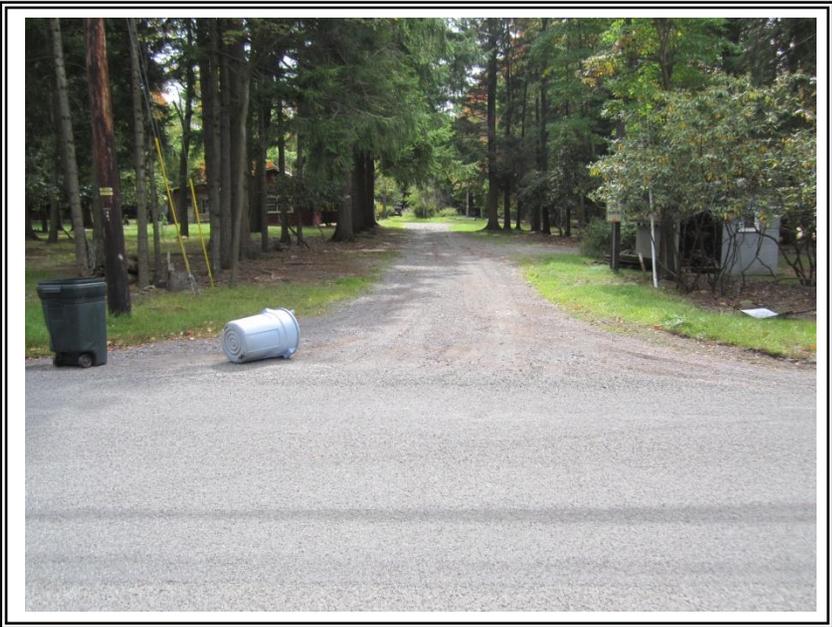
**T33- Lake Harmony Estates**  
Unpaved and uncrowned roads

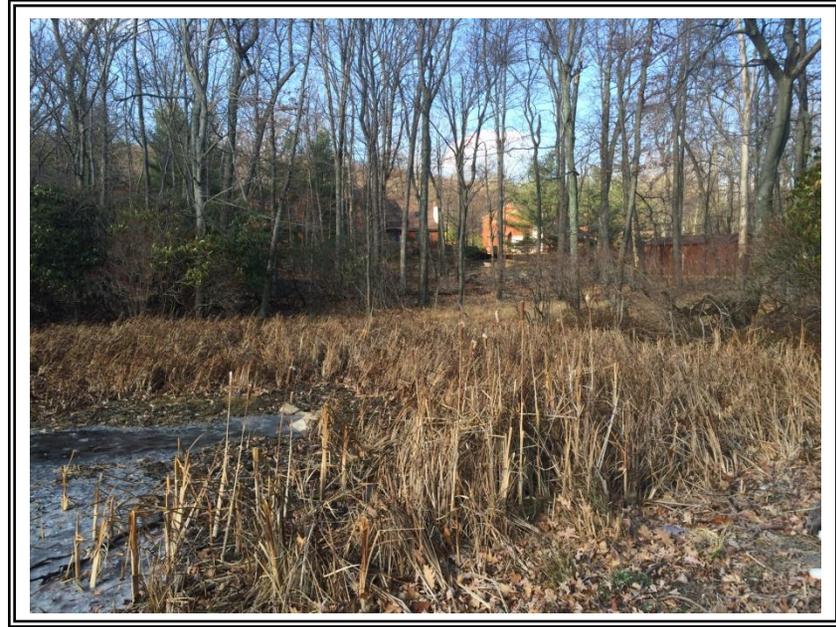
**T34-Blue Heron**  
Wetland settling area prior to Lake

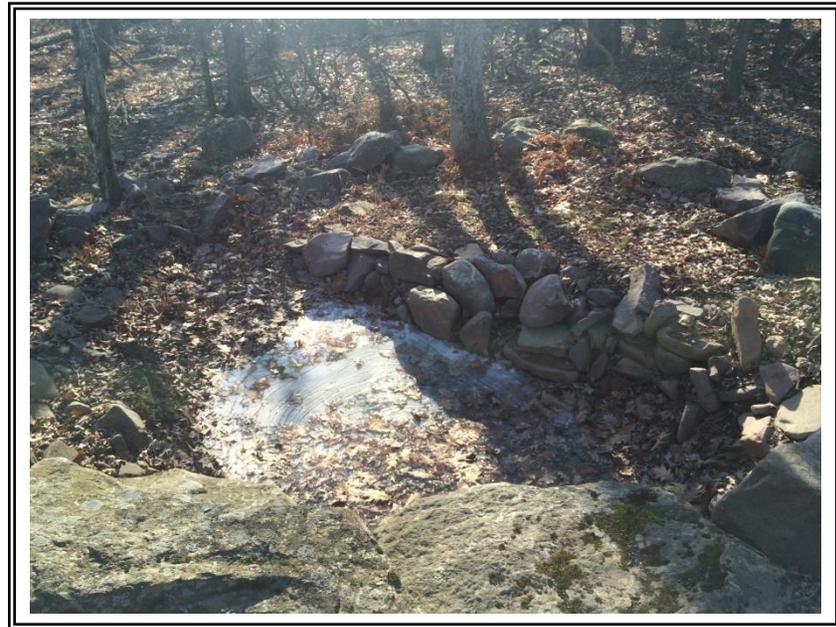
**T34-Blue Heron**  
Stilling Basin Below Pipe Discharge

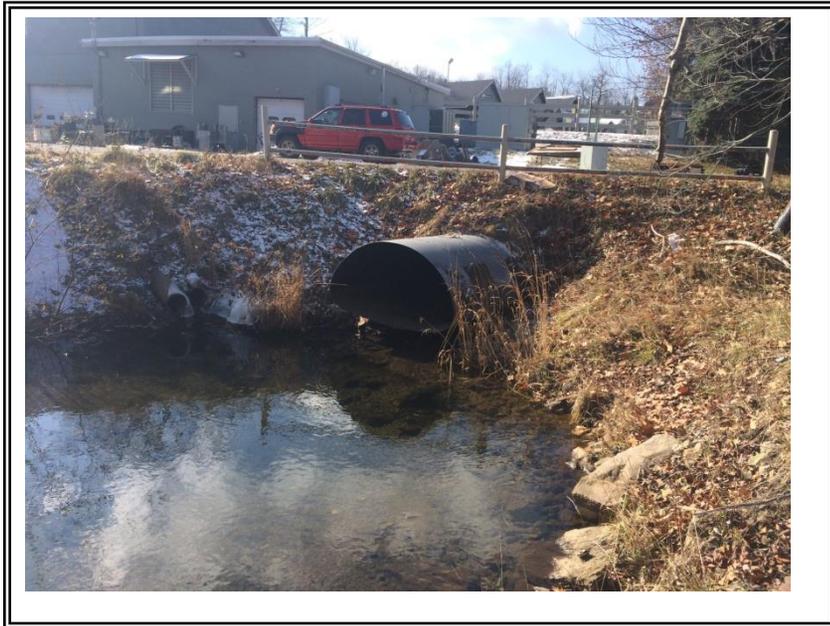
Existing Deficiency: Large dirt and gravel parking lot downstream of ski slope. Heavy vehicle usages and pollution generator, with an existing rock swale and rain garden facility at the bottom that outlets to the lake.

**T36-Big Boulder**  
Drainage pipe of Ski resort to lake

Recommendation: Conduct a study to investigate upstream drainage area and re-size rain garden to handle anticipated flows. Perform routine maintenance to remove sediment and install additional vegetation in the basin to filter runoff. Continuing repair of bare dirt spots with stone or consider paving main drive aisles to drain to infiltration beds or other means to promote infiltration and to reduce sediment runoff from stone driveways.

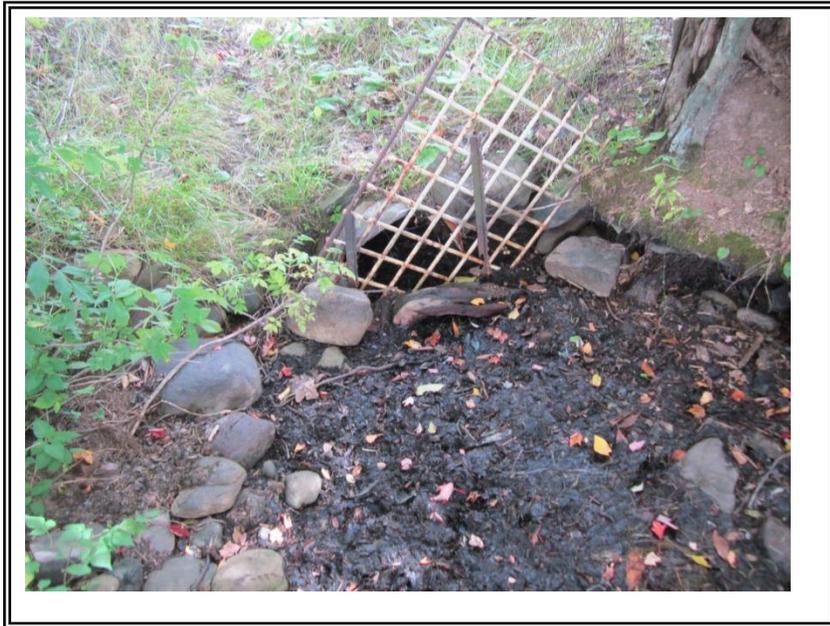
Existing Deficiency: Pipe culvert between water bodies and outlet structures experiencing deterioration. Heavy roadway anti-skid and oil and chip material entering lake and pond.

**T38-Big Boulder & Round Pond Pipe**

Recommendation: Request additional street sweeping and vacuum procedures along this area to remove and minimize roadway material from entering the Lake. Install vegetative berms or filter strips to provide large areas of vegetation to capture sediment and filter water before entering into the bodies of water.

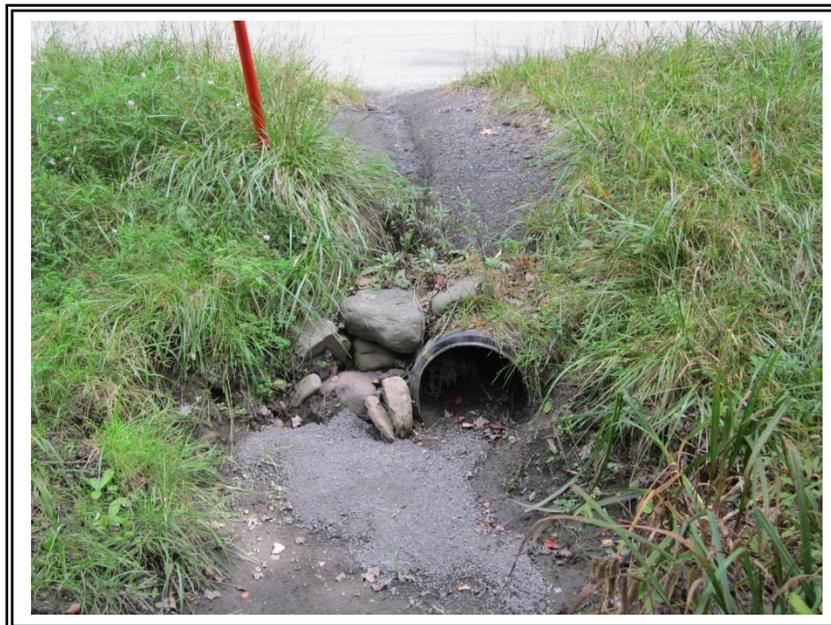
**T38- Lake Harmony Road**  
Pipe discharge above Big Boulder  
Lake

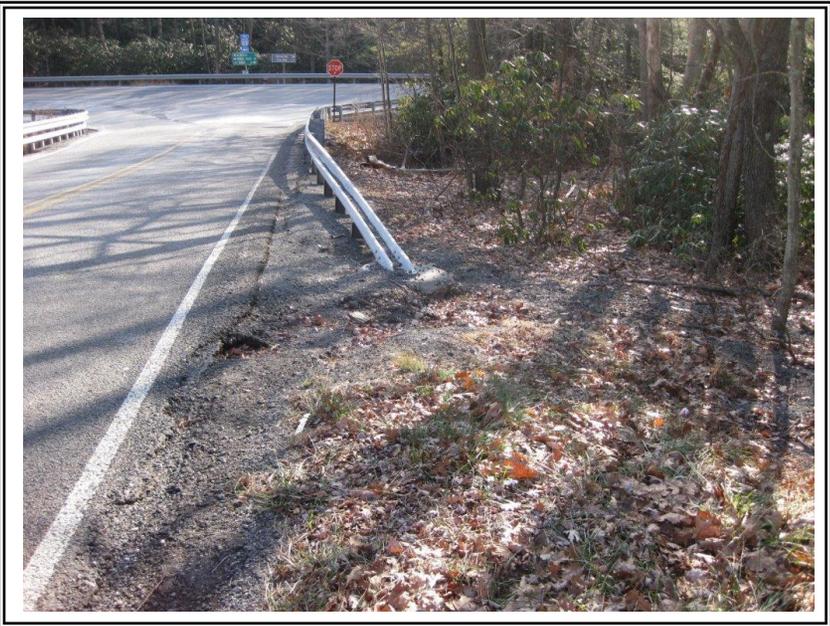
Existing Deficiency: Large accumulation of anti-skid and oil and chip stone material along edge of road and culvert headwall.

**T39- Lake Harmony Road**  
Eroded shoulder and roadway  
material deposits

Recommendation: Perform additional street sweeping and vacuuming of roadway surface. Install compost filter and/or rock filter berms at each corner of the wingwalls to provide locations for roadway debris to accumulate; ensuring removal can be easily performed.

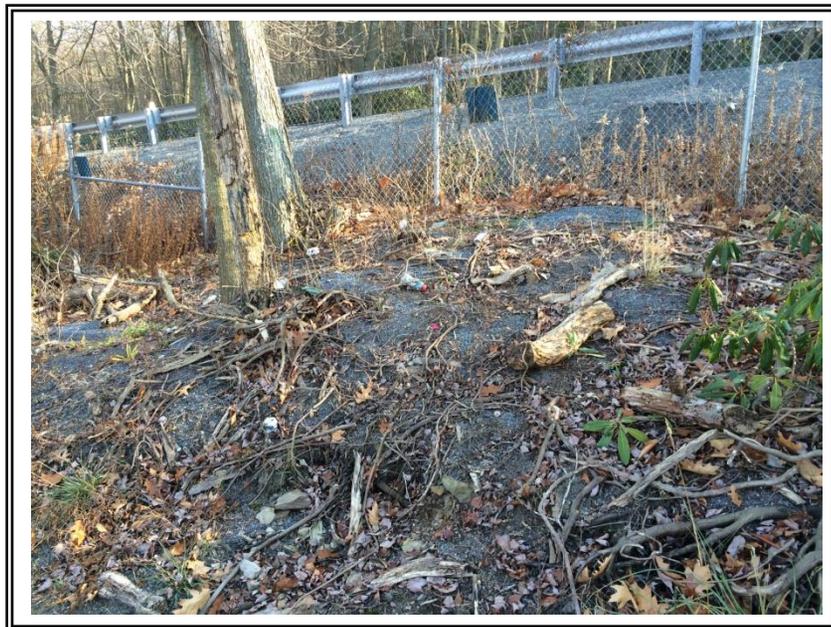
**T40- SR 903 & Big Boulder Dam**

Existing Deficiency: Large accumulation of anti-skid, roadway debris, and trash blocking the existing inlet on south side of SR 903. Large accumulation of sediment and trash at outlet pipe location and down along the bank towards the outlet of Big Boulder Lake and stream.

Large deposit of roadway debris and garbage below clogged Inlet

Recommendation: Clean and remove debris and sediment from inlet and outlet location. Property owner has installed several check dams downstream of outlet pipe that is collecting sediment and filtering water. Maintenance and removal of sediment behind check dams should be performed and additional dams installed as needed.
